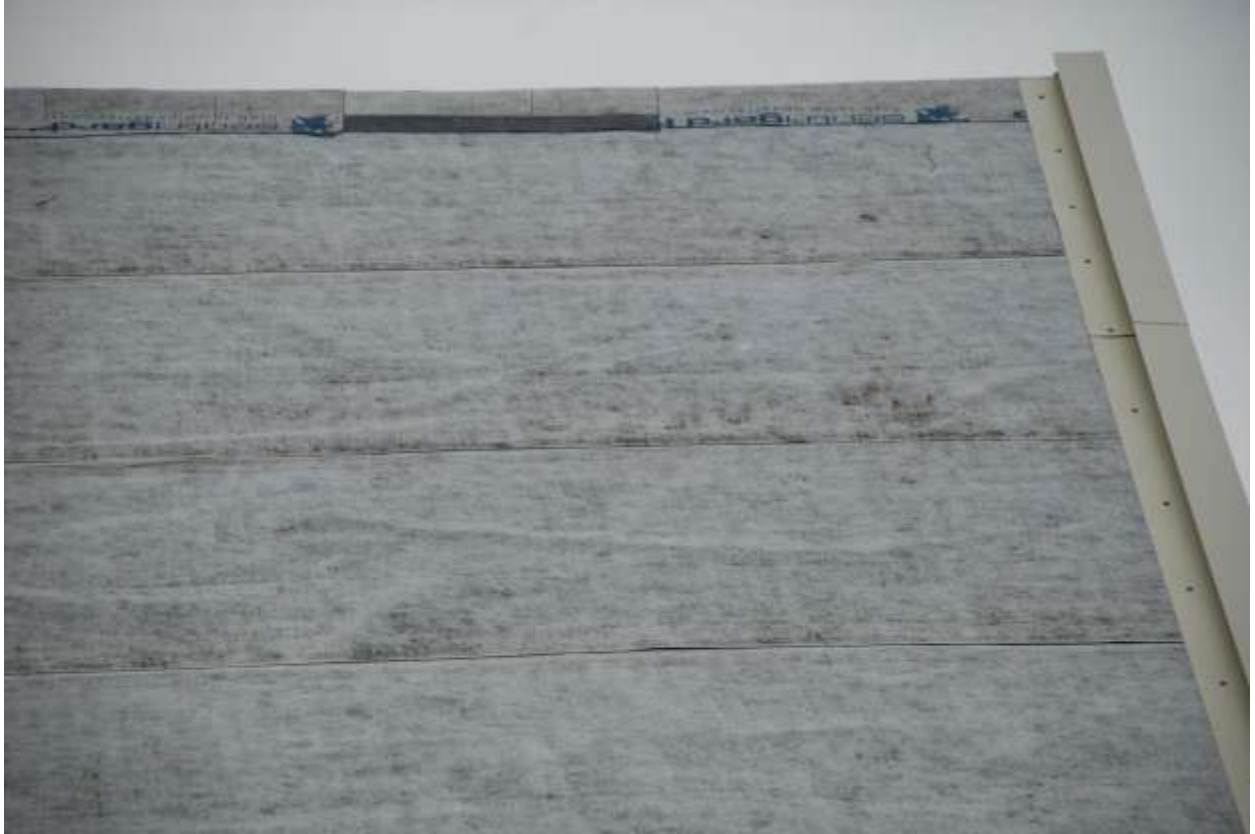
Found this pic here showing how the underlayment was installed. I don't remember if this is layer 1,2, or 3. They are all the same material and the first 2 were either stapled or nailed which is both wrong

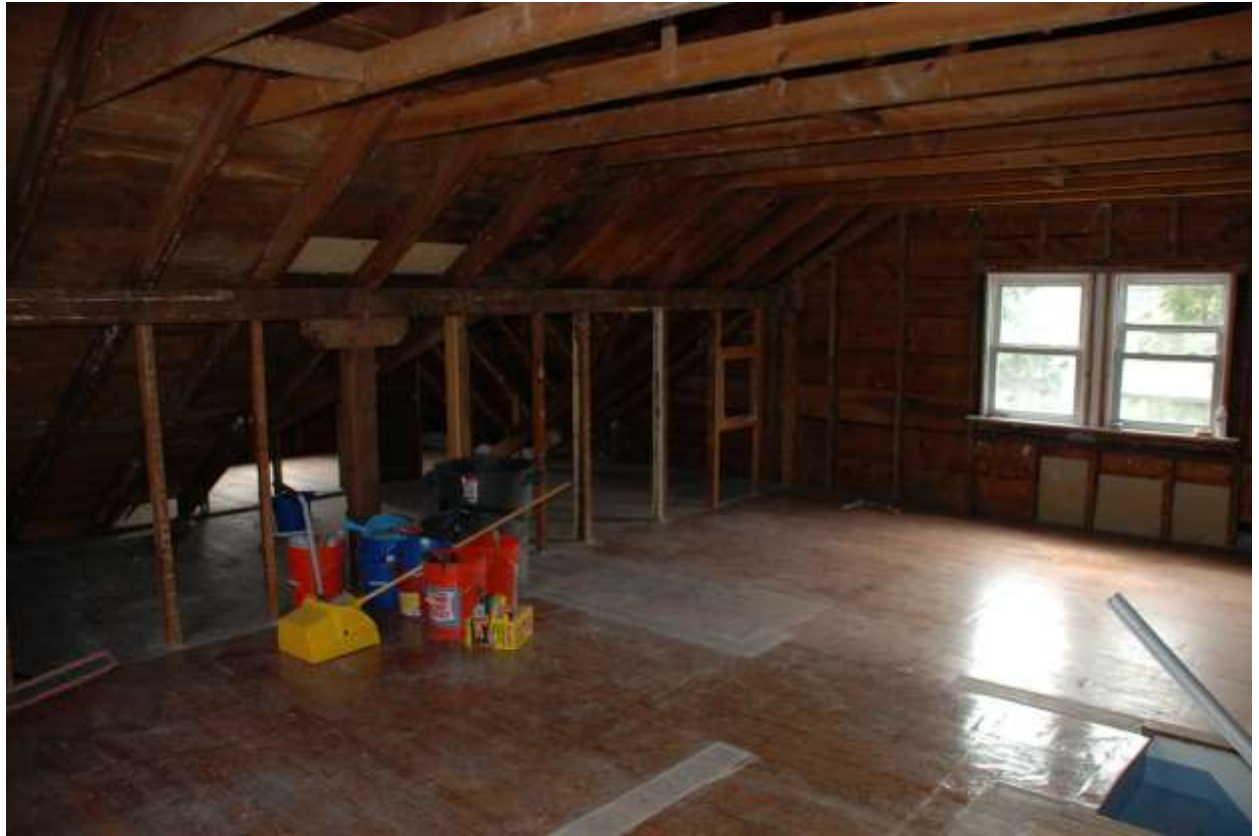
The surface mold was quite a bit of work to remove. I used TSP which worked fine but it's quite potent. Supposedly it prevents future mold growth as well that's why I used it:

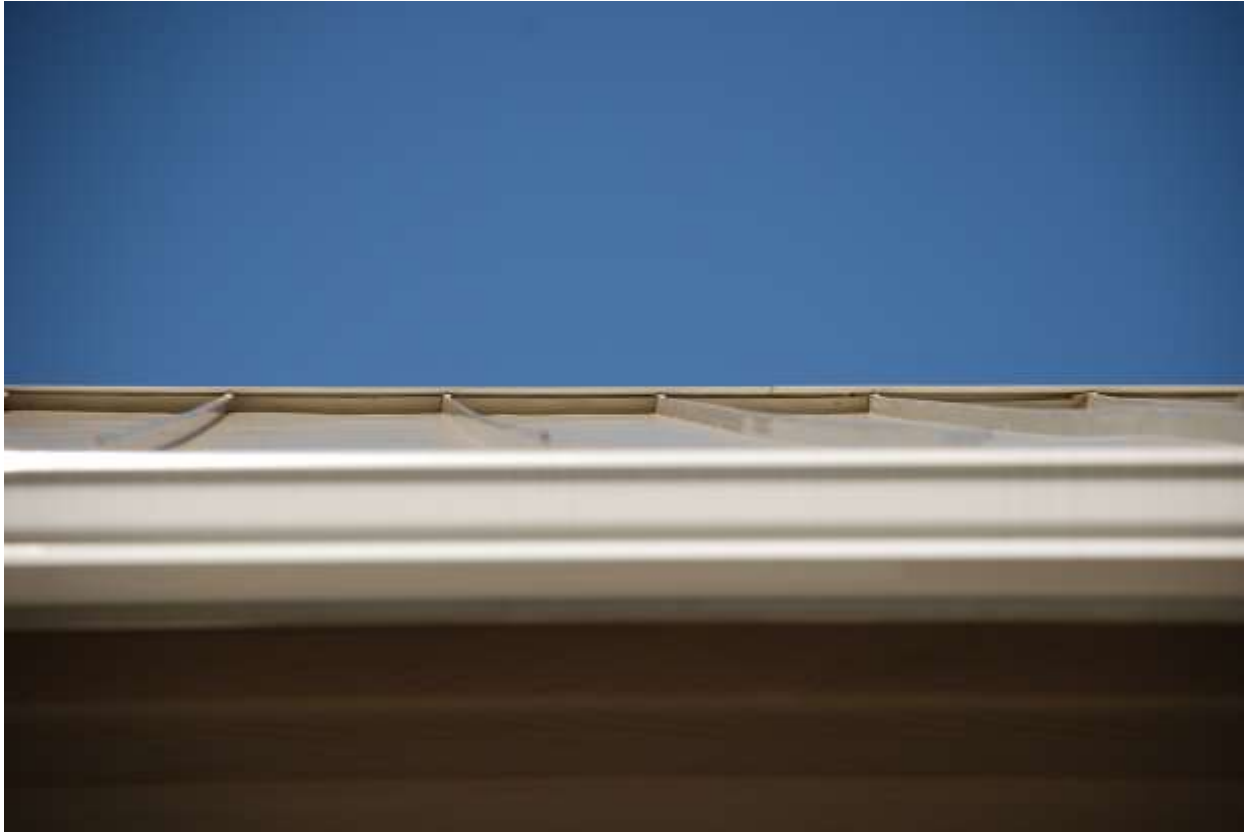
It's funny that up until now no one in this forum believes it's the roof. All other experts I talked to were quick to blame the roof and nothing but the roof. You can see here the gaps between metal cap and

panels. Lots of roofers told me “you gotta have a z-closure” to prevent wind-driven rain from entering:

And indeed the water dripping from the ceiling started at the end of May right after a strong thunderstorm with unusual wind driven rain patterns.

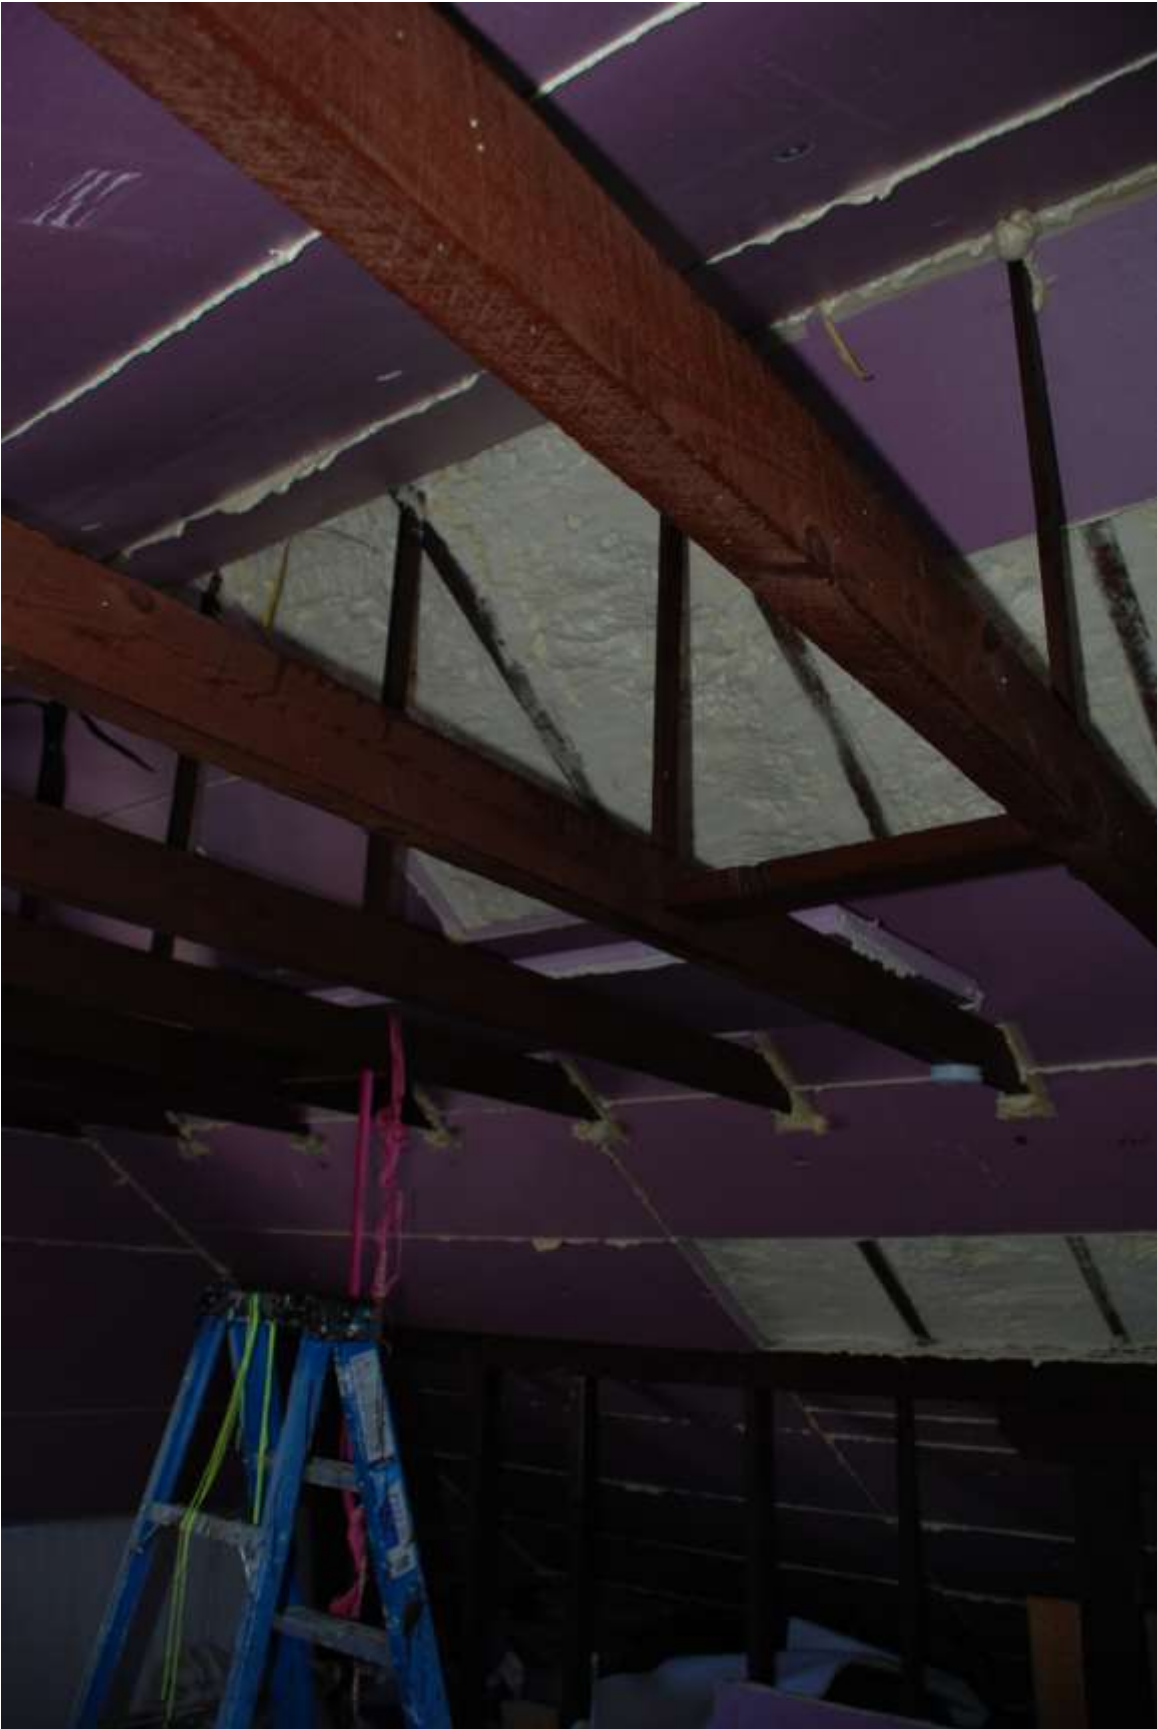
This pic shows the XPS over the Icynene after I started taking it back down again. When I took out the top 2 sheets, they were wet behind. More than a pint of water behind each XPS sheet, at least it looked like that much.

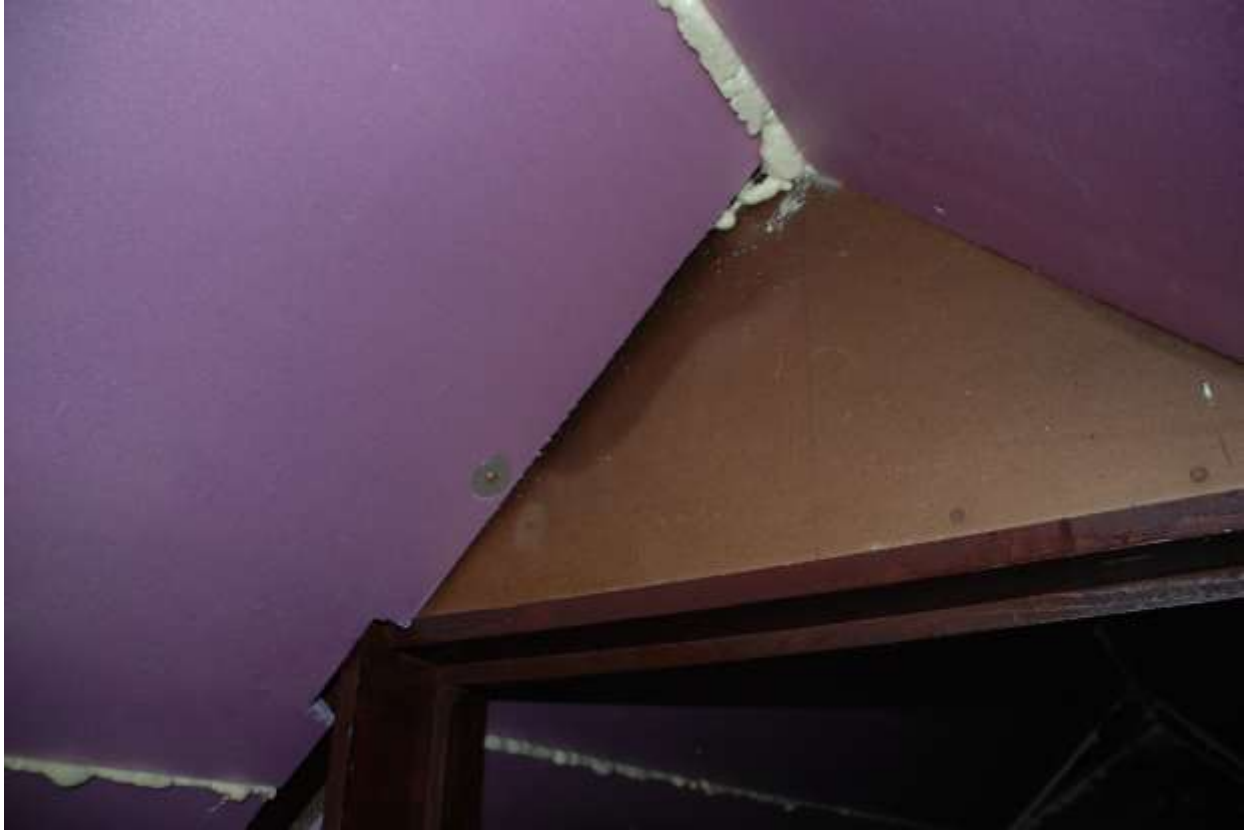
This is how the moisture problem started to manifest itself, wet drywall:

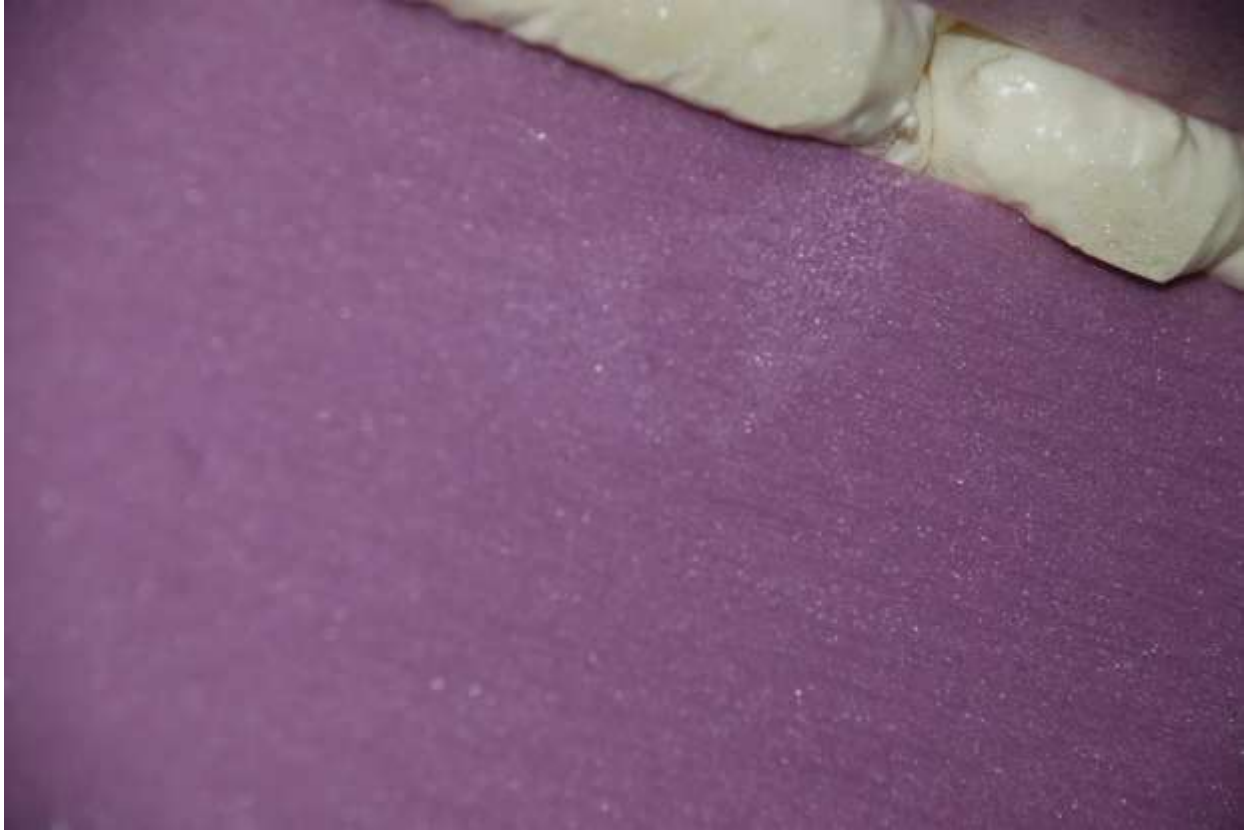
Initially at a handful of spots you would only see this at the very top: There's moisture apparently escaping from behind the foam and condensing on the XPS surface:

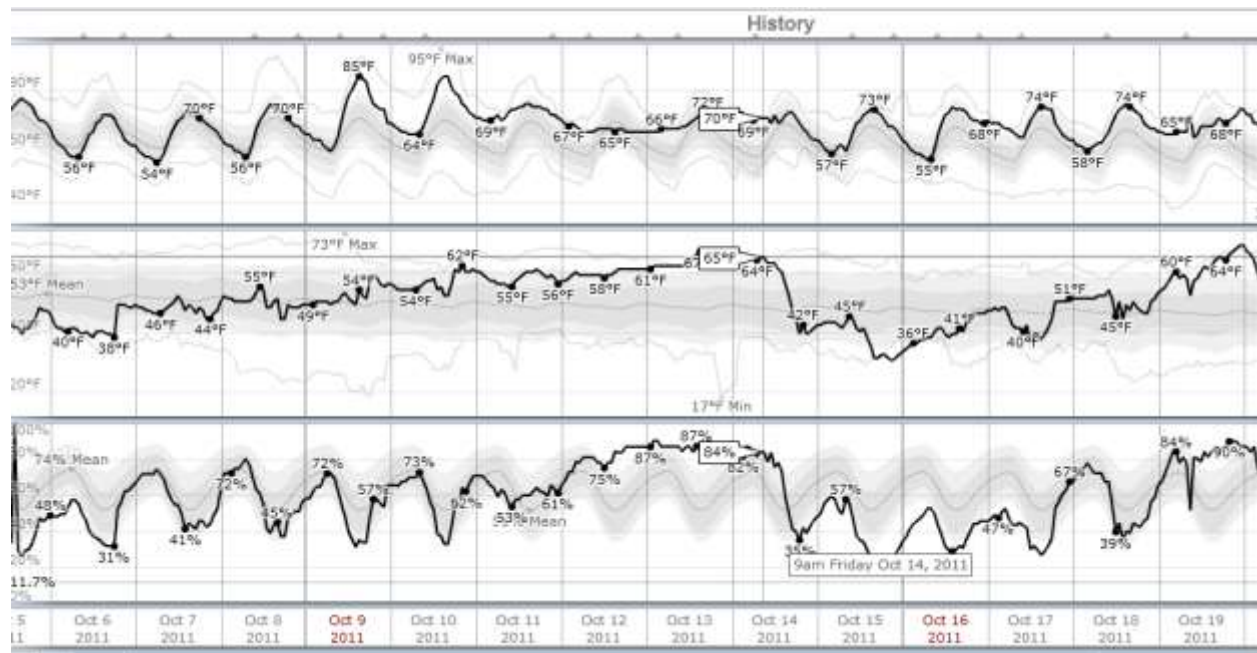
Was the foam not installed correctly? The foam was installed when the RH and hence dew point were relatively high. 70F air temp at weather station, 65F dew point, and over 24h of over 84% RH before spray foam was applied:

It could be the planks were a little moist when they started in the morning but I didn't check that day.

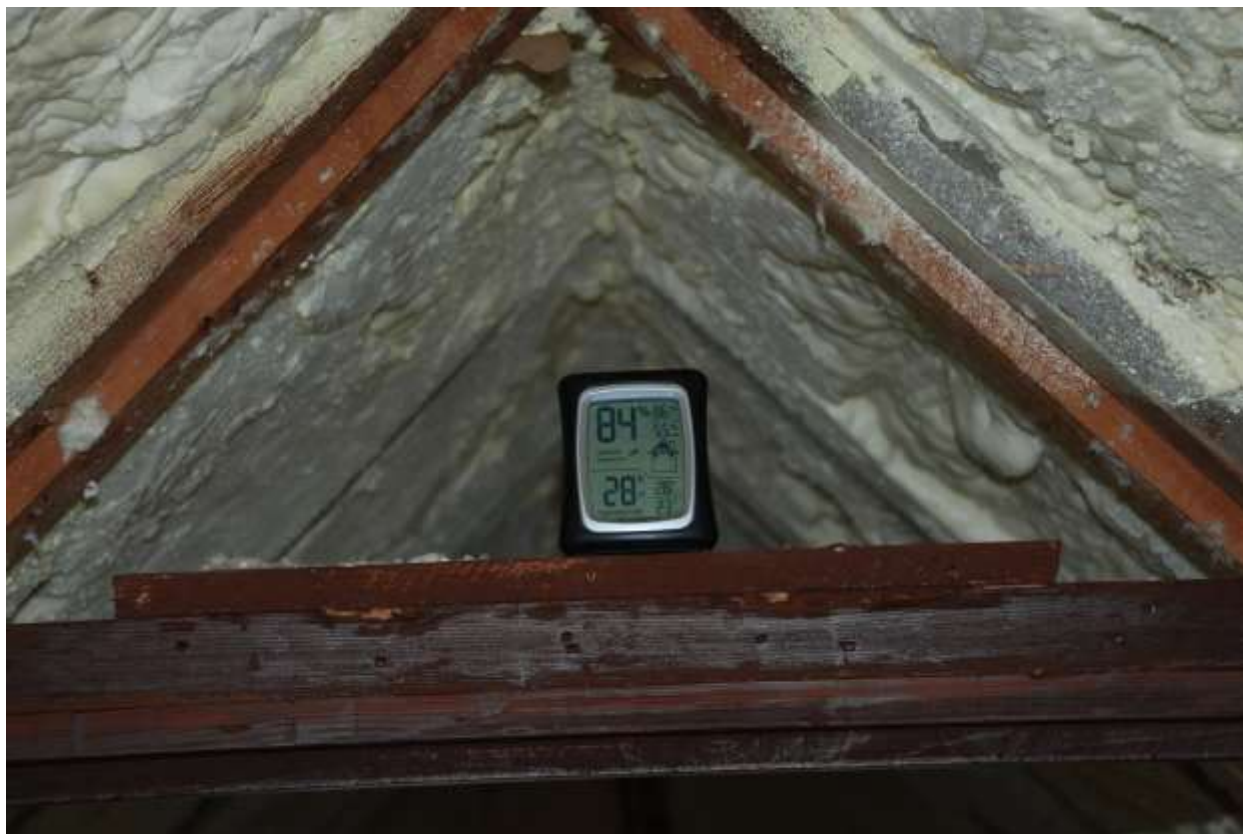
This is what happens every single day after around 10AM since beginning of June:

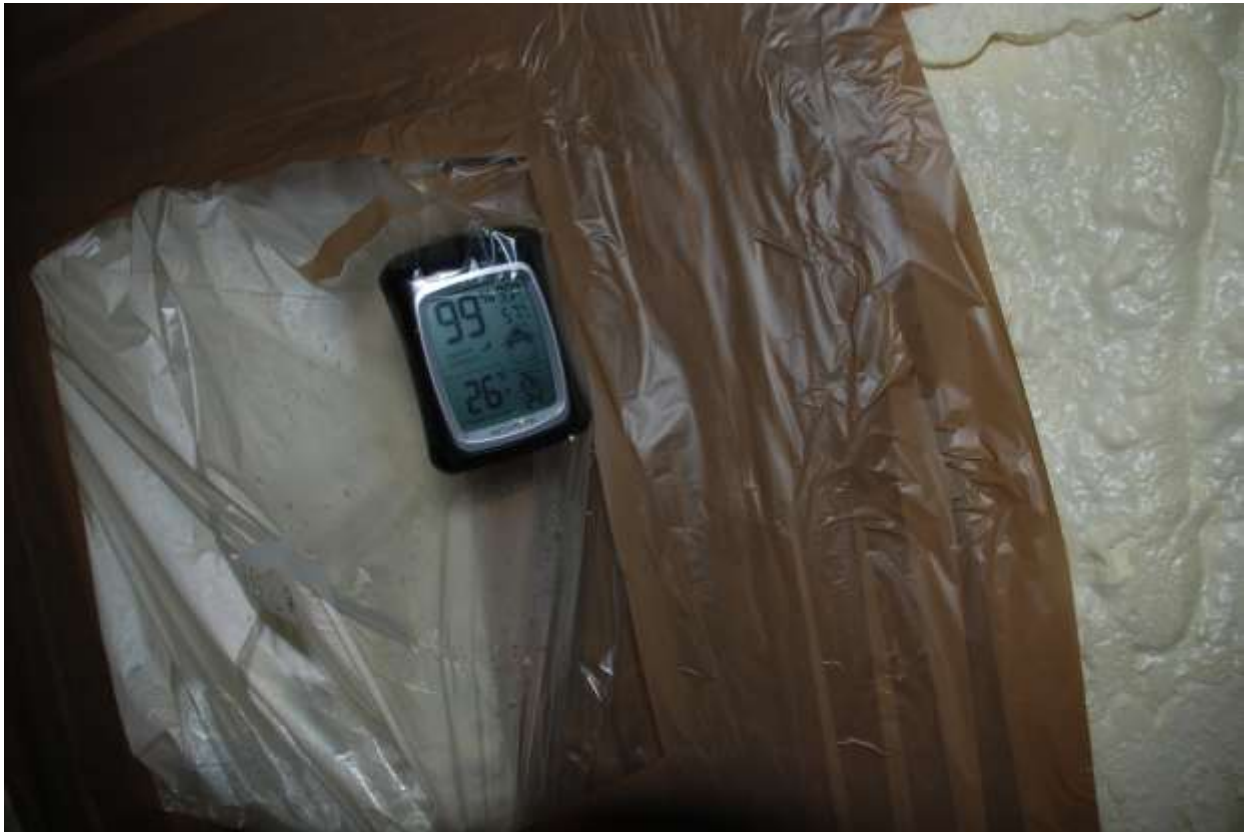
Check this out, around 11:30 AM the RH shoots up to 100% while the other exposed thermometer is still in the 50s:

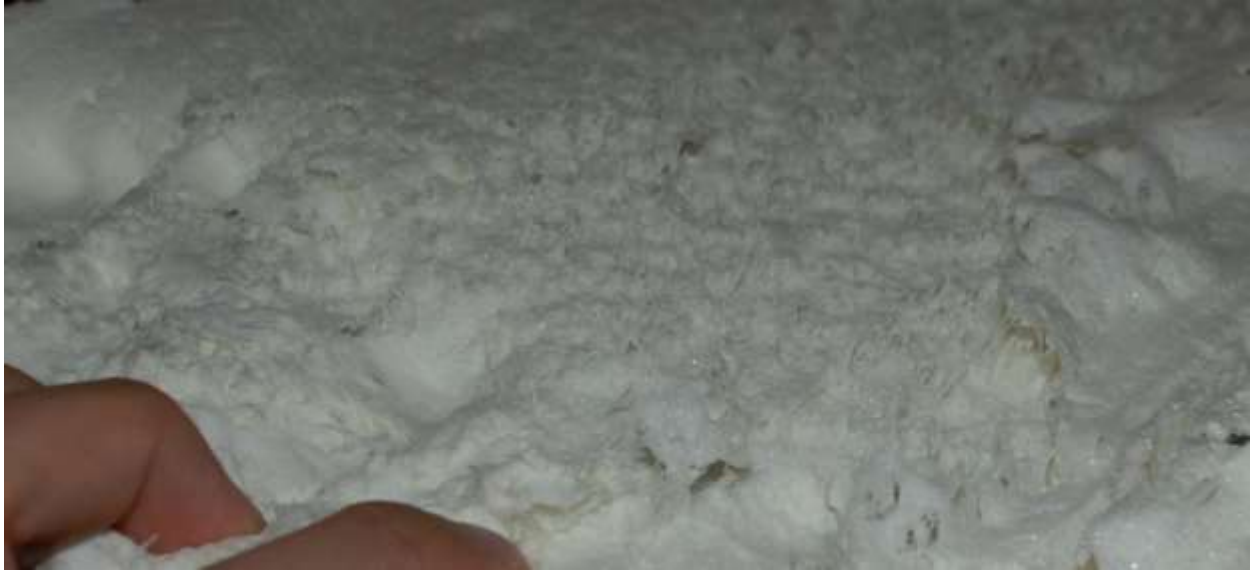
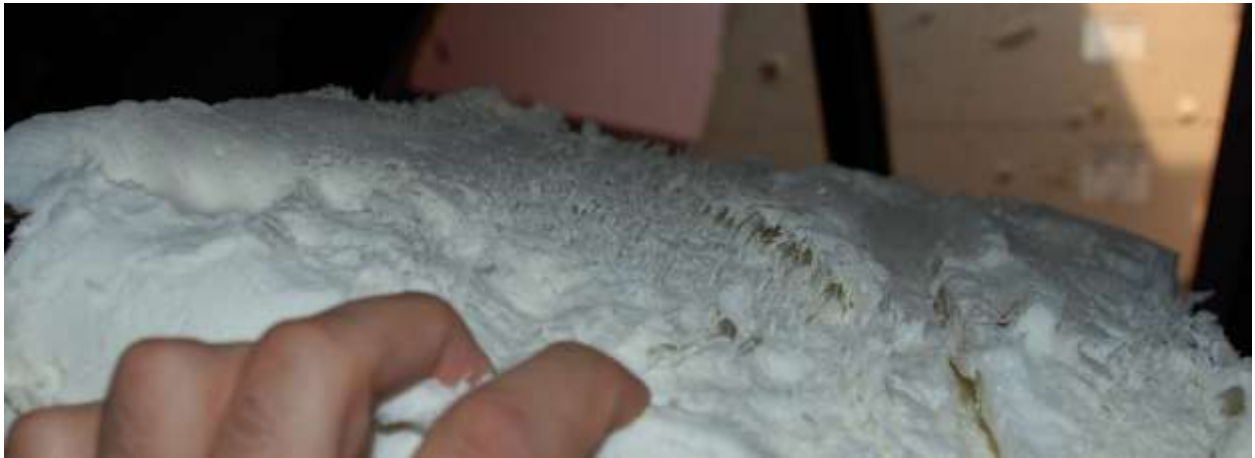
I cut out a couple of areas and the foam appears to have 'hair' on the exterior side. Which leads me to believe the foam actually didn't stick at all to the roof deck:

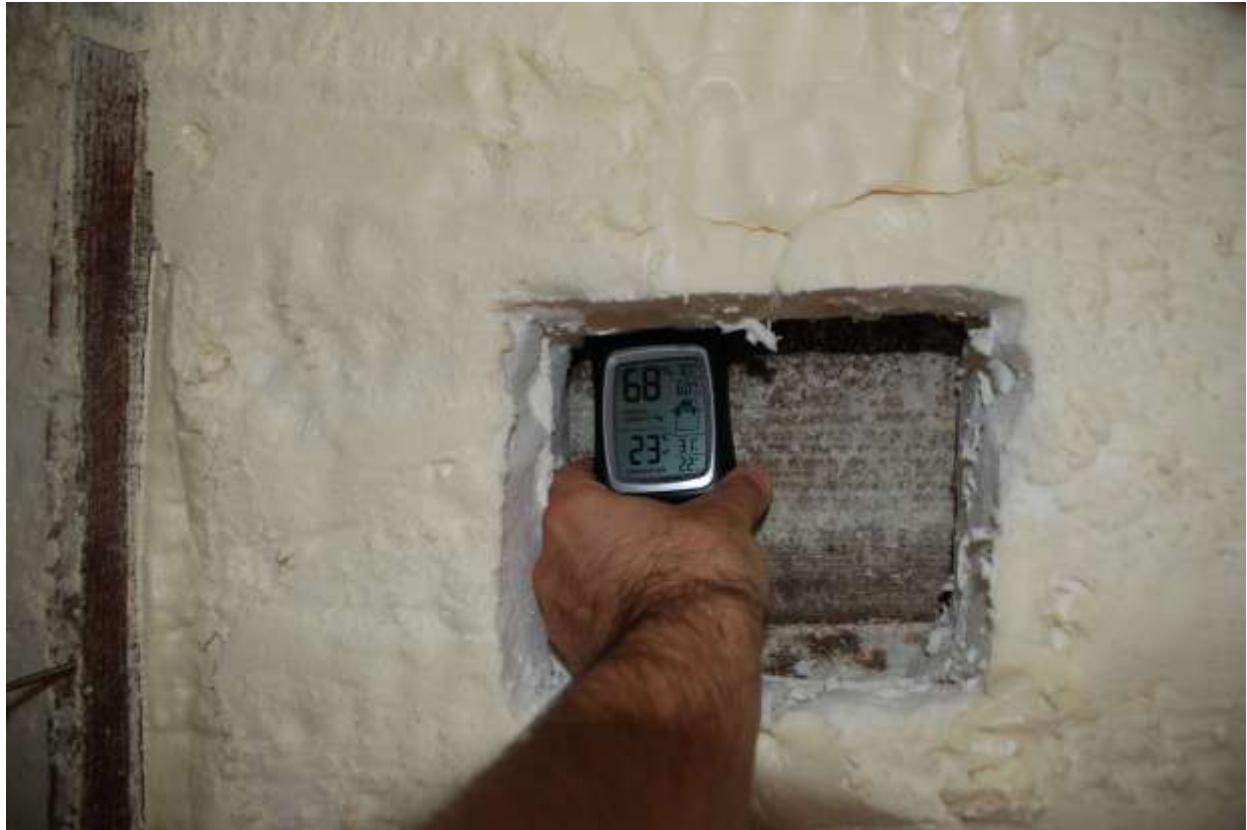
The exact same time behind the foam:

You can clearly see same temperature but much higher RH. The absolute moisture difference behind foam vs. interior side vs. outdoors appears to be fluctuating. BTW, the hole was covered with the foam pieces I cut out and the thermometer was stuck between planks and foam.

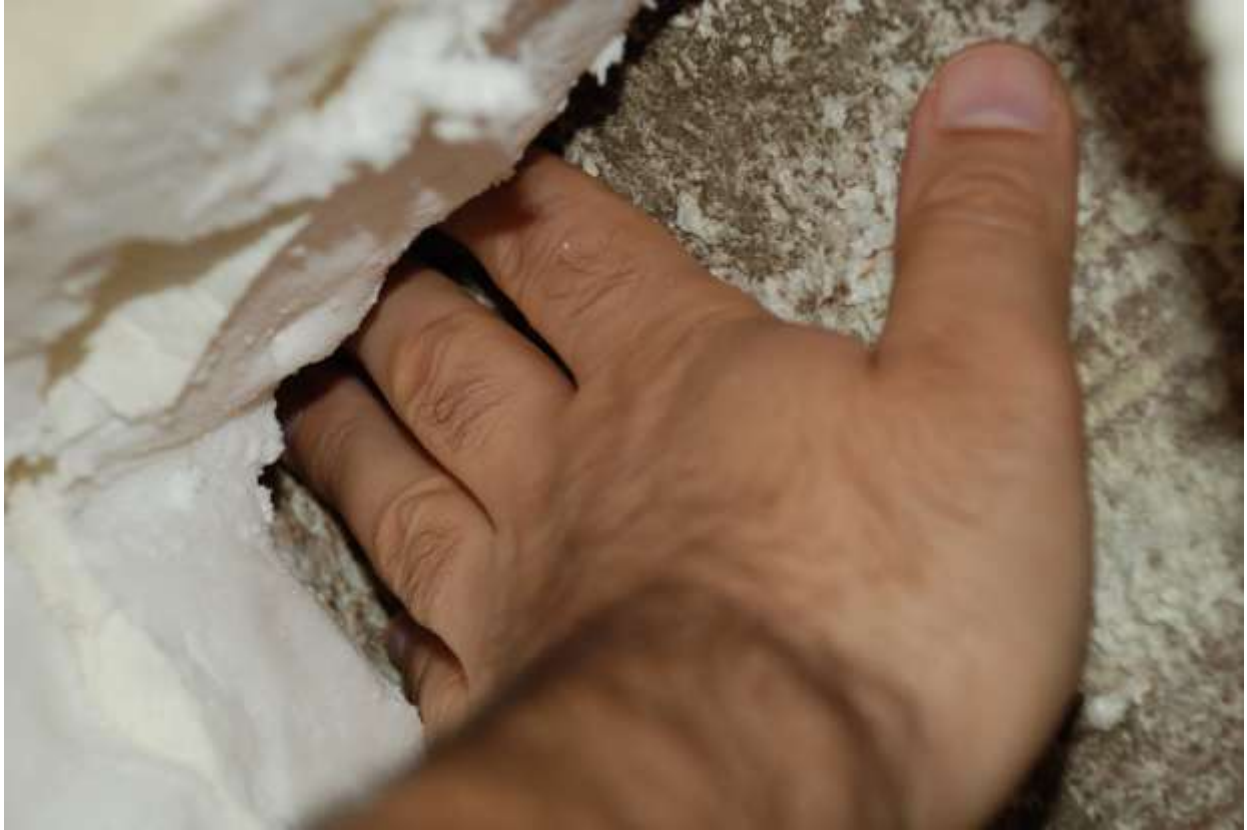
So how much of a gap are we talking about:

Between 1 and 2 inches.

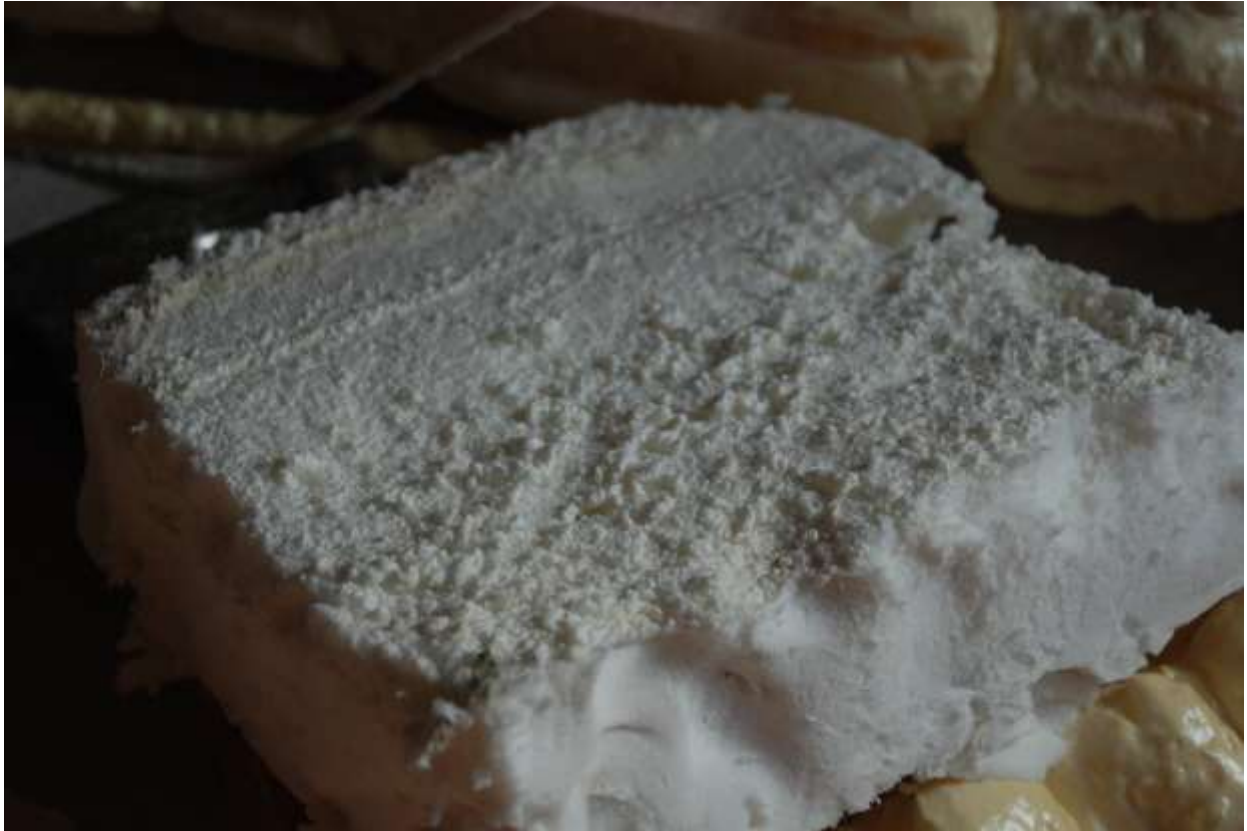
This is the piece I pulled out, also shows there was no adhesion to planks:
