## **Open Cell (Icynene) Spray Foam Defects under Roof Deck**

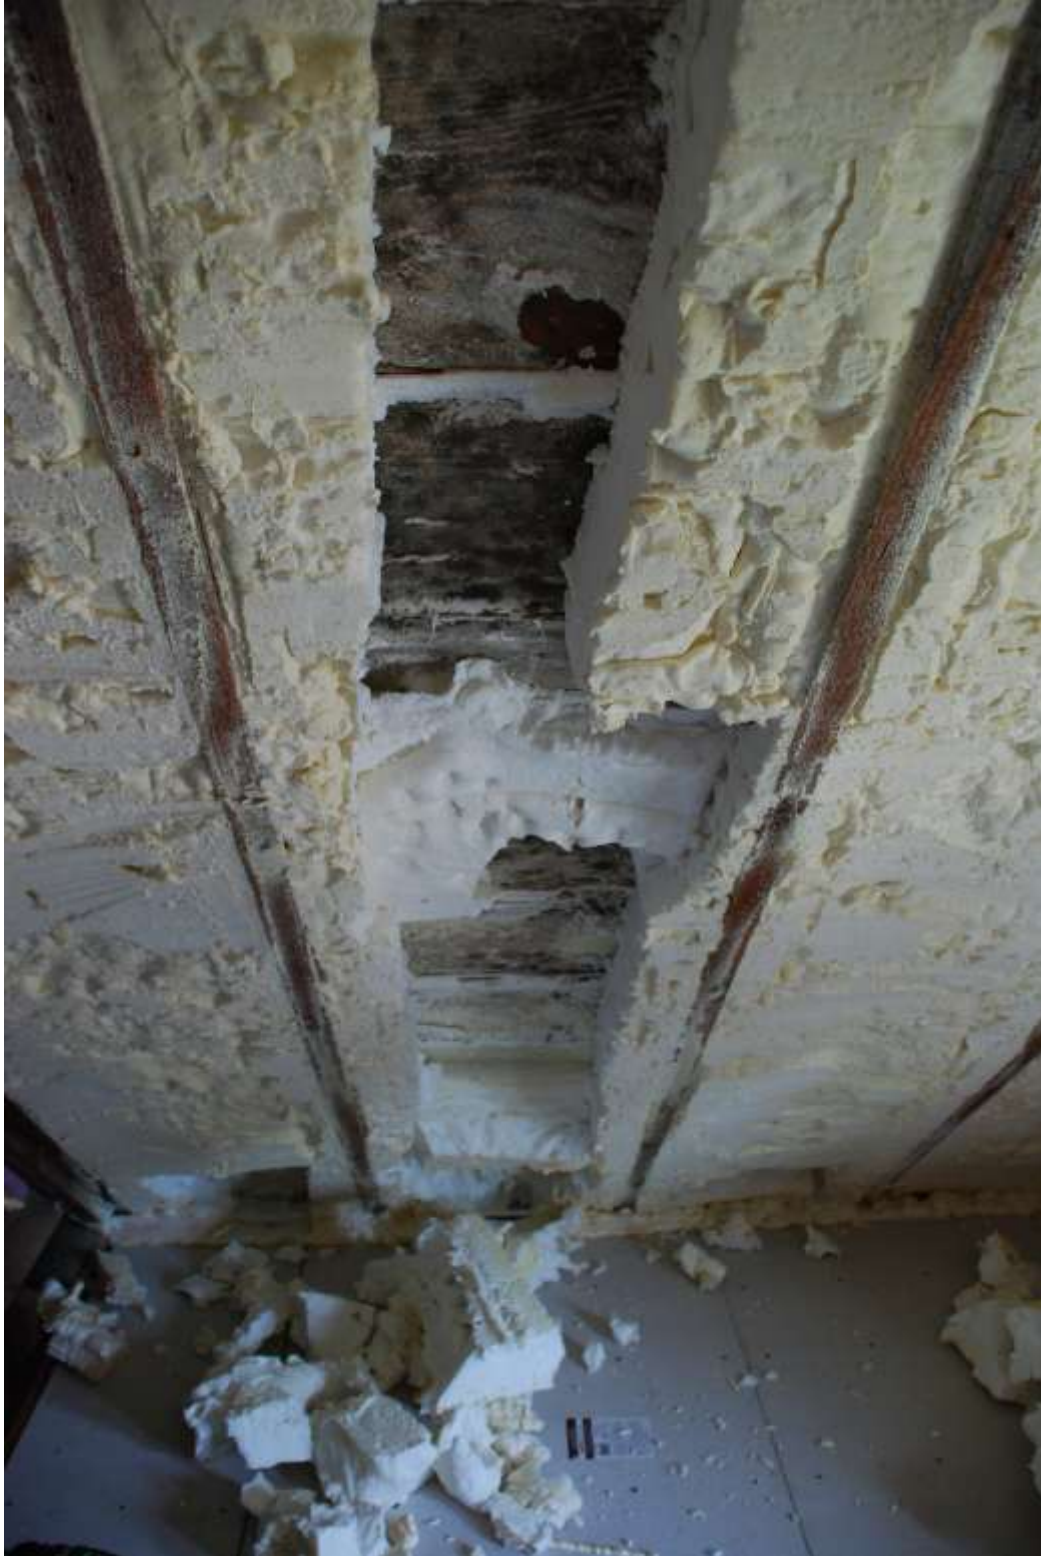
The following area had been scanned using IR, we didn't notice anything.

No deflection either. I started cutting at eye level and cut out a small box.

I felt I can slide it out as there was no adhesion at the back.

I then "followed the trail" going down all the way to the soffit. There appeared to be an almost direct "line" of voids leading down to the soffit:

You can feel air coming in from the soffit in the center but not at the left and right openings (you can see I opened the neighboring soffits, too). You can see above two layers at least were sprayed and the foam

adhered well only at two spots in the middle and at bottom. However there are voids around those areas, too. Rafter adhesion is good everywhere.

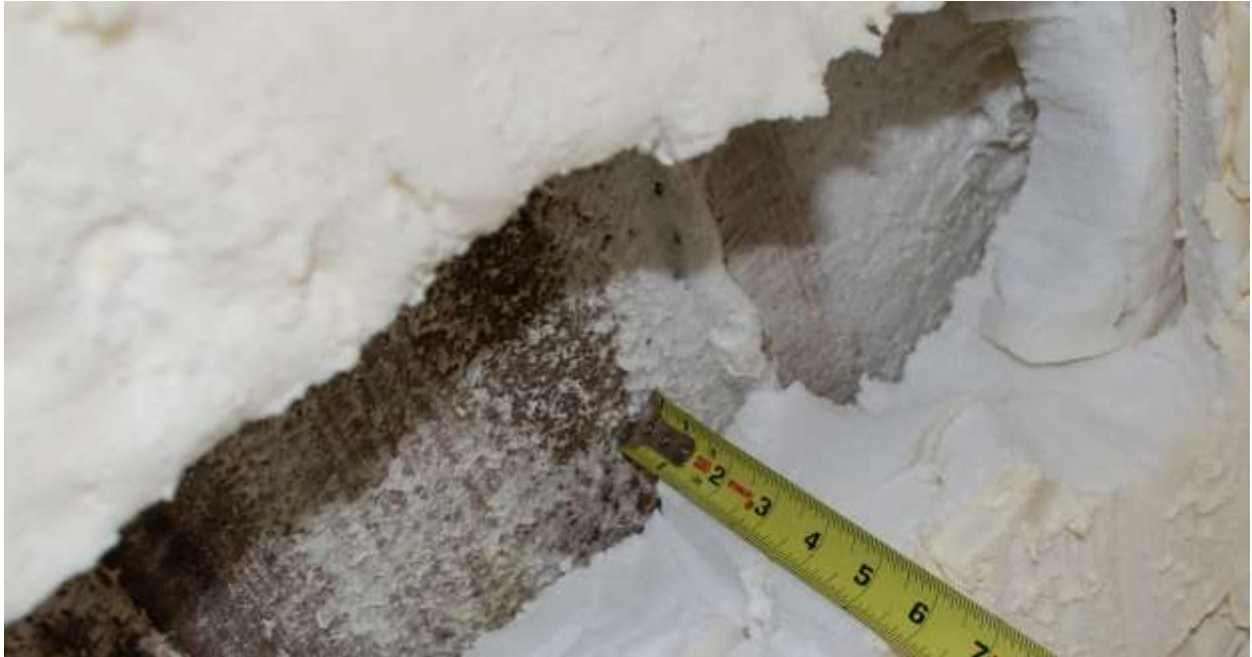
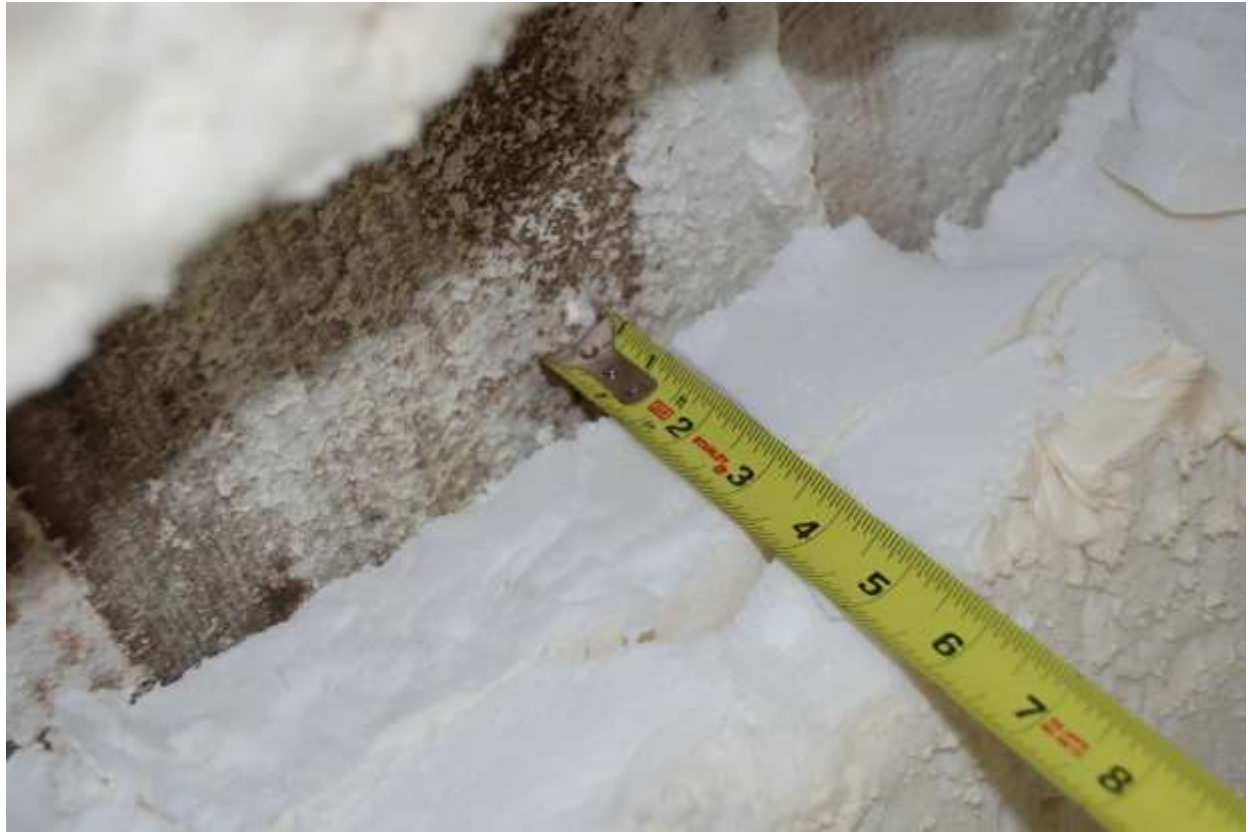
A closer look at the top looking towards ridge. Around 1" gap pretty much everywhere.

You can see the foam initially did stick to wood, there is a fine film on the wood. I suspect it then detached during the foam's curing period and sagged; hence, there's "hair" on the exterior side of foam.

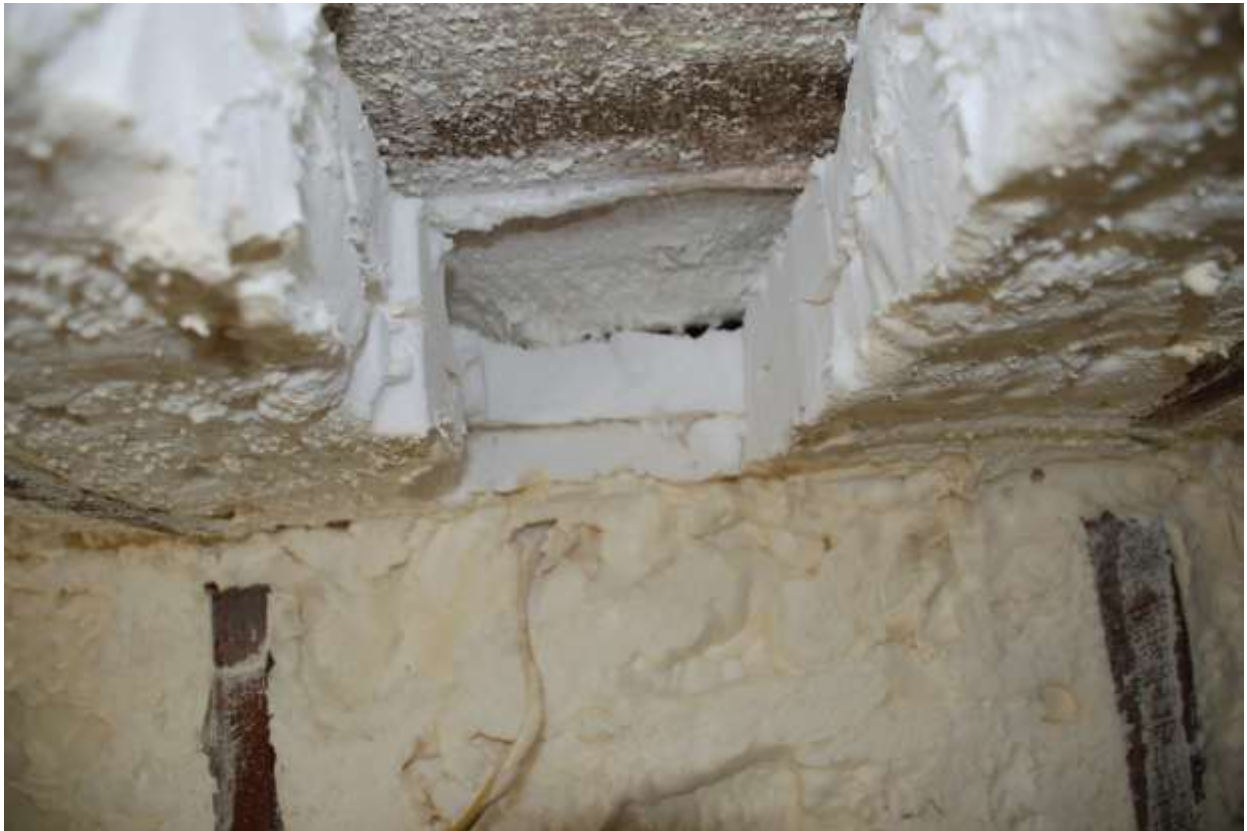
Here we are looking up towards ridge, you can see the gap at top right is even bigger, that's right under the ridge. You can also see voids between the two layers.

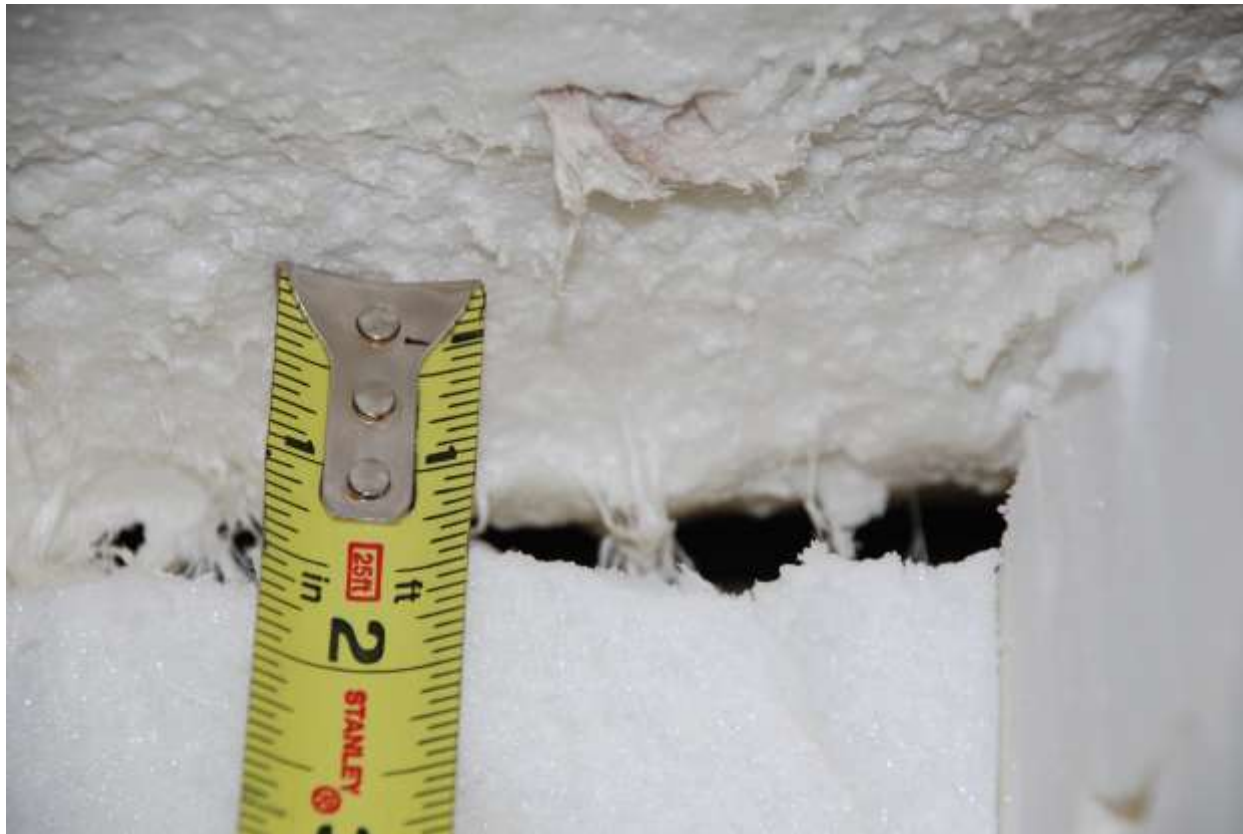
This is a closeup of the above. Gap almost 2 inches. You can see the 'hairs' which remind me of homemade bread rising too quickly when baked too early. You can also see the foam has detached

before fully cured. The area above void is the wood plank:

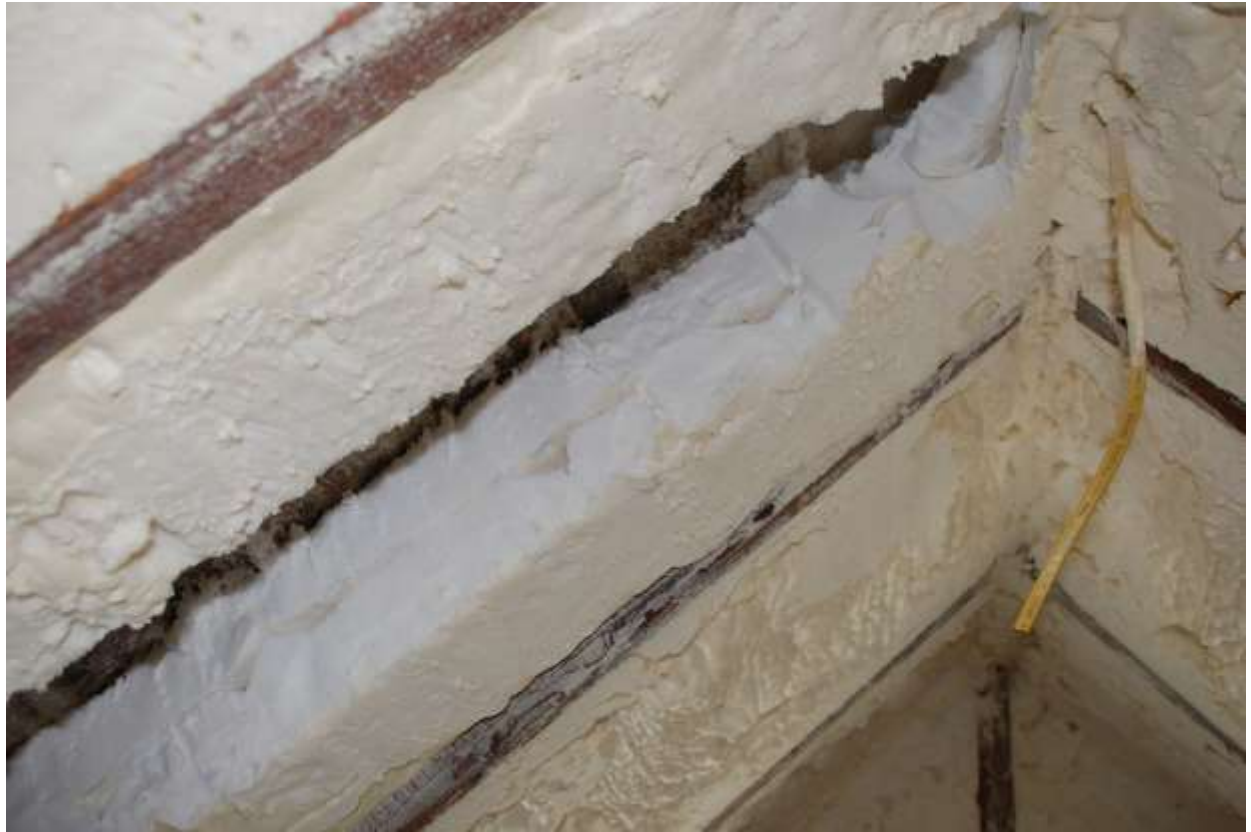
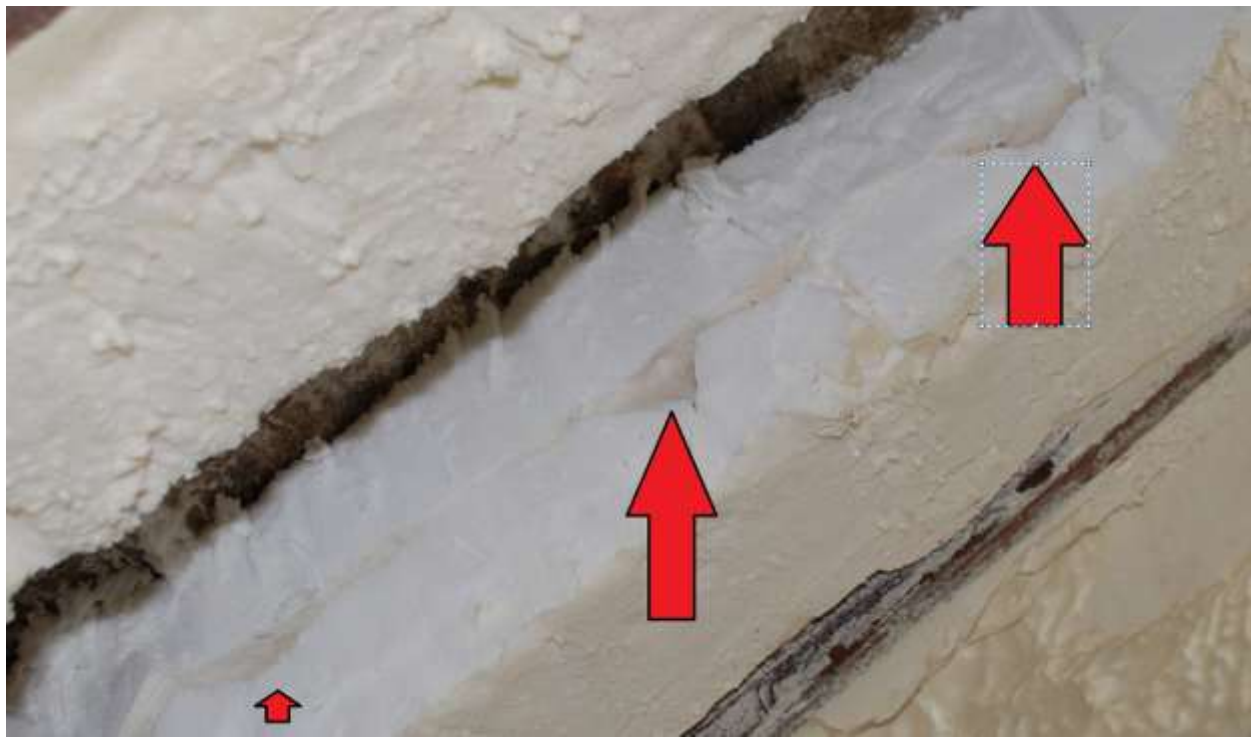
The next photo was taken without flash to give a better view of the voids because the flash tends to hide them:

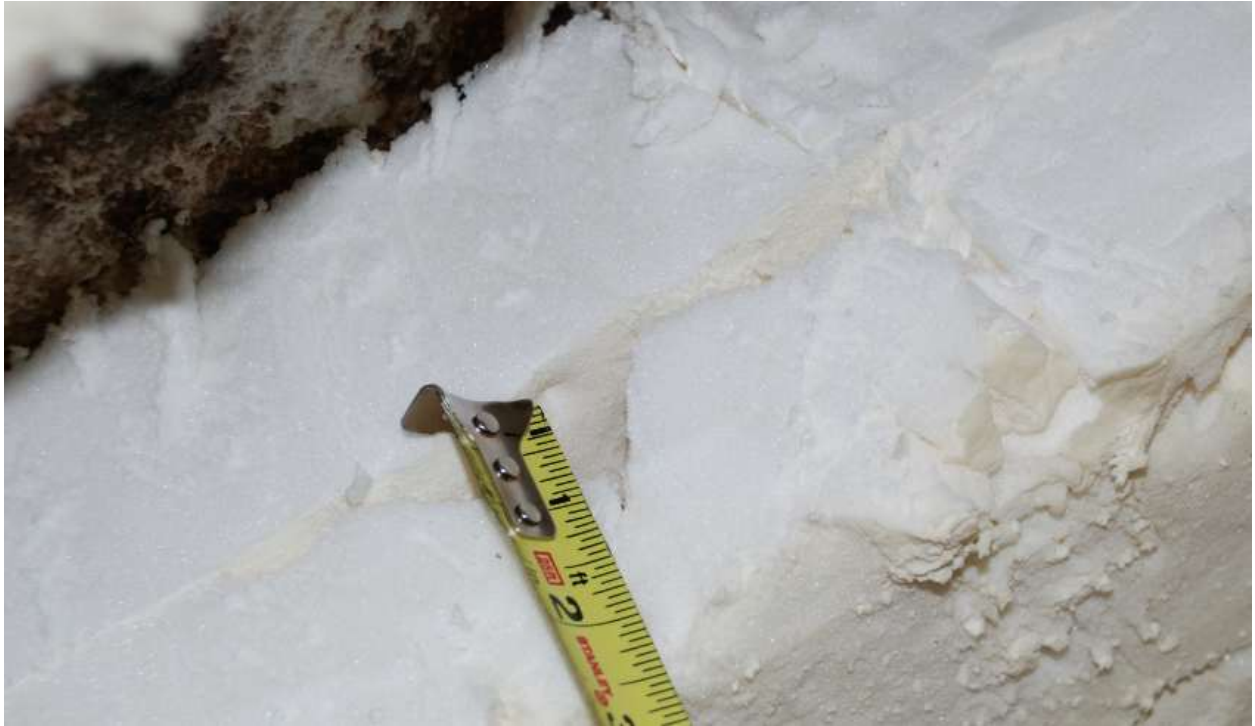
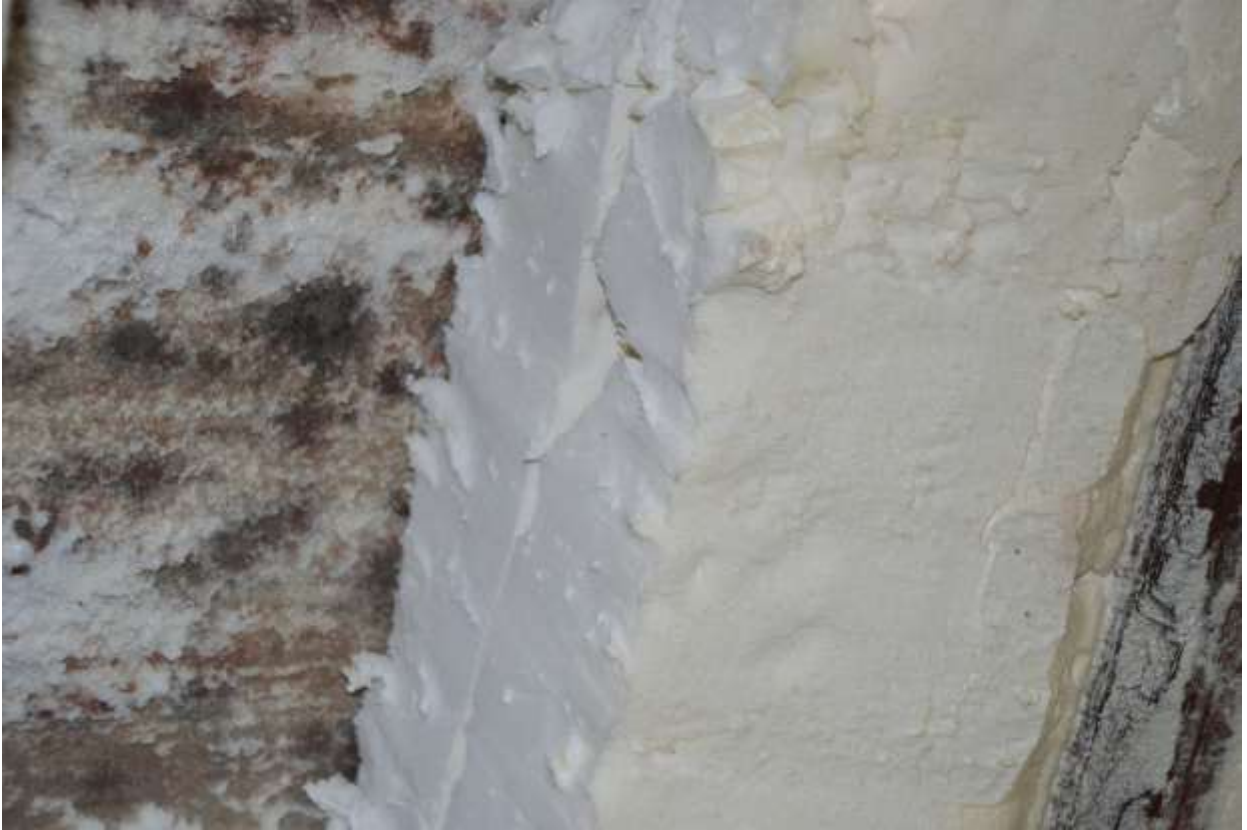
Voids between layers over 1”:

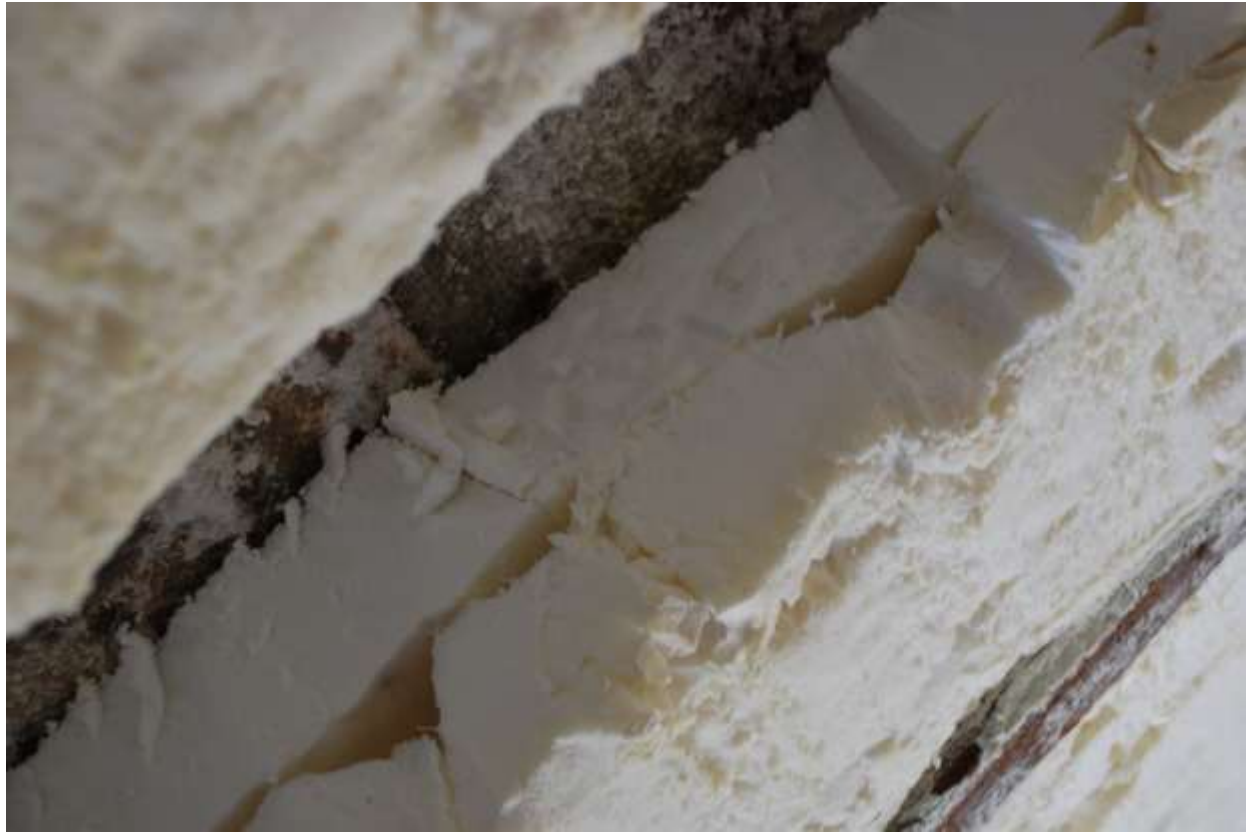
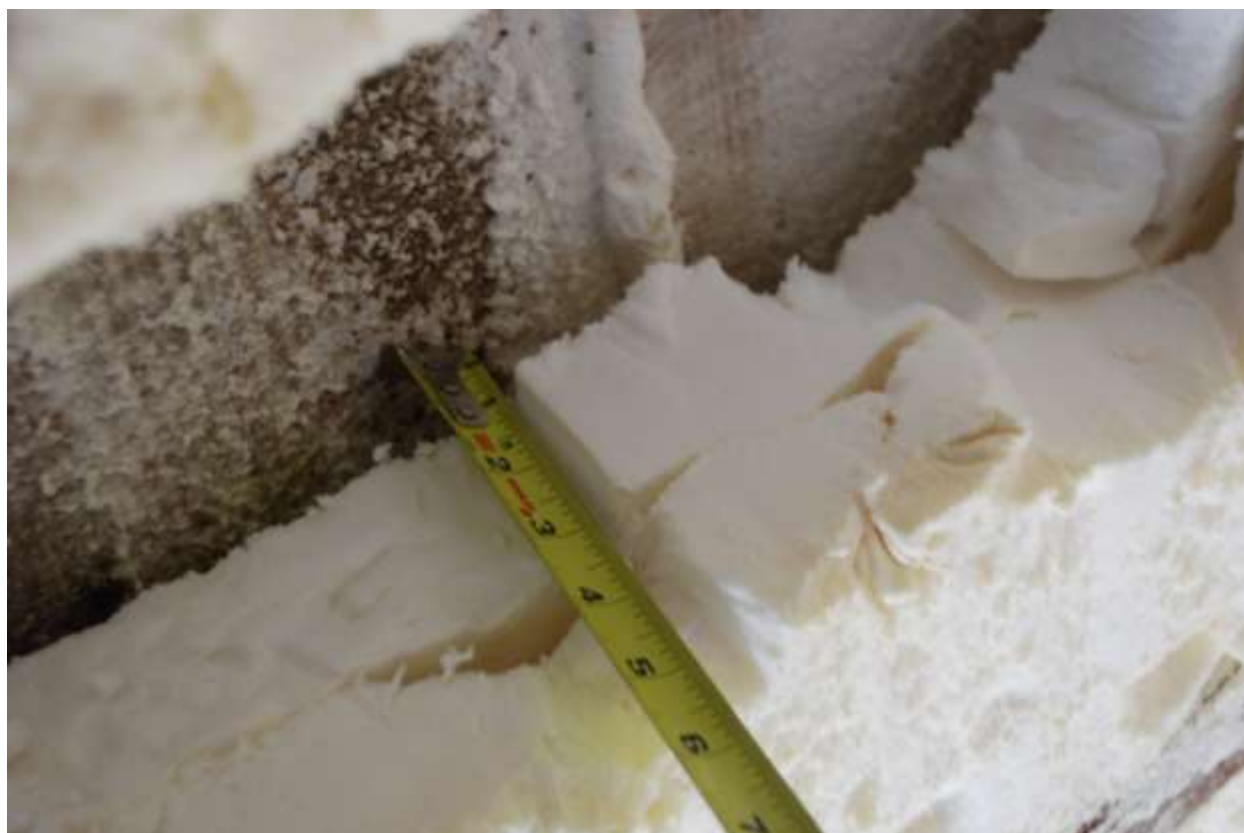
A better shot from the left here:

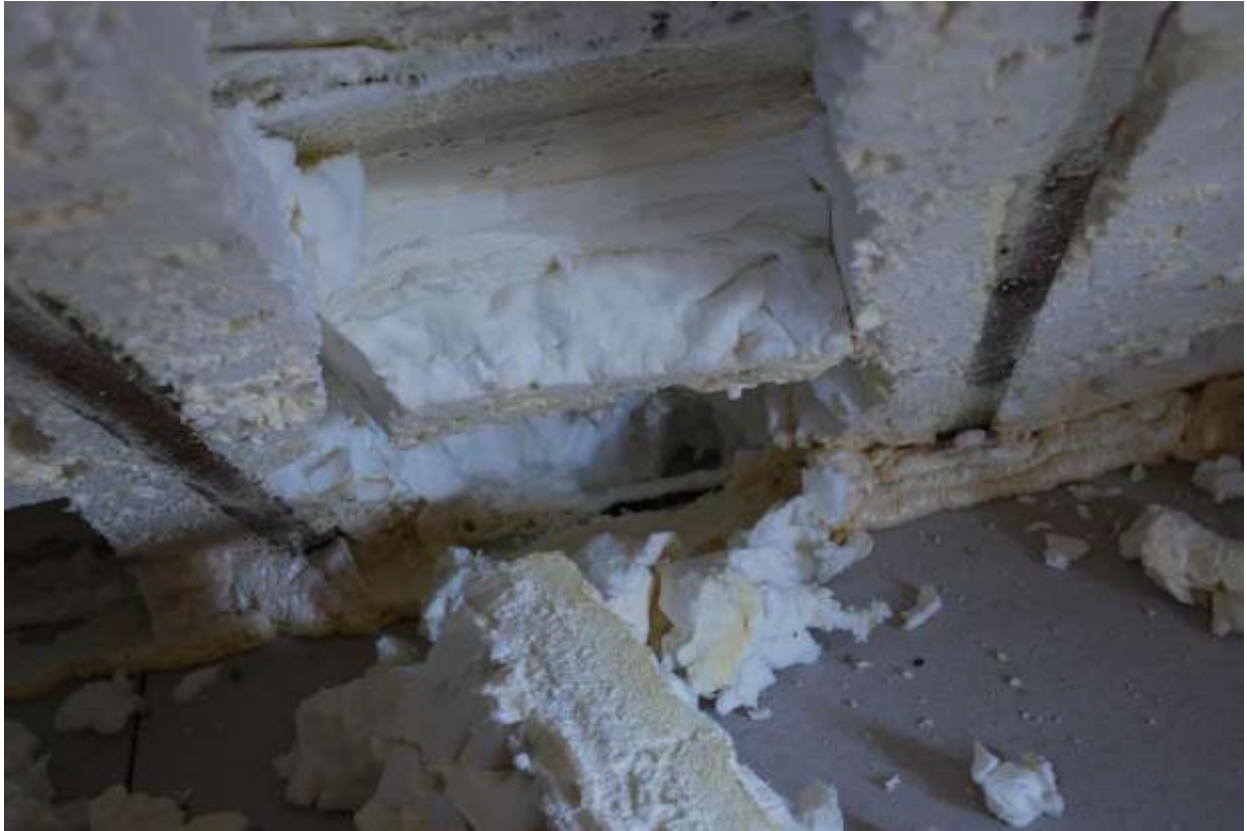
The moisture appeared to be coming from down there, the soffit. After I opened this a few days ago, the RH in the upper floor is fine! I suspect the moist air was coming in behind the foam where it condensed at night. The water and vapors were absorbed by the foam and accumulated over time.

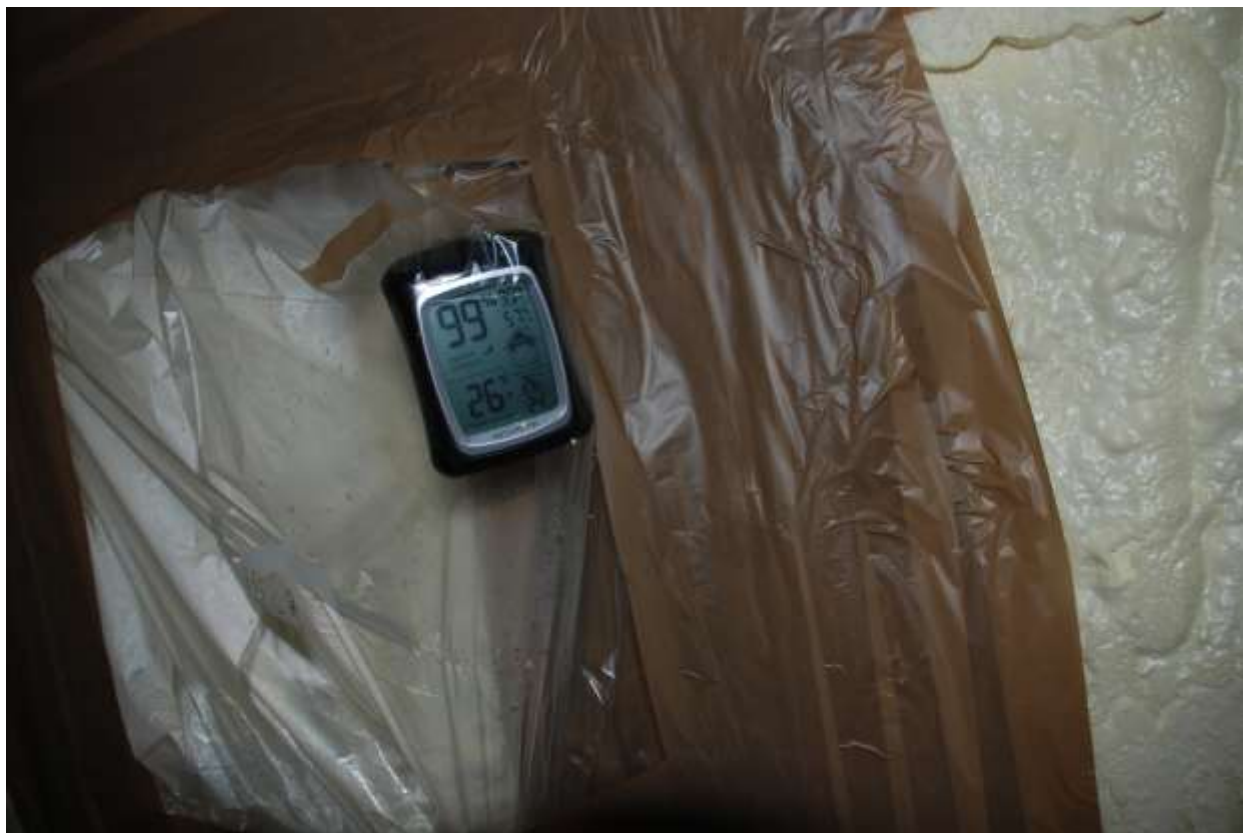
This would also explain the results of my plastic sheet experiment. Plastic was taped airtight over foam in the morning with a thermometer stuck behind the plastic. The RH shot up to 99% within 3-4 hours. The plastic later condensed from the inside (condensation occurred inside the plastic between plastic and foam) 26C = 79F:

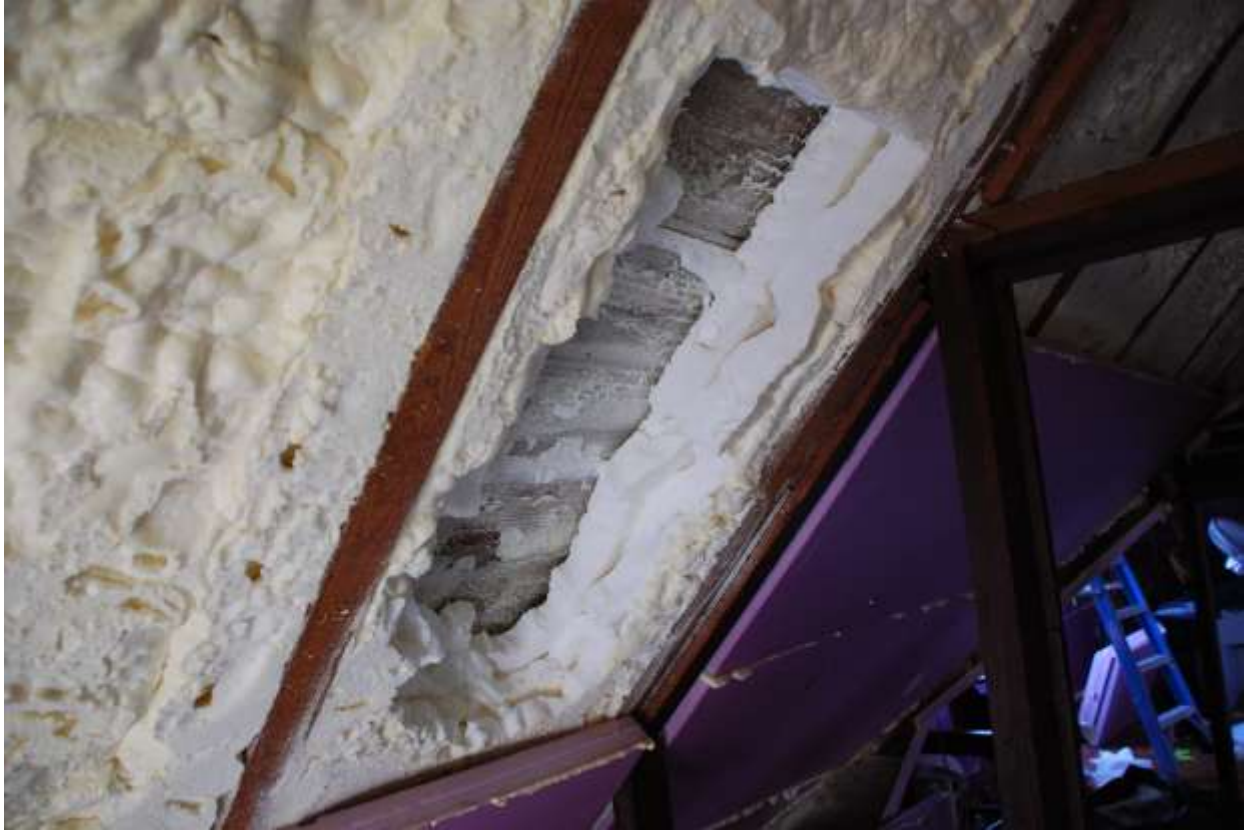
The last photo was north facing. This ceiling is facing south:

You can see three layers above and also large voids behind foam.

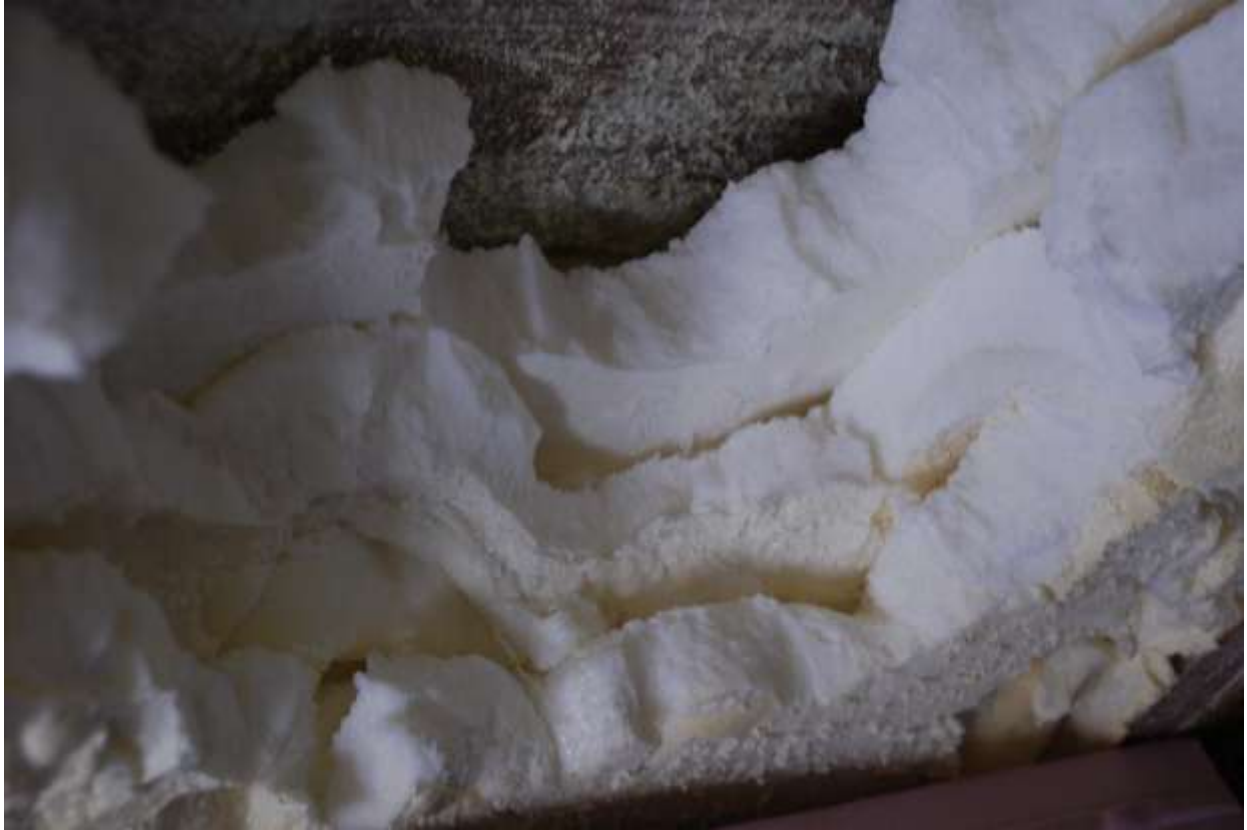
This is the closeup:

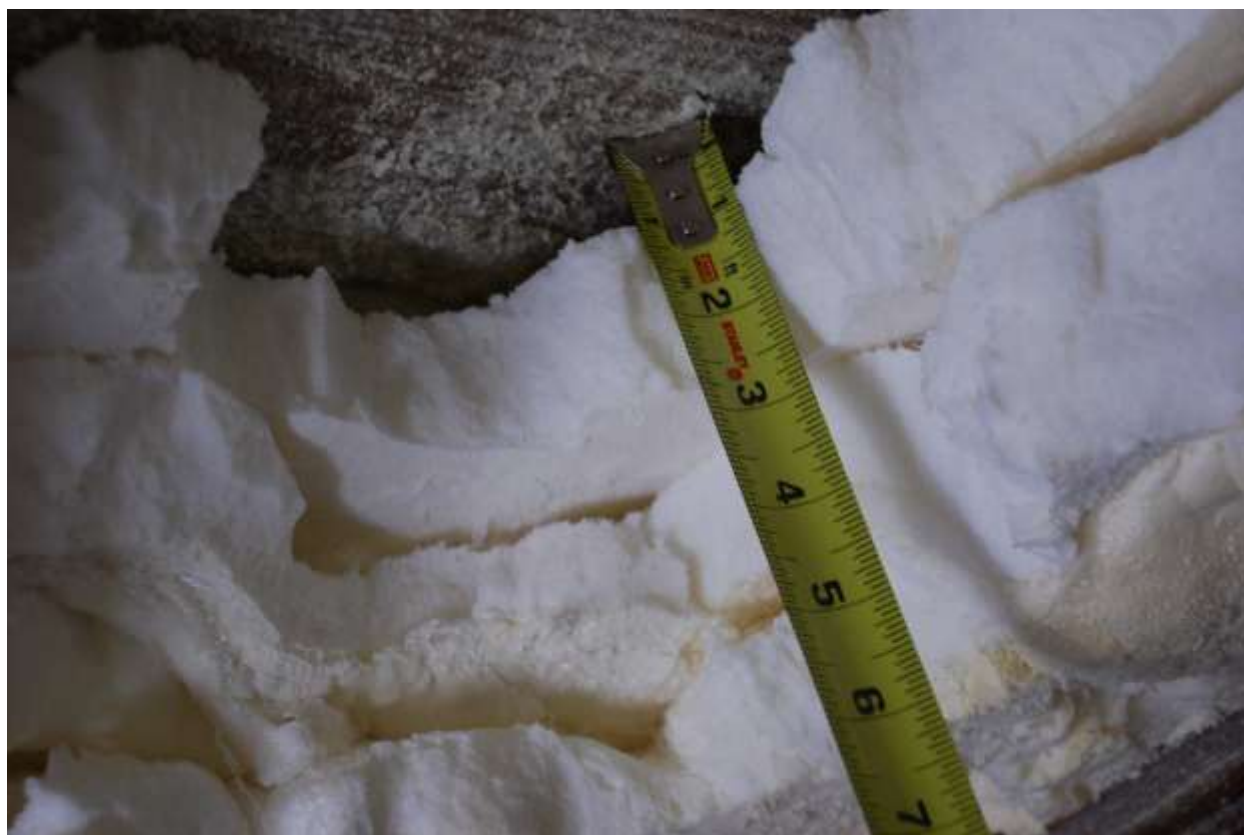
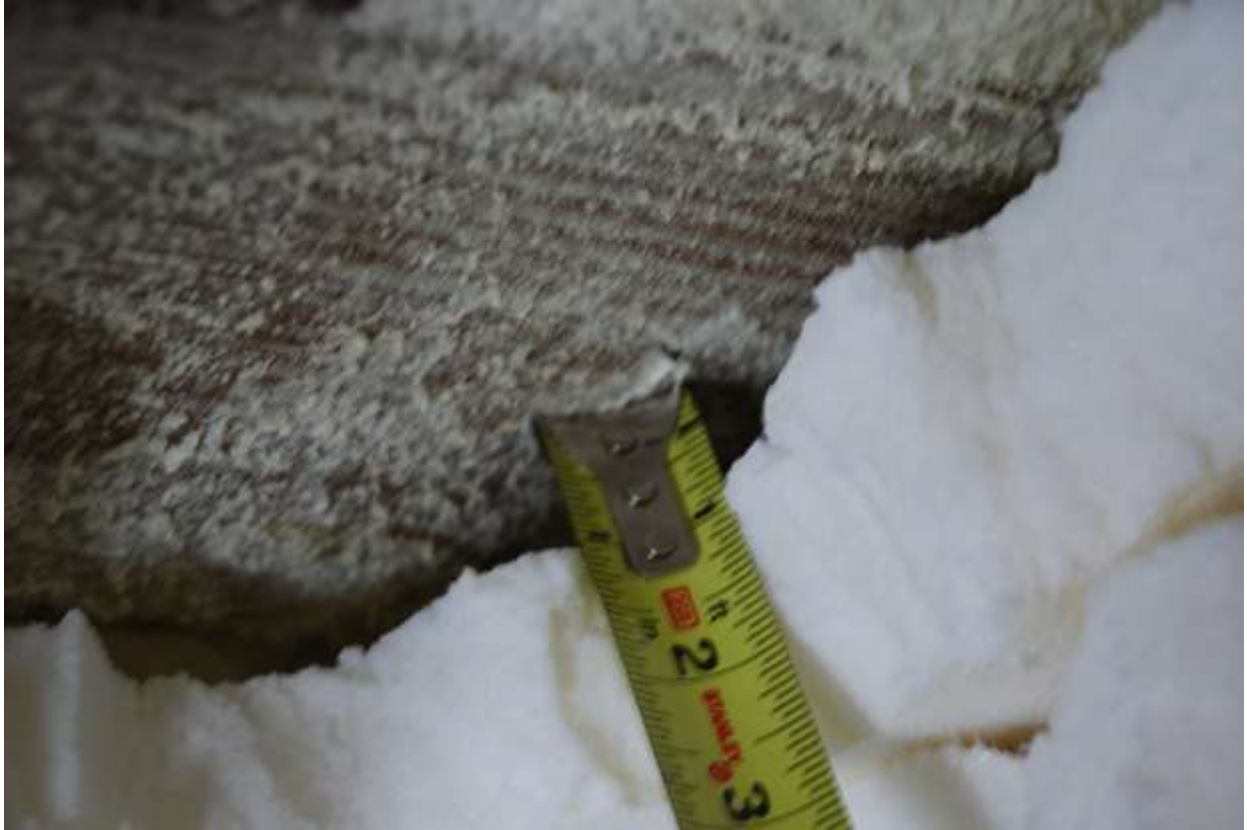
Proof more than 1":

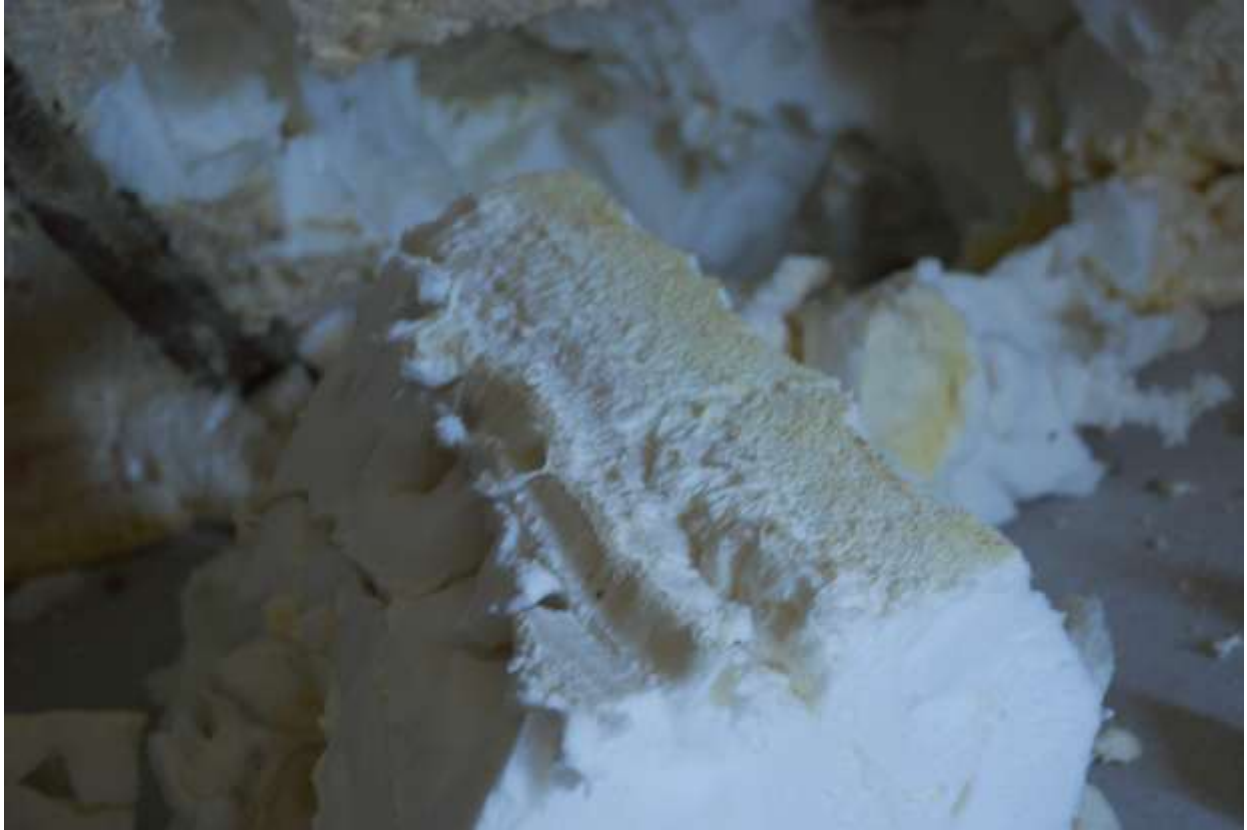
The following are some foam samples, exterior side of foam is at top:

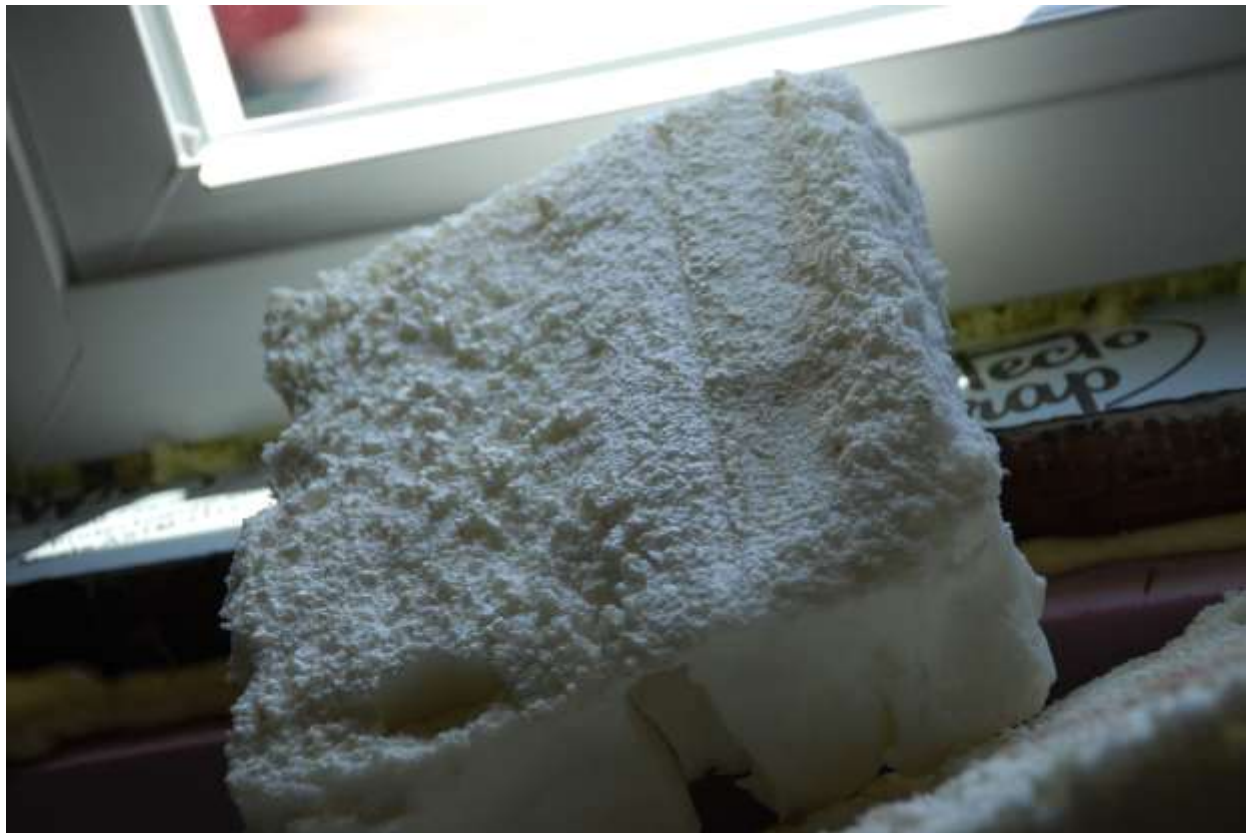
The hair like appearance:

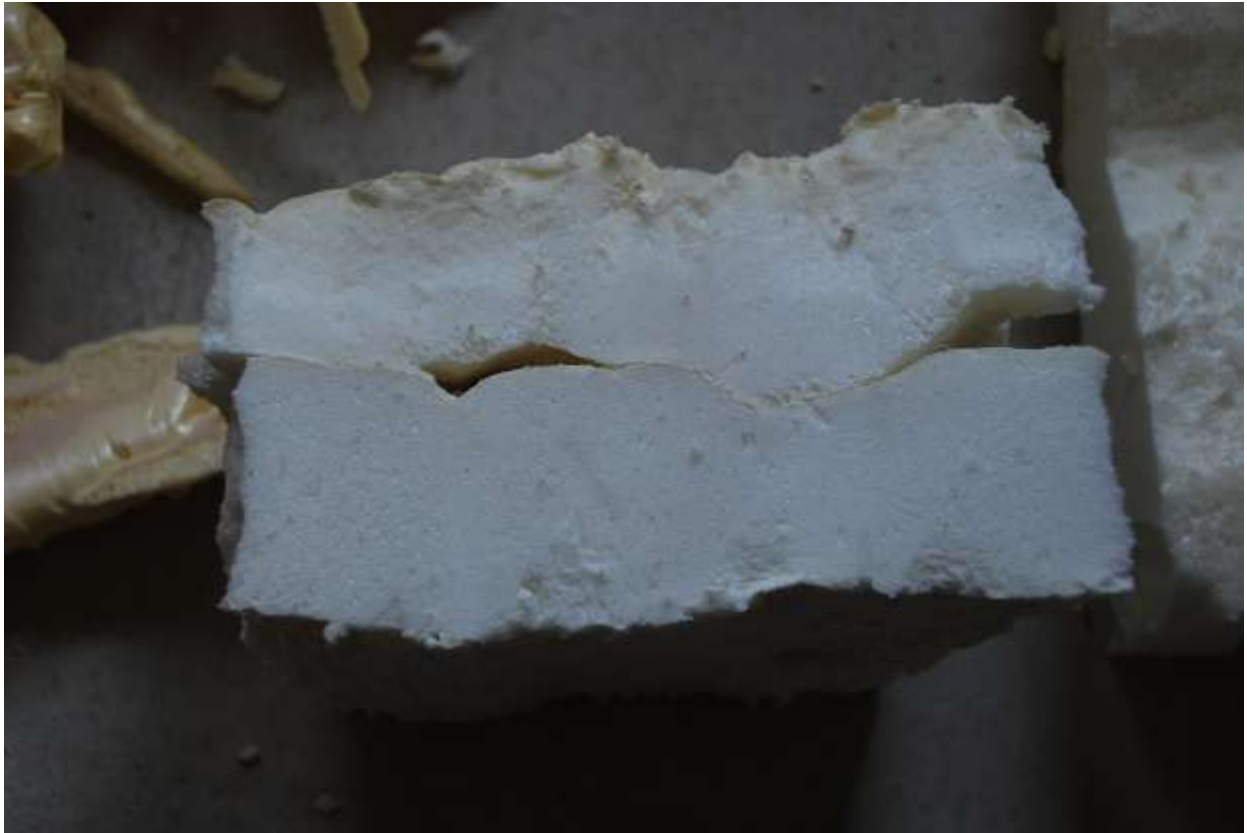
Poor adhesion between layers and large voids in-between:

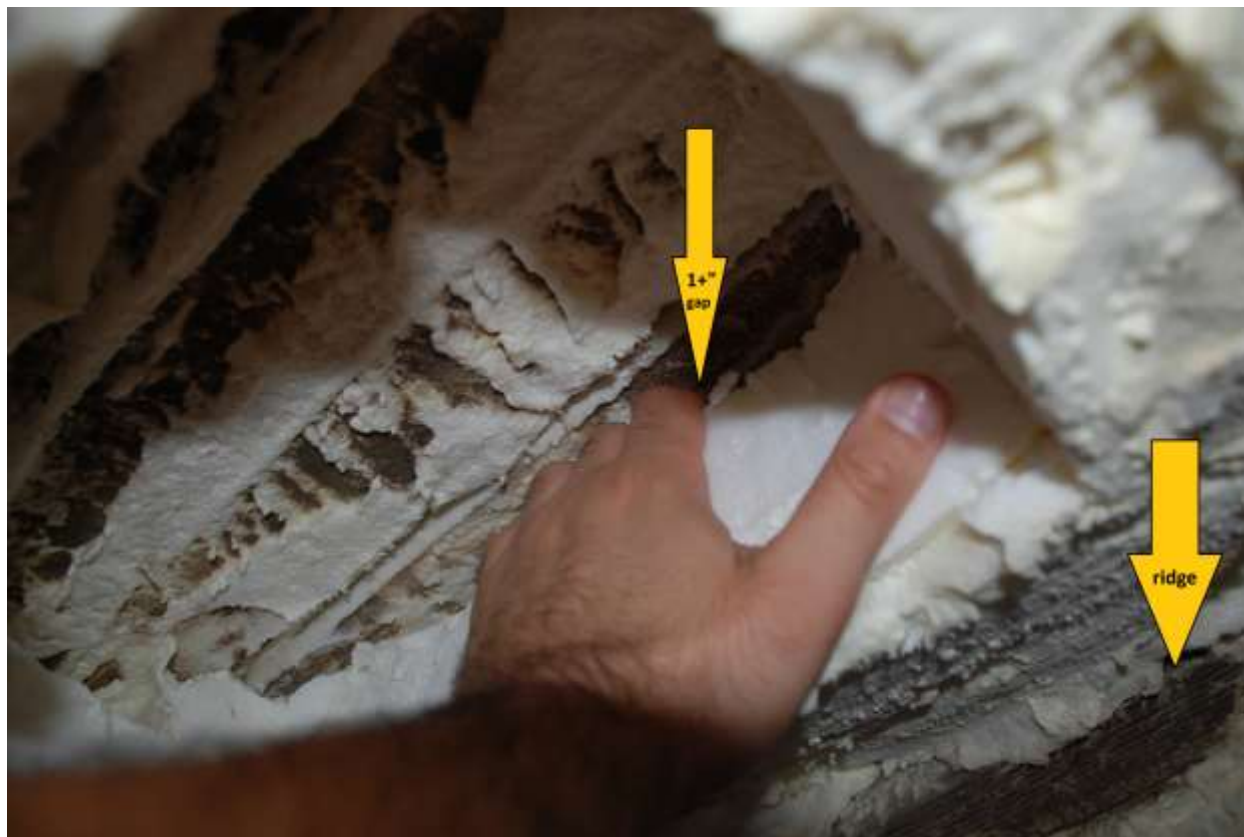
This one was taken at house's main ridge. We are looking upwards. I opened a random area, no deflection or other clues before opening. I believe we looked up here as well using the IR and didn't see anything suspicious:
