## **Open Cell (Icynene) Spray Foam Defects under Roof Deck**

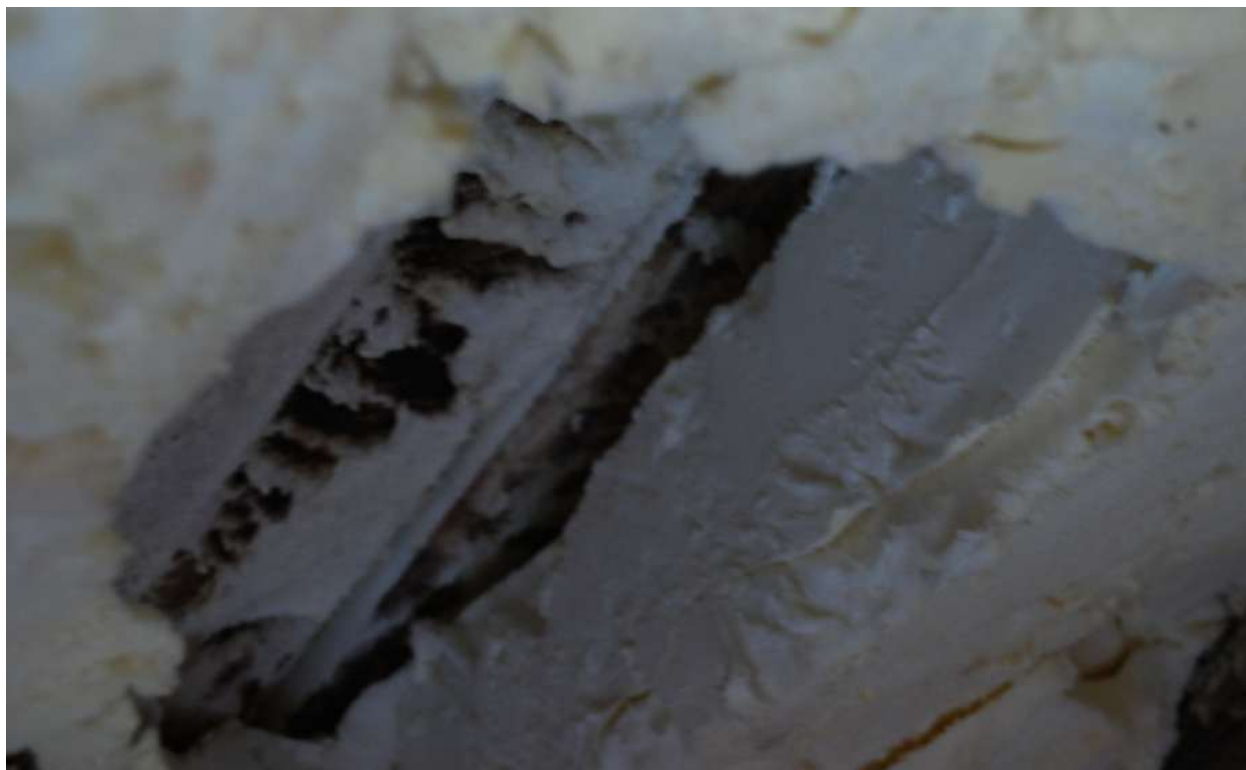
A large >1" void right near the ridge. Photographed again without flash for better contrast:

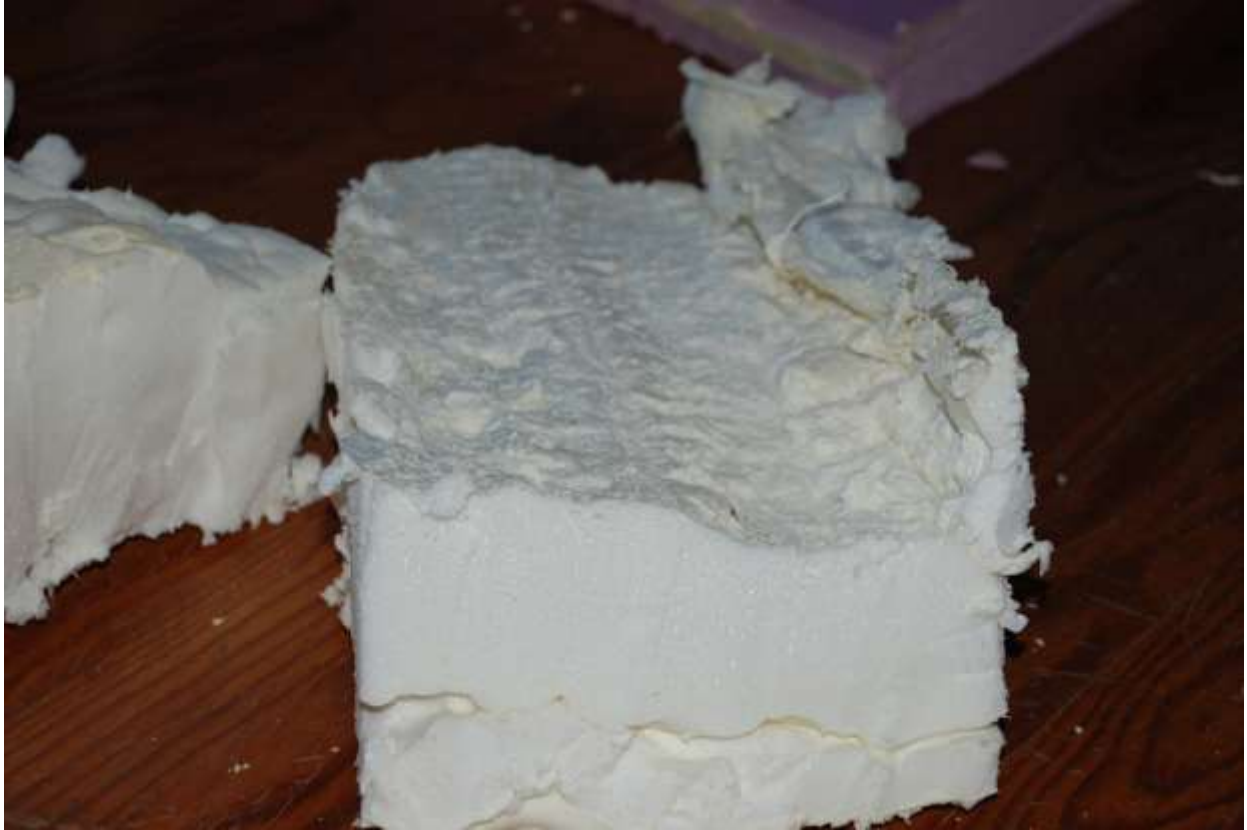
This is what I pulled out of that area:

Above you see again two layers, and it's a foam piece called "Prince" with a "perm" ☺. The top is the exterior side, which should have been flat but instead, at the right it sticks out almost 2". This clearly shows the foam wasn't applied correctly.
