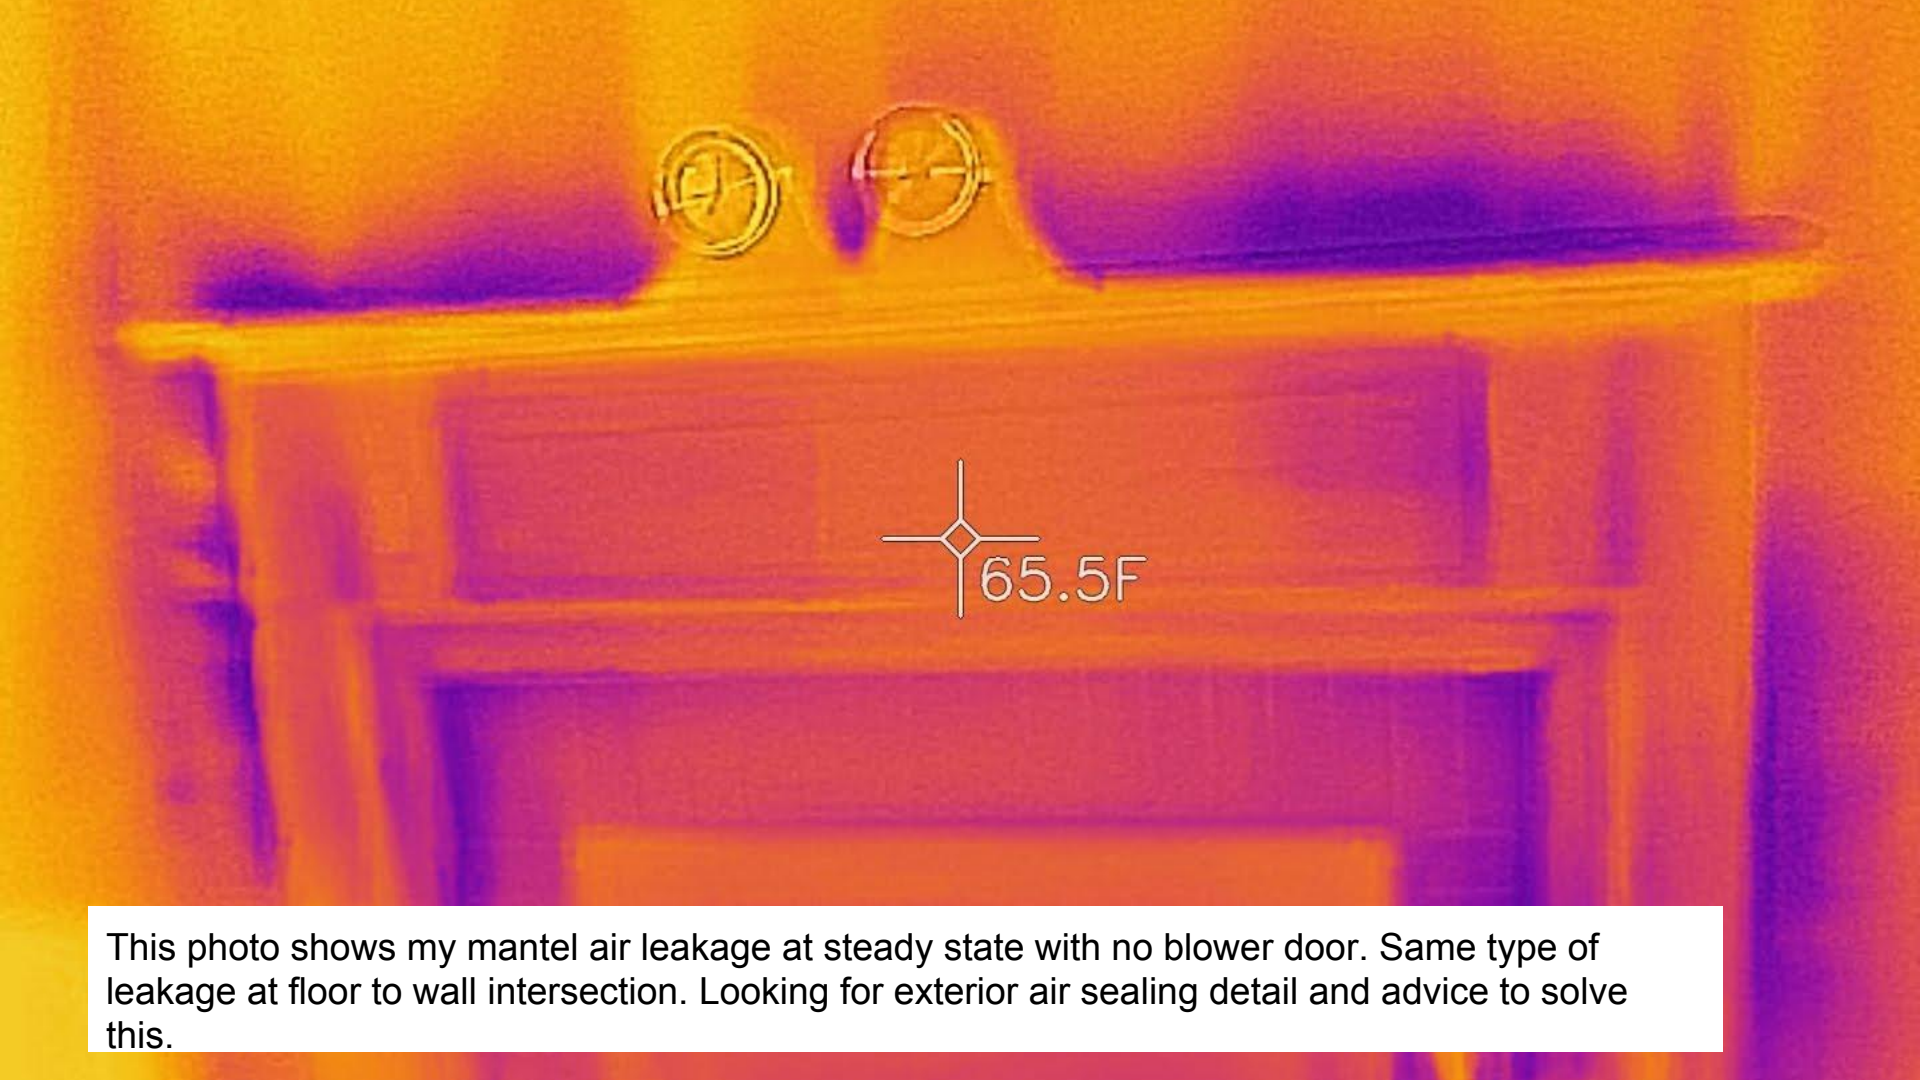
This photo shows my mantel air leakage at steady state with no blower door. Same type of leakage at floor to wall intersection. Looking for exterior air sealing detail and advice to solve this.

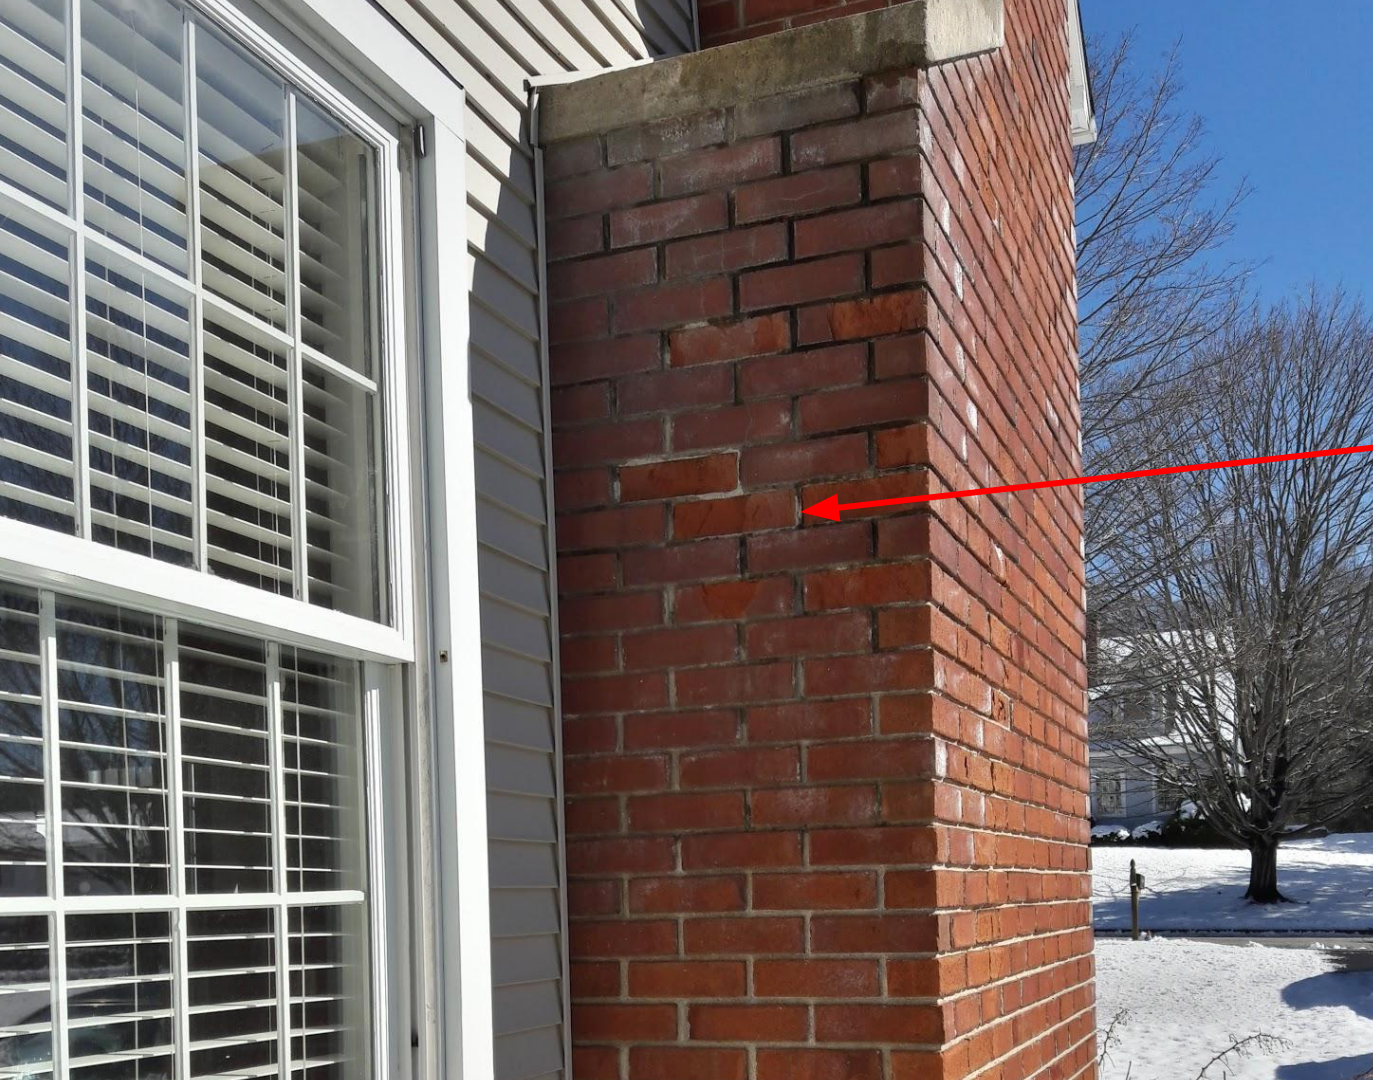
Spalling at face of bricks. Chimney top and flue liner was repointed with concrete and aluminum rain cap two years ago. Spalling continues.

-My understanding is I have water intrusion somewhere still. Or is it flue gasses condensing? Furnace is oil fired 126K BTU Peerless boiler with a Beckett AFG burner. No stainless steel liner inside of chimney.

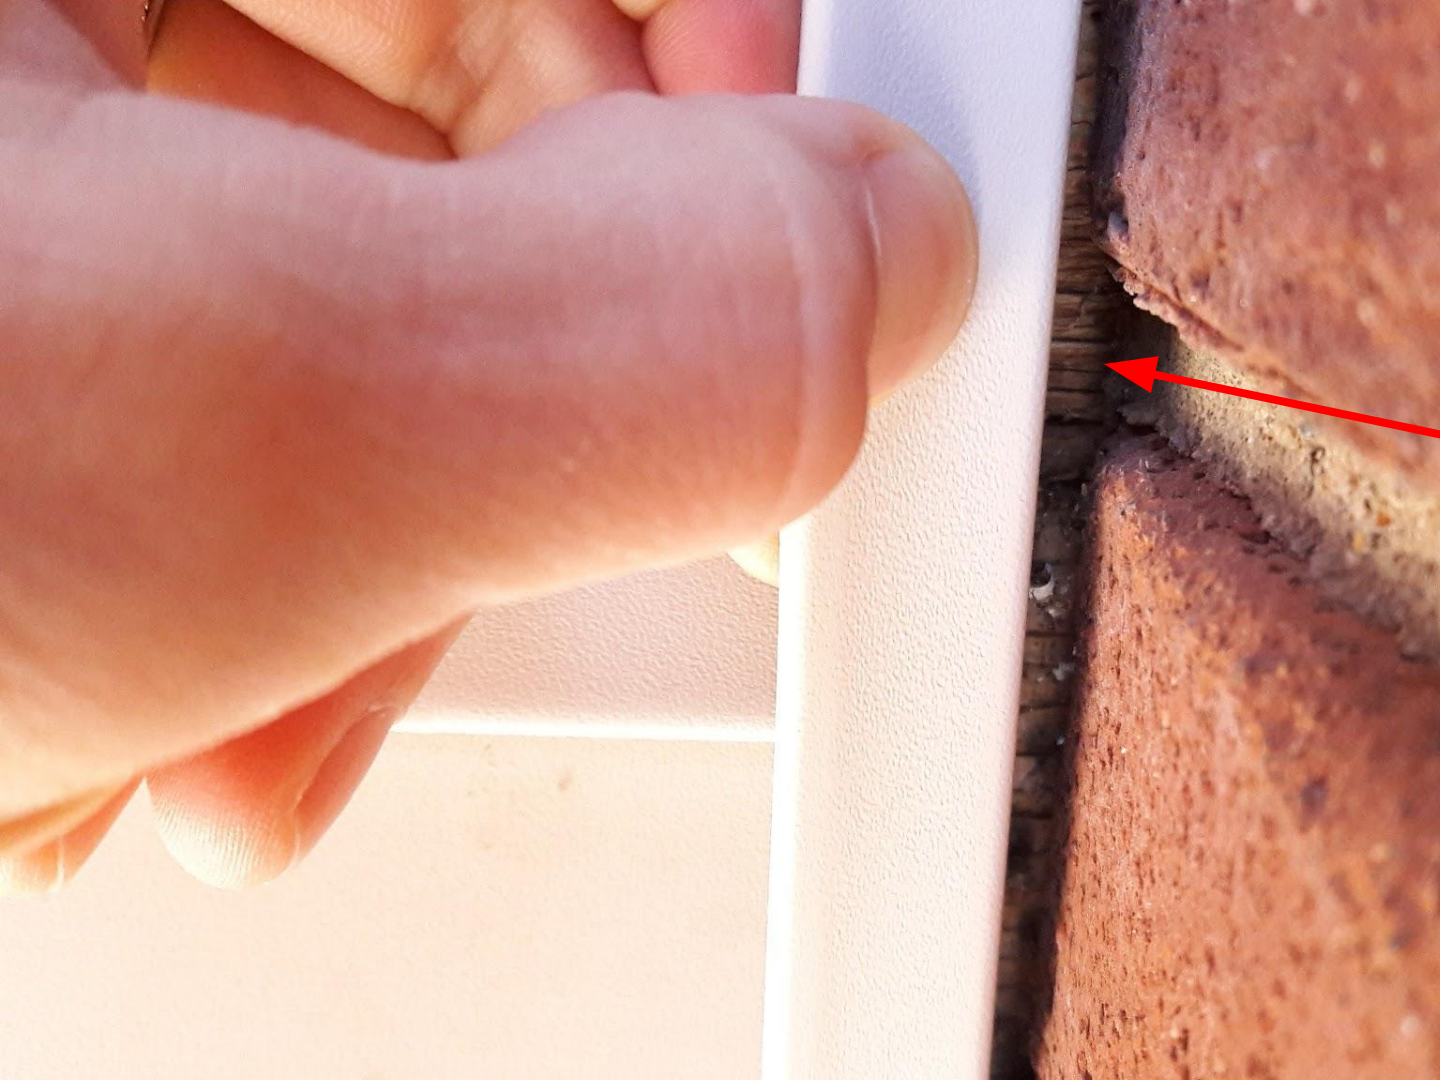
Detail of chimney to wall intersection. Vinyl siding J-channel pulled back. Exposed is unsealed sheathing to brick connection. Plywood appears sun bleached and not in great shape. The situation in this photo continues at all points of inspection within reach. There is tyvek under siding, but not visible here.

-What is the air sealing and flashing detail that is appropriate here? The situation in this photo continues at all points of inspection within reach
