Attic Insulation Testing Jan 2021

Schertz

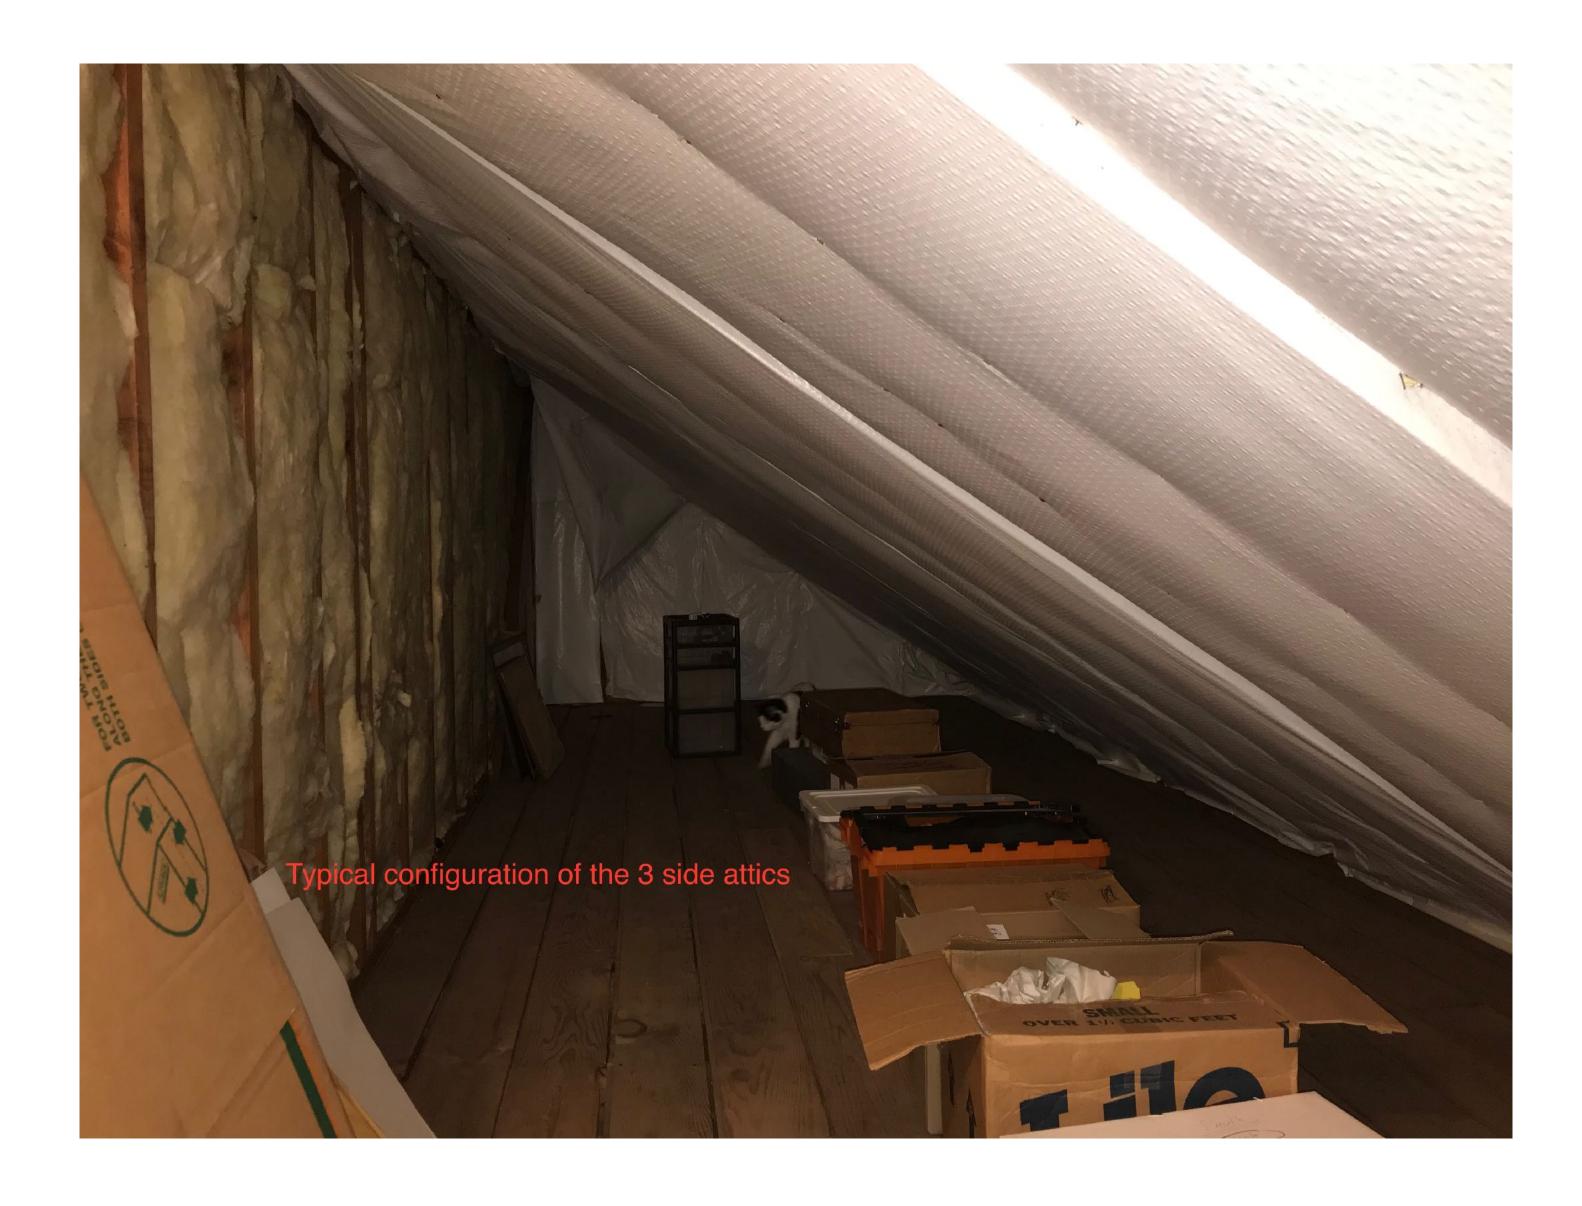
Initial configuration showing vinyl on the rafters and the knee wall insulation

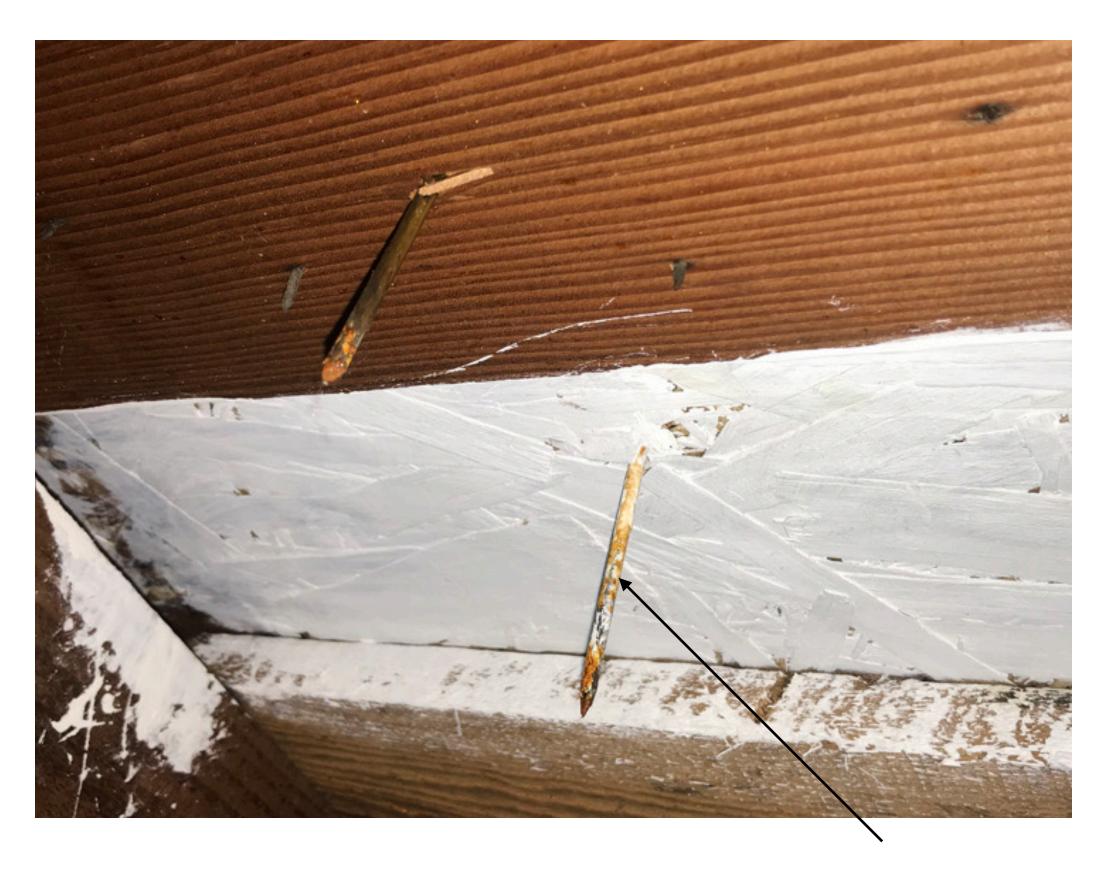
Results Bay 2

New rust on nails

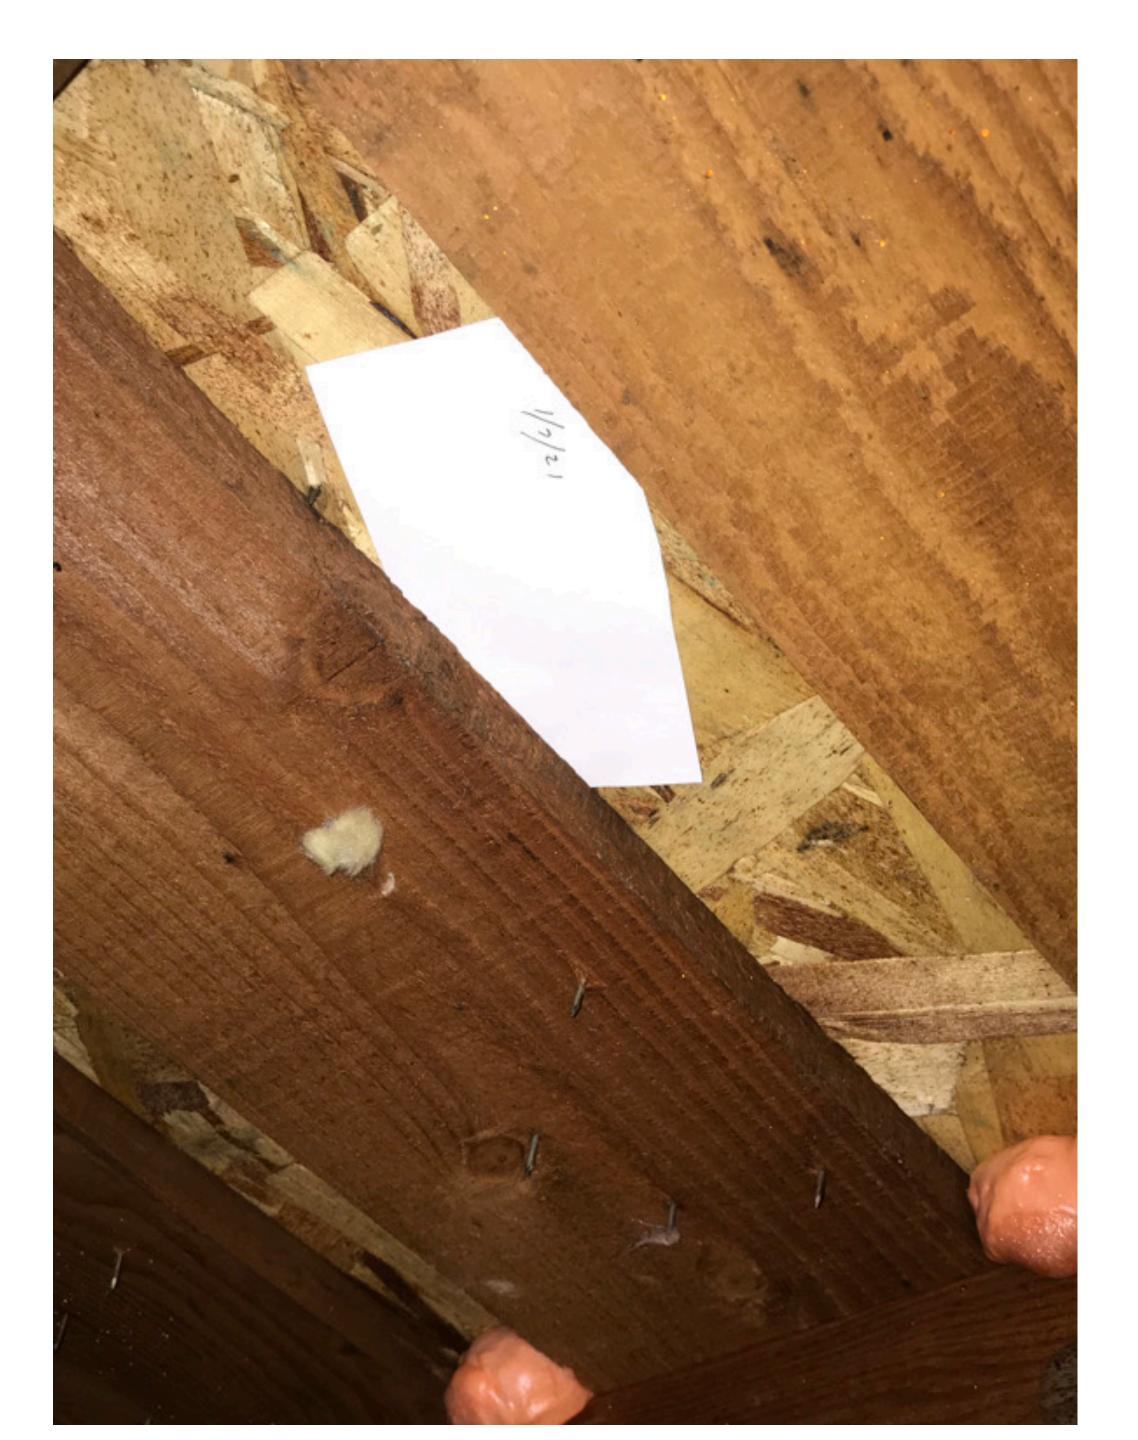
Paper Cards

Paper cards were placed against the OSB.

None showed evidence of being wet although each one felt damp (all 3 bays)

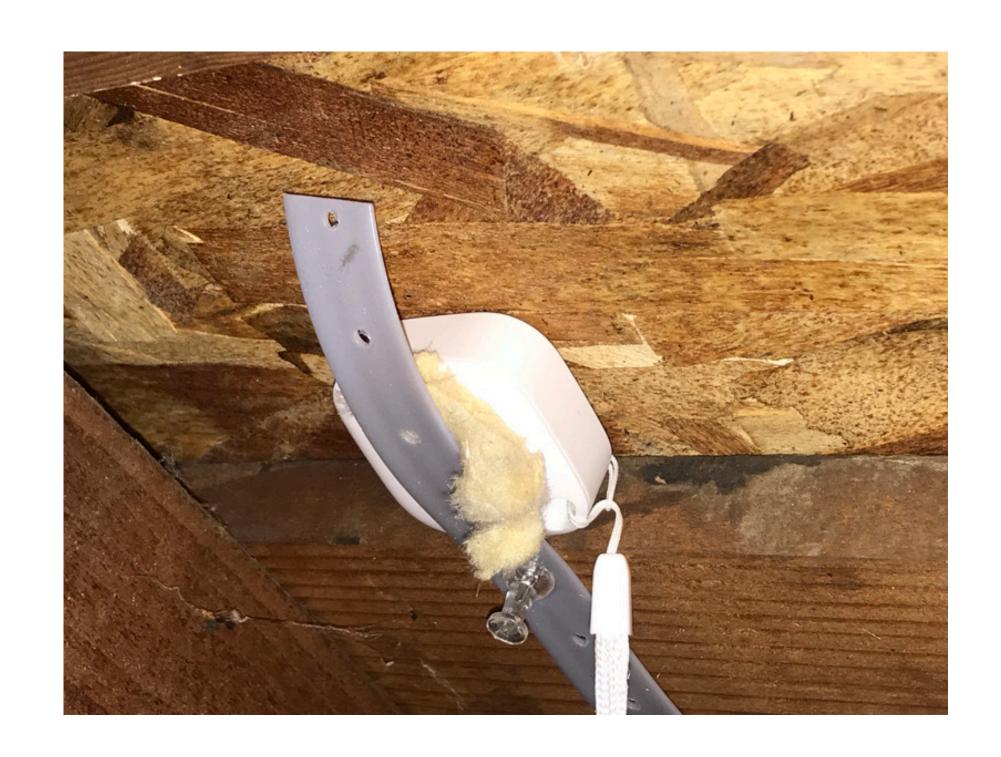
Temp/RH Sensors

Sensor assemblies were placed between insulation and OSB. The sensing elements were roughly 1/8" from the OSB

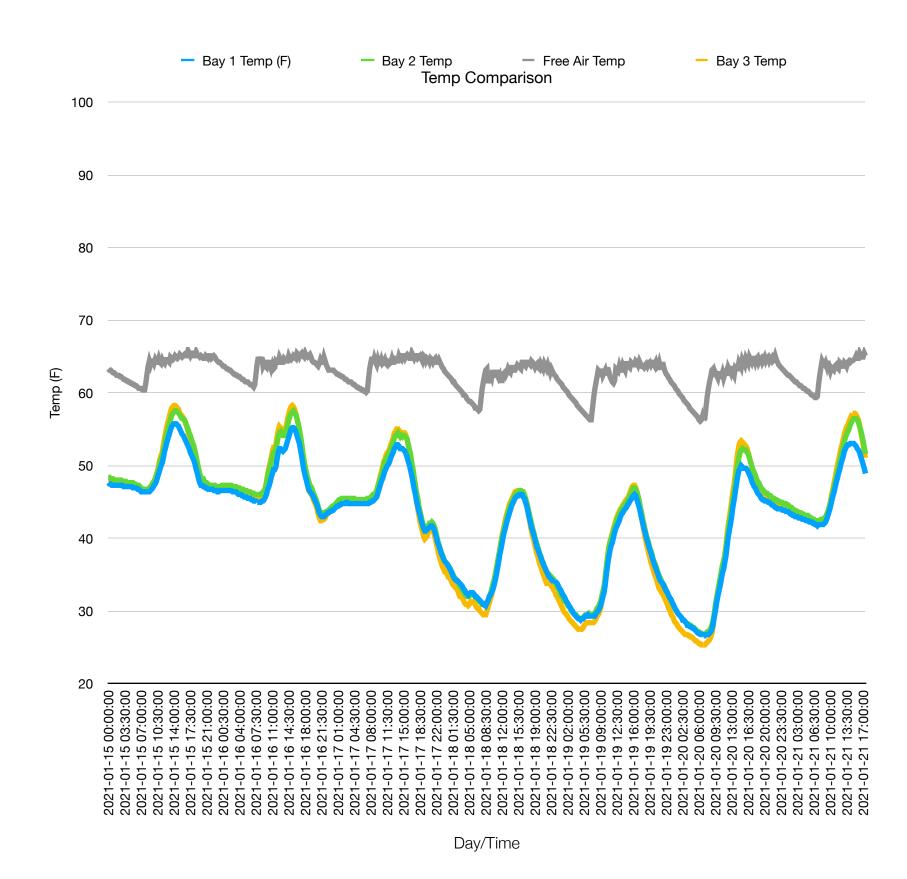
Temp/RH data

High RH in all 3 bays, particularly on clear/cold nights. No dramatic difference between the bays in terms of temp or RH.

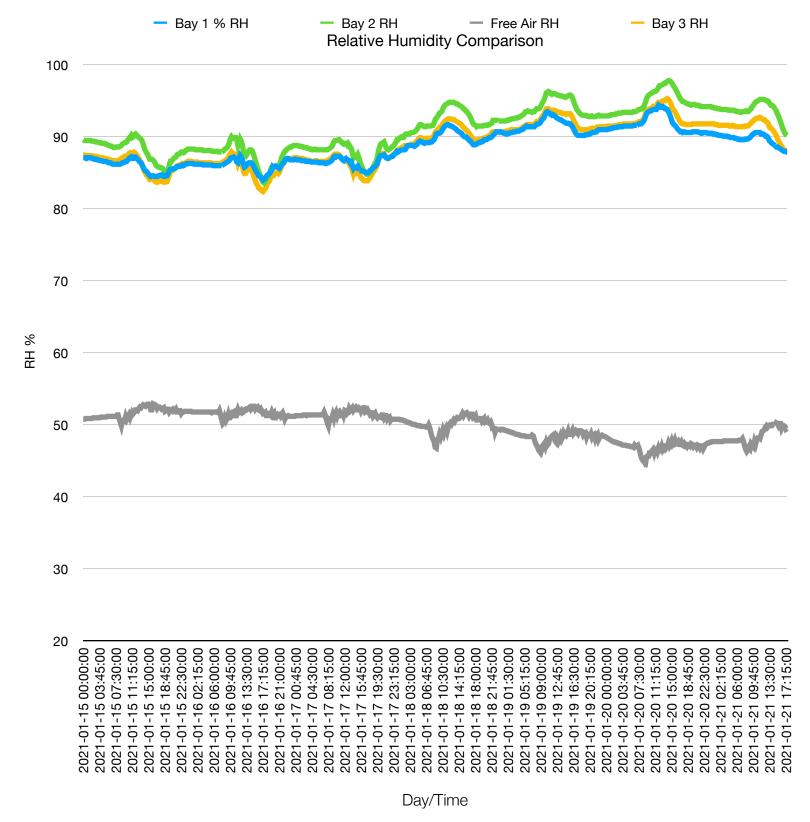
Outdoor RH avg 86% in Jan.
Outdoor temp typically in 30's and 40's.
Jan 18, 19, 20 had clear nighttime sky. Other nights were overcast.
Bay 1 had slightly less exposure to night sky radiation.
