Issues with current roof:

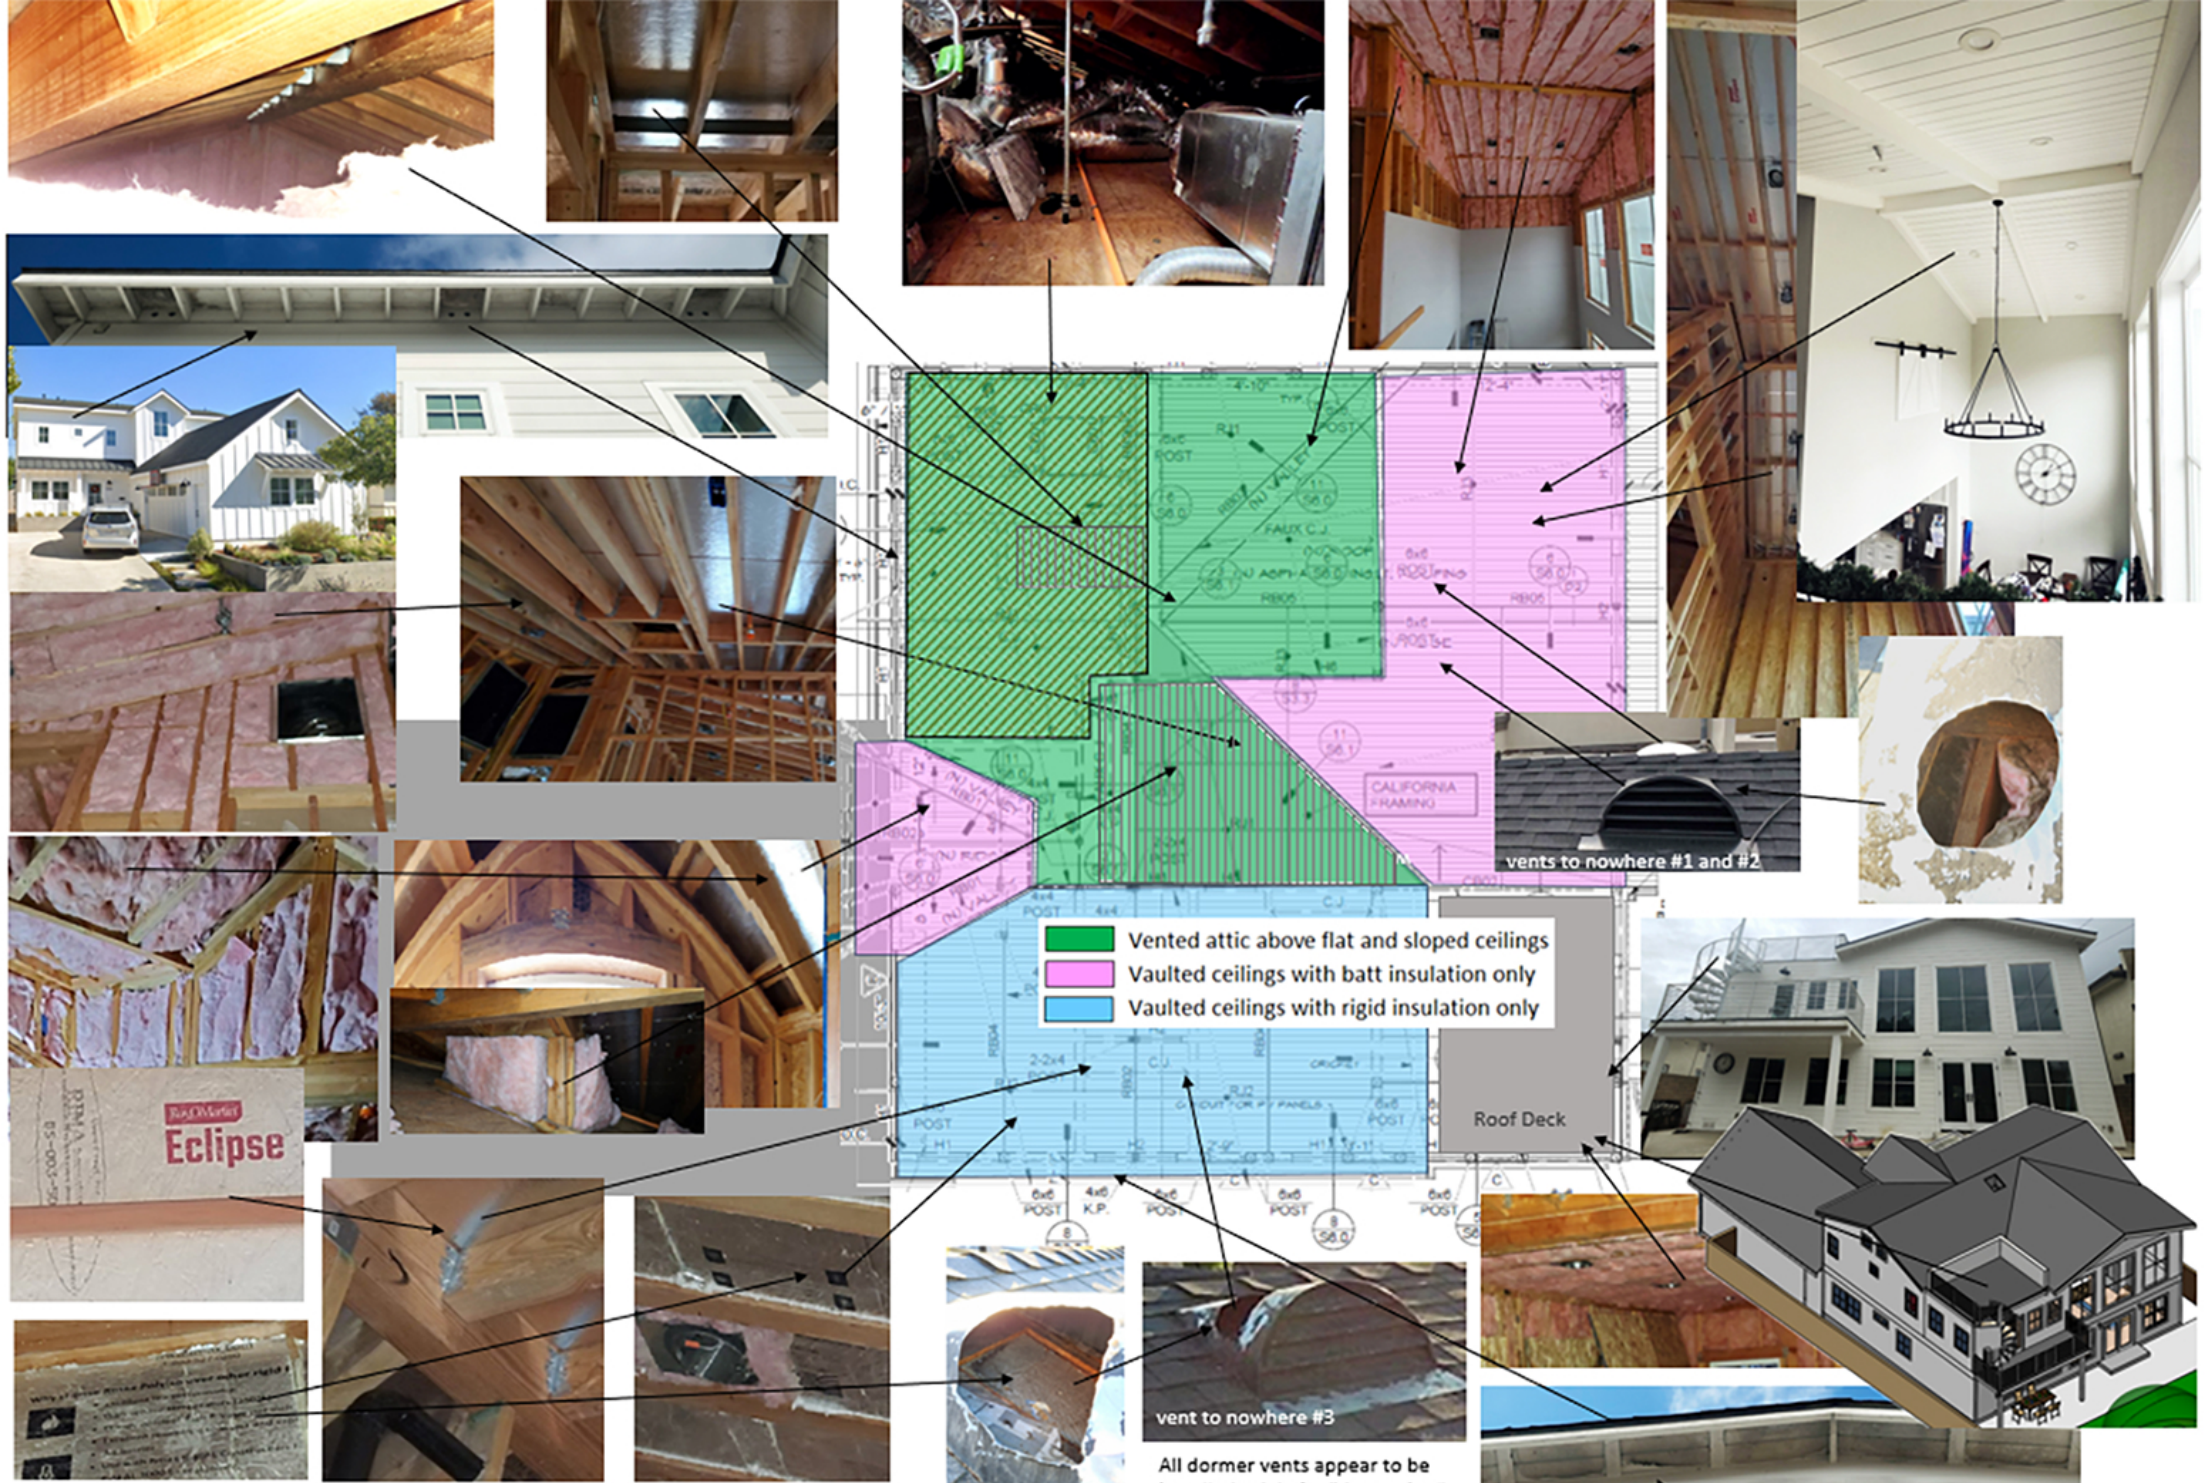
- Only six, 2-in ventilation holes - approximately 4% of the area needed with no dormer vents
-

- Aluminum facers on both sides of the rigid polyiso foam (above the master bath and closet)
-

- R-value is approximately 25 for this area (R-30 requirement)
-

- Fiberglass batt insulation between the rafters with no ventilation also requires:
 - Rigid insulation above the roof sheathing: CRC R806.5 - 5.1.2.
-

- Radiant barrier on OSB limits drying to the interior
-

- Aluminum facers on the polyiso foam (class I vapor retarders not allowed, R806.5 - 1.)
-

- Radiant barrier on OSB limits drying to the interior

- Unvented deck has fiberglass batt insulation only
