В	0	U	W	К	Α	Ν	S
			_				
Project						The Netherl	ands
Subject	t		Investigati	on of dama	ged Insulat	ting Glass U	nits

17KB1-R1

February 10th, 2017

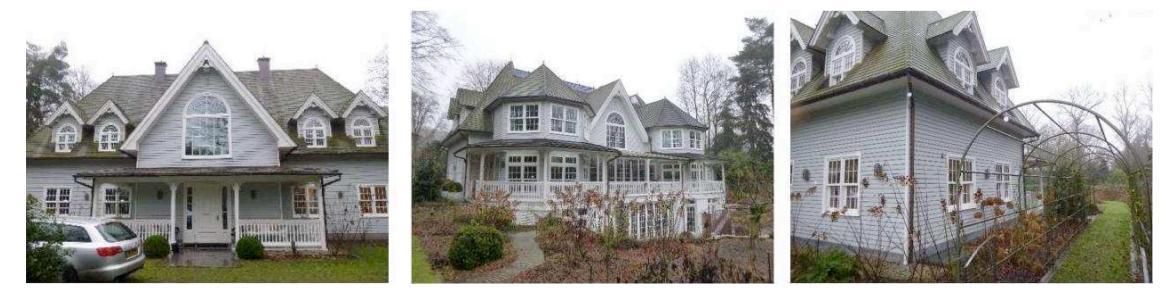
Photos 1, 2, 3: Front side of the villa is facing NNW, backside SSE, right side WSW.

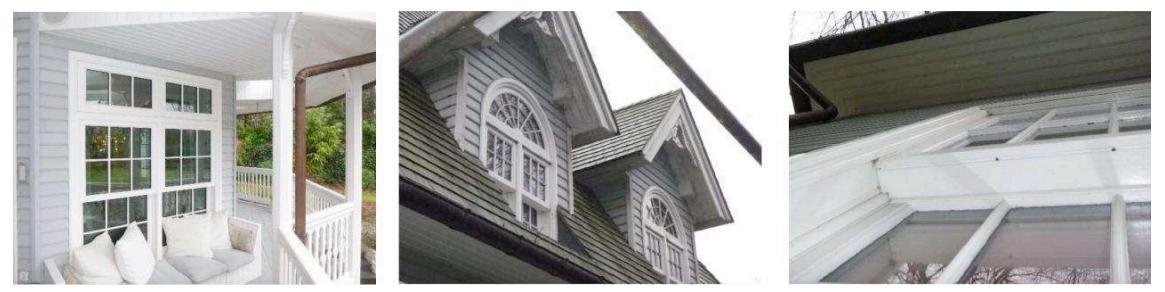
Photos 4, 5, 6: Shielding by canopies, eaves and gutters.

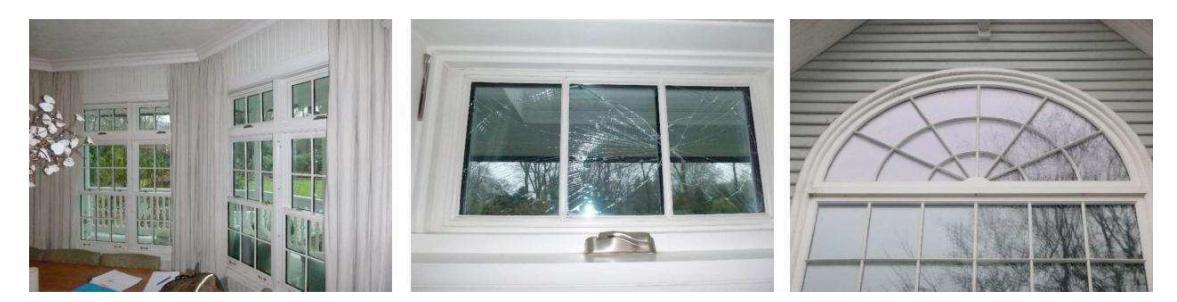
Photos 7, 8, 9: Bottom an top sash windows with hinged vent windows above them, fixed windows half round shaped windows. All with crossbars on both sides.

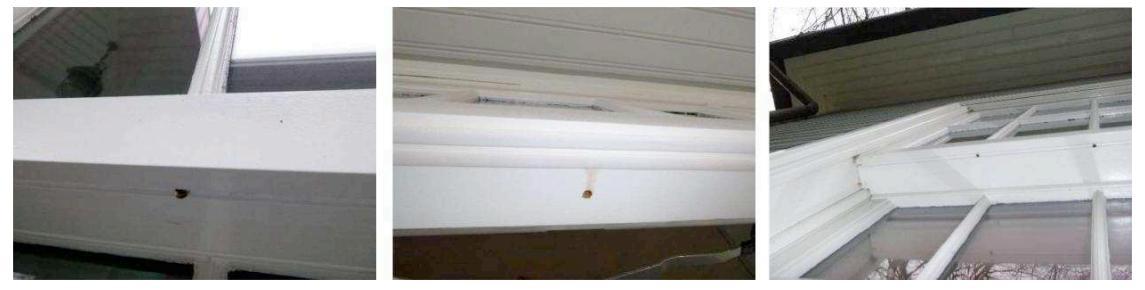
From the outside weep holes for water drainage are visible on the underside of all of the in-spected window frames (sash, hinged and fixed). The number of weep holes varies from 1-3 per window frame. The weep holes were not incorporated in framing system originally but were, according to information provided by mr. drilled before the IGUs were placed as advised by the workmen hired for placing the IGUs. The size of the weep holes is approximately 6 mm.

Photos 10, 11, 12: 1-3 weep holes for water drainage per window.

All of the inspected sealant joints on the outside were intact, attached and sloping outwards. No residue signs of stagnant water were observed.

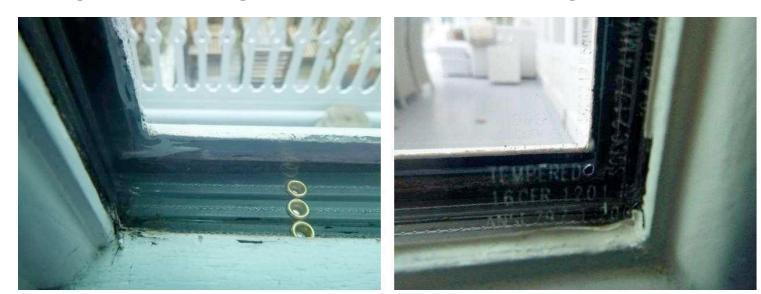
The thickness of the glass panes was measured indicatively by means of glass reflection thickness measurement. The outside panes were typically 5 - 6 mm and the inside panes 4 - 5 mm.In all cases the outside pane was thicker than the inside pane of the same unit. Clearly visible were the dark coloured spacer bars and copper coloured in- and outlets for the gas filling process.

The two layers of foil have a small pressure equalising hole in one of the corners.

Photos 13, 14: Spacers and gas filling holes, inscription and holes in the foil.

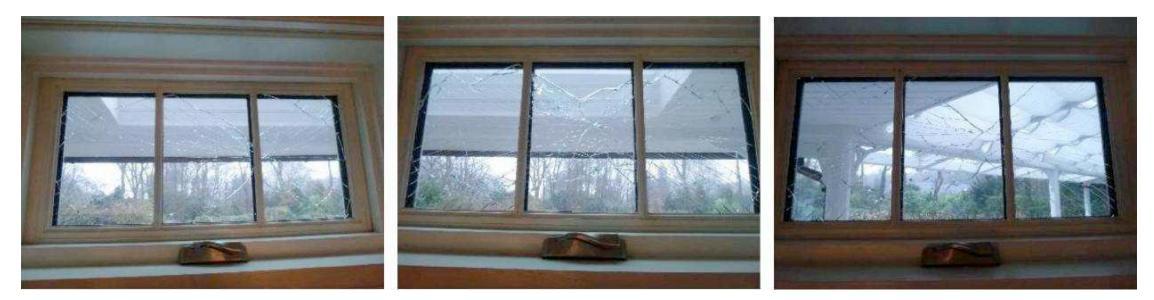
In total 7 broken glass panes were inspected, all of which were inside panes that had col-lapsed inwards (i.e. in the direction of the cavity). Most of the breaking patterns are very typi-cal for breakage due to an equally distributed load like exterior air pressure. No impact re-lated markings were observed.

Photos 15, 16, 17: Three imploded units (numbered 1, 2 and 3) with broken inside panes. All are hinged vent

windows situated right under the large canopy on the back side of the villa (photo 4).

No known remedies exist for the diffusion/absorption process. All IGUs must be replaced.

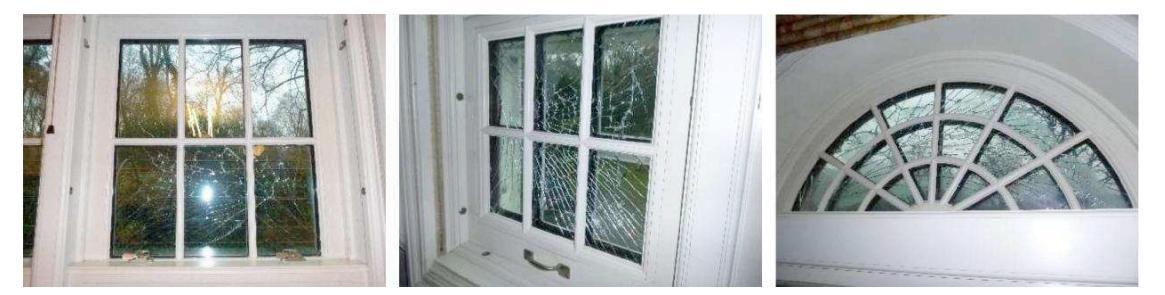
Photos 18, 19, 20: Three imploded units (numbered 4, 5 and 6) with broken inside panes. Situated respec-tively in a: top sash window ground floor in the office, bottom sash window and half round fixed window both in the same window frame at the first floor bedroom. All units are in the WSW facing (right side) façade.

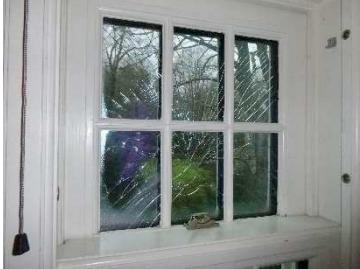
Photo 21: Imploded unit (numbered 7) with broken inside pane. Situated in a top sash window at the first floor bedroom in the SSE facing (back side) façade.

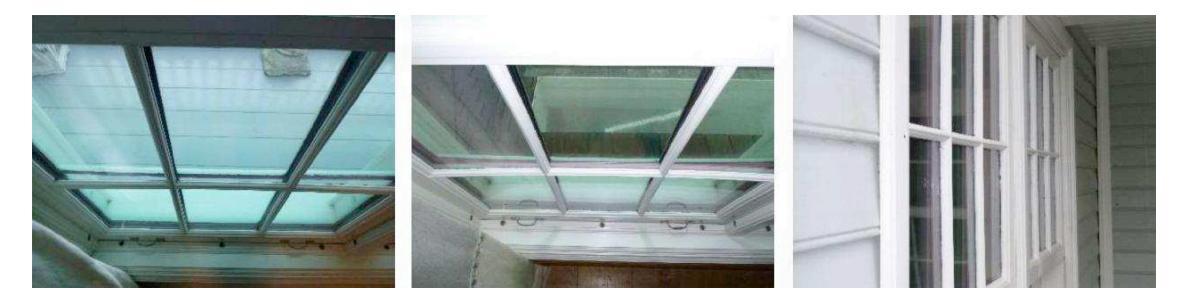
All of the inspected IGUs, except for one, had visible concave shaped glass panes. The in-side pane was always distorted considerably more than the outside pane. The quantity of dis-tortion varied considerably, but was clearly visible.

Photos 22, 23, 24: Concave shaped glass panes, clearly visible by the bent crossbars..

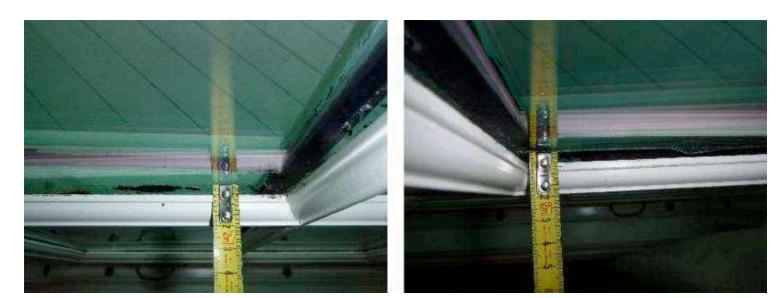
Due to the distortion of the panes the crossbars of many windows were detached from the glass pane.

Photos 25, 26: Detached crossbars with 5 mm spacing between crossbar and glass pane.

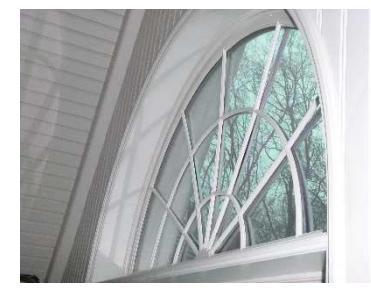
One of the larger half circle shaped units shows the touching of the panes clearly by the closeness of the crossbars as viewed from a side.

Photo 27: The closeness of the crossbars indicates touching panes and foils.

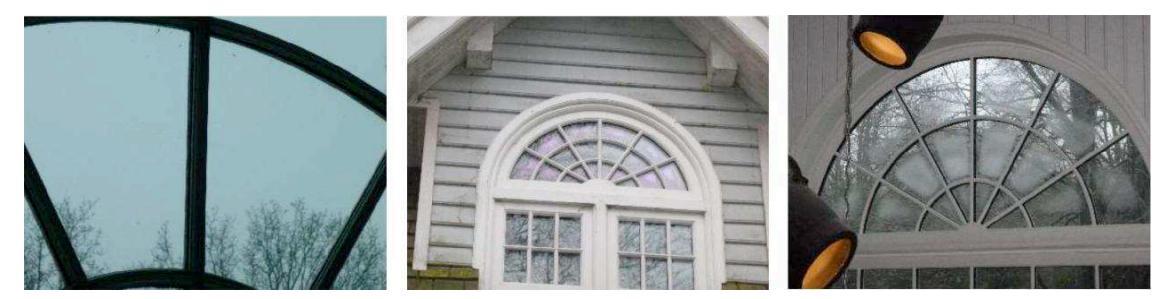
Some of the larger units show clear signs of touching foils and/or glass panes (i.e. Moiré or interference patterns and discoloration). Due to the decrease of the insulating properties of the greatly reduced cavity and the atmospheric conditions condensation patterns on the inside were visible on one unit.

Photos 28, 29, 30: Signs of touching foils and or glass panes inside the cavity: Moiré, interference discolora-tion and inside condensation.

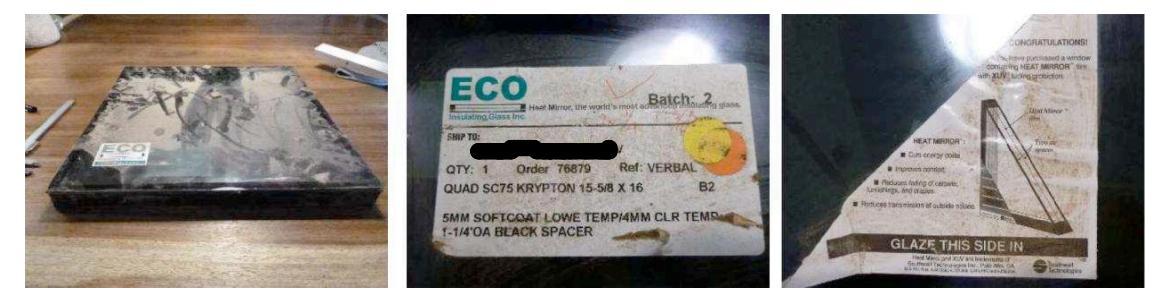
Photos 31, 32, 33: The spare IGU and its stickers.

- The unit measures 396 x 407 mm.
- The distortion of the 4 mm inside pane is 3,8 mm.
- The distortion related to the diagonal and shortest side are given in tables 2 and 3.
- The spacer is curved and pulled inwards up to 4,5 mm in the centre (viewed frontally).
- The secondary sealant is distorted and shaped inwards for approximately 5 mm.

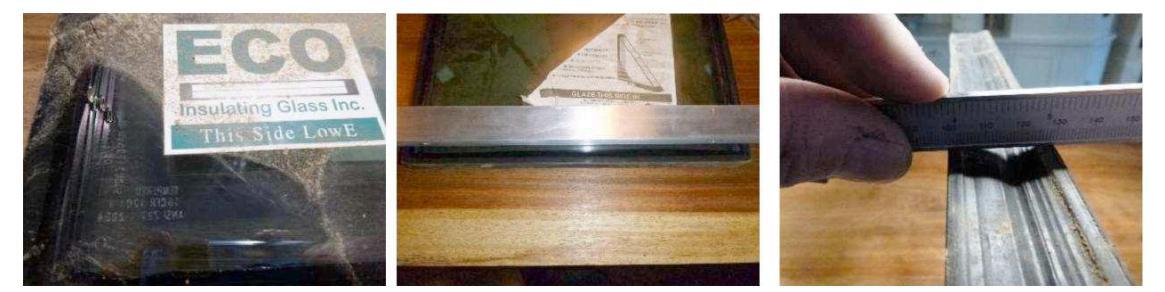
Photos 34, 35, 36: The etched markings, the inward curved spacer compared to the ruler and the inward shaped secondary sealant.

This conclusion that no external influences (or influences the owner can be held responsible for) cause the occurring damage becomes indisputable by observations made on a spare IGU that was stored inside, dry and shielded from sunlight. This unit also showed the con-cave shape an even showed deformed spacers that were pulled inwards. Both are a clear sign of a low pressure inside the unit.
