FRONT VIEW: 2 CAR GARAGE WITH UNINSULATED FLOATING SLAB

PROPOSAL ONE: FORST-PROTECTED SHALLOW FOUNDATION

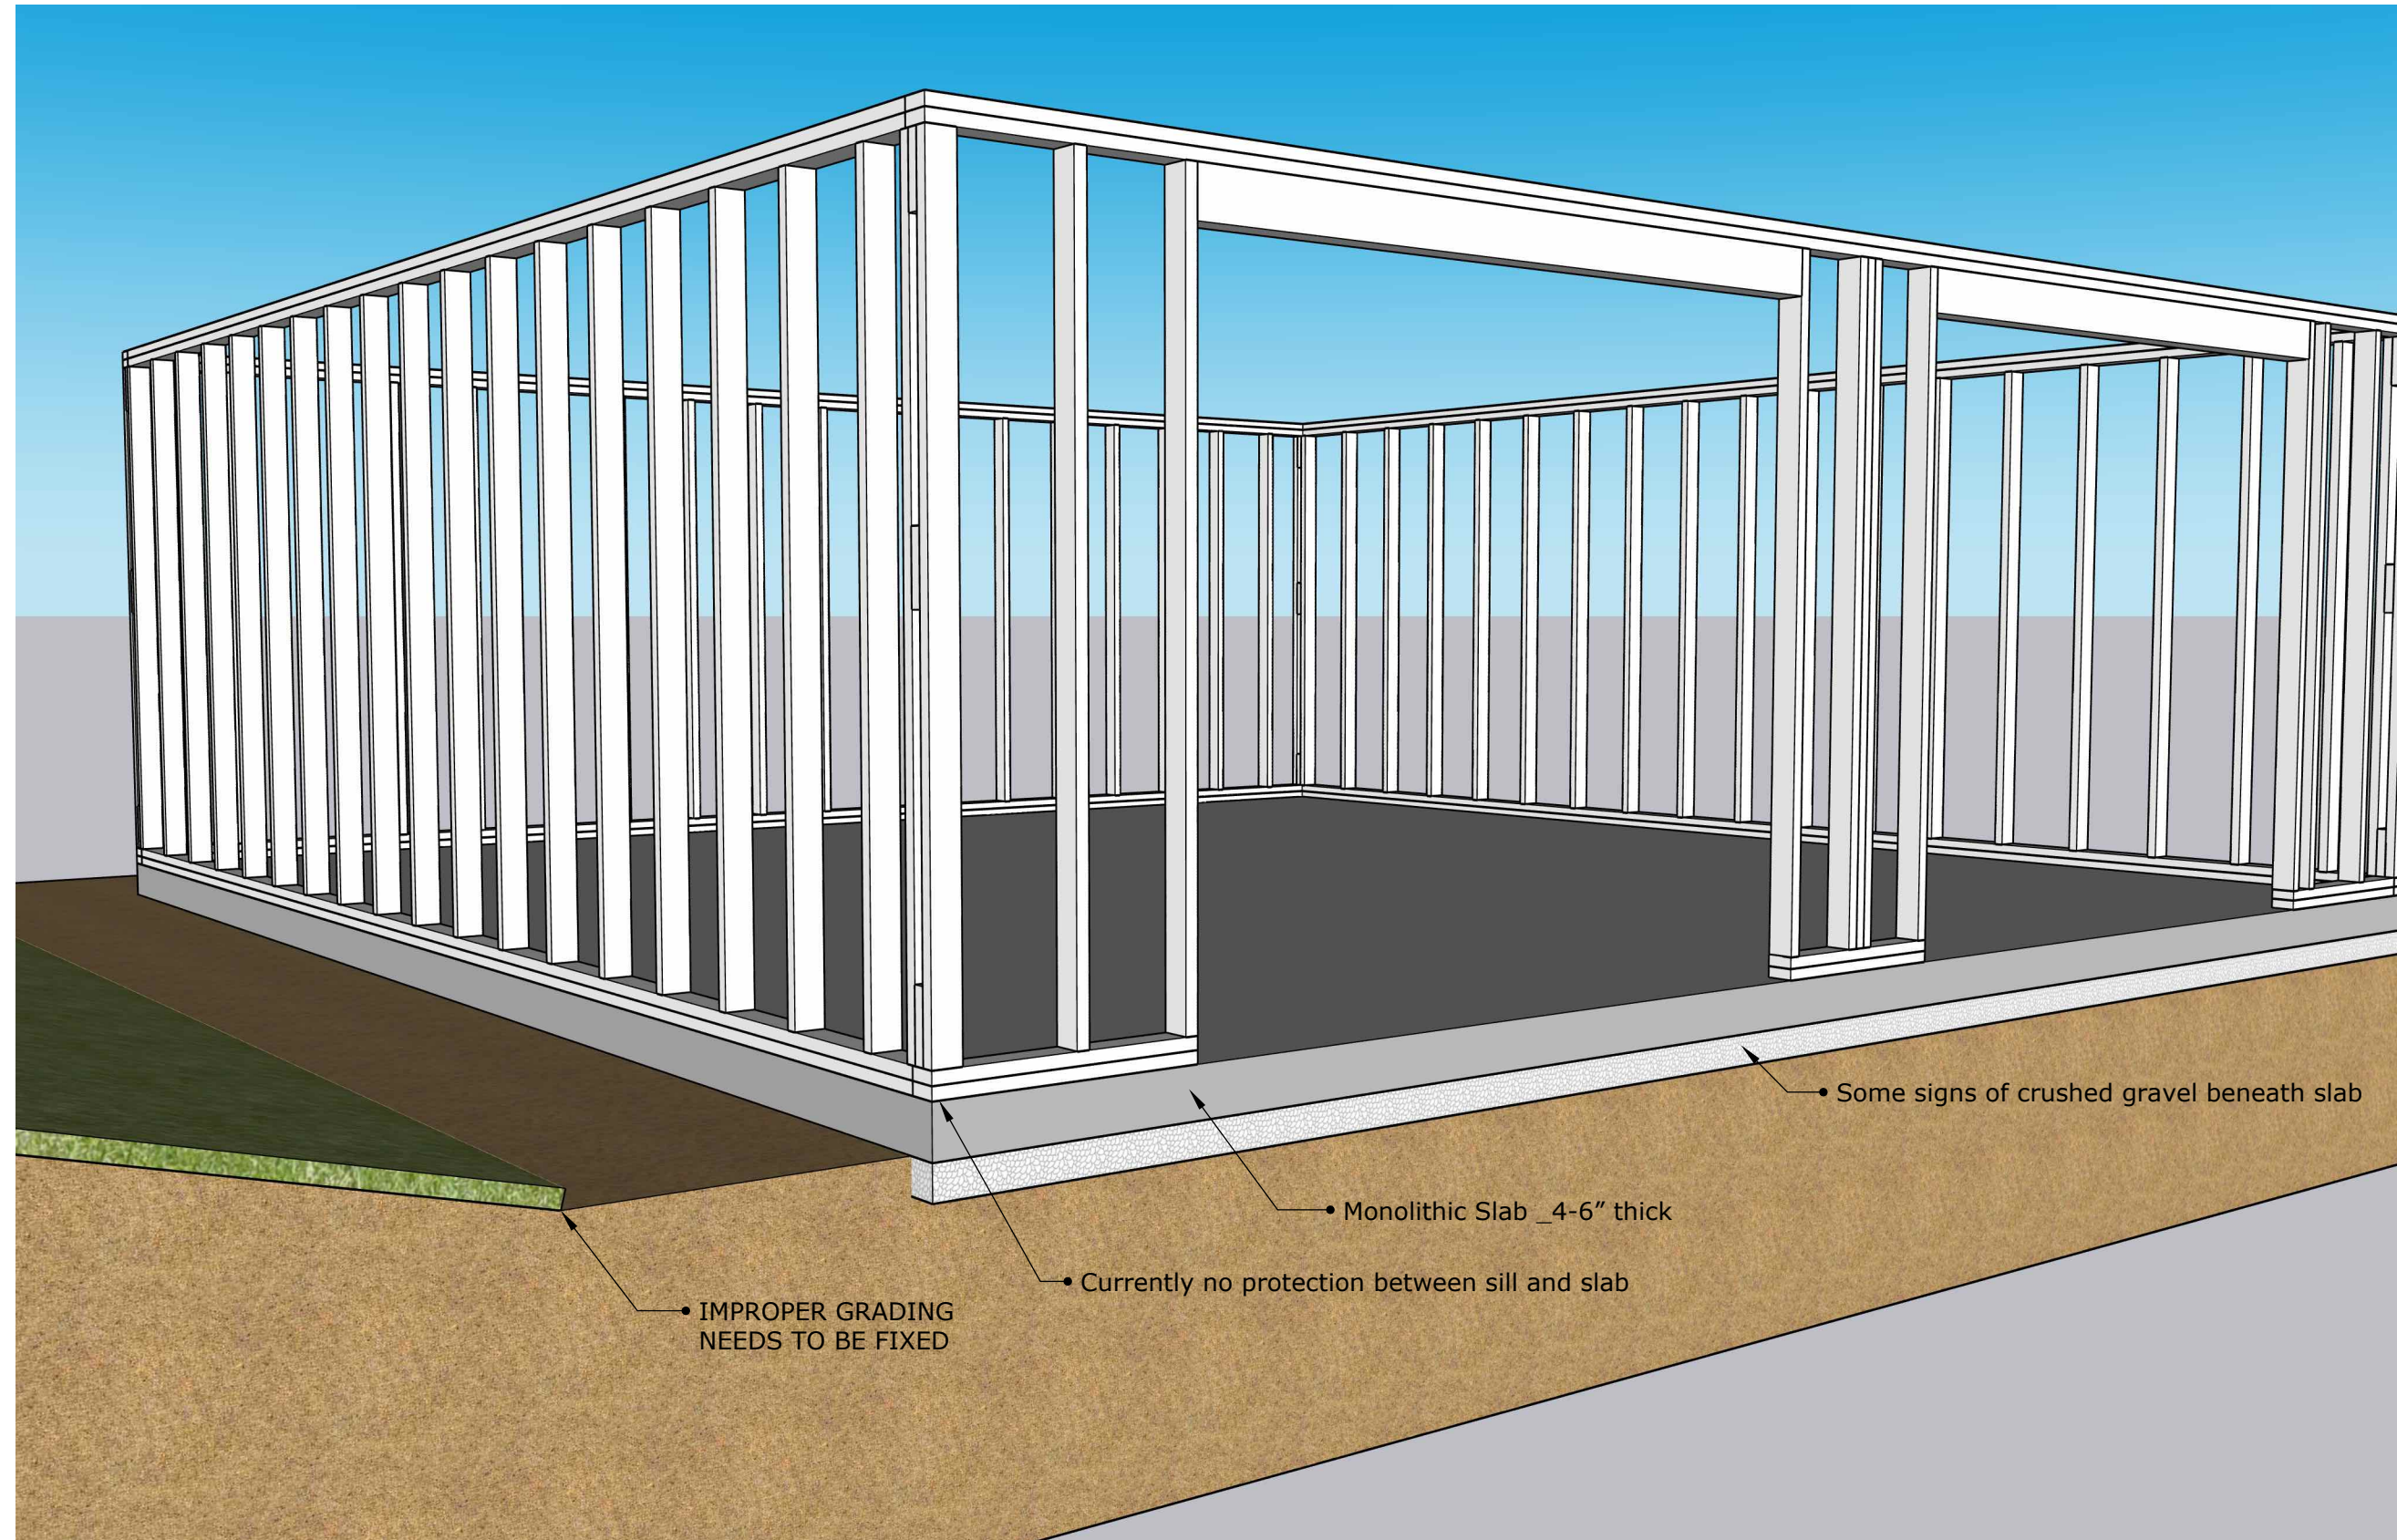
HOUSE WITH BASEMENT FOUNDATION UP THIS BANK

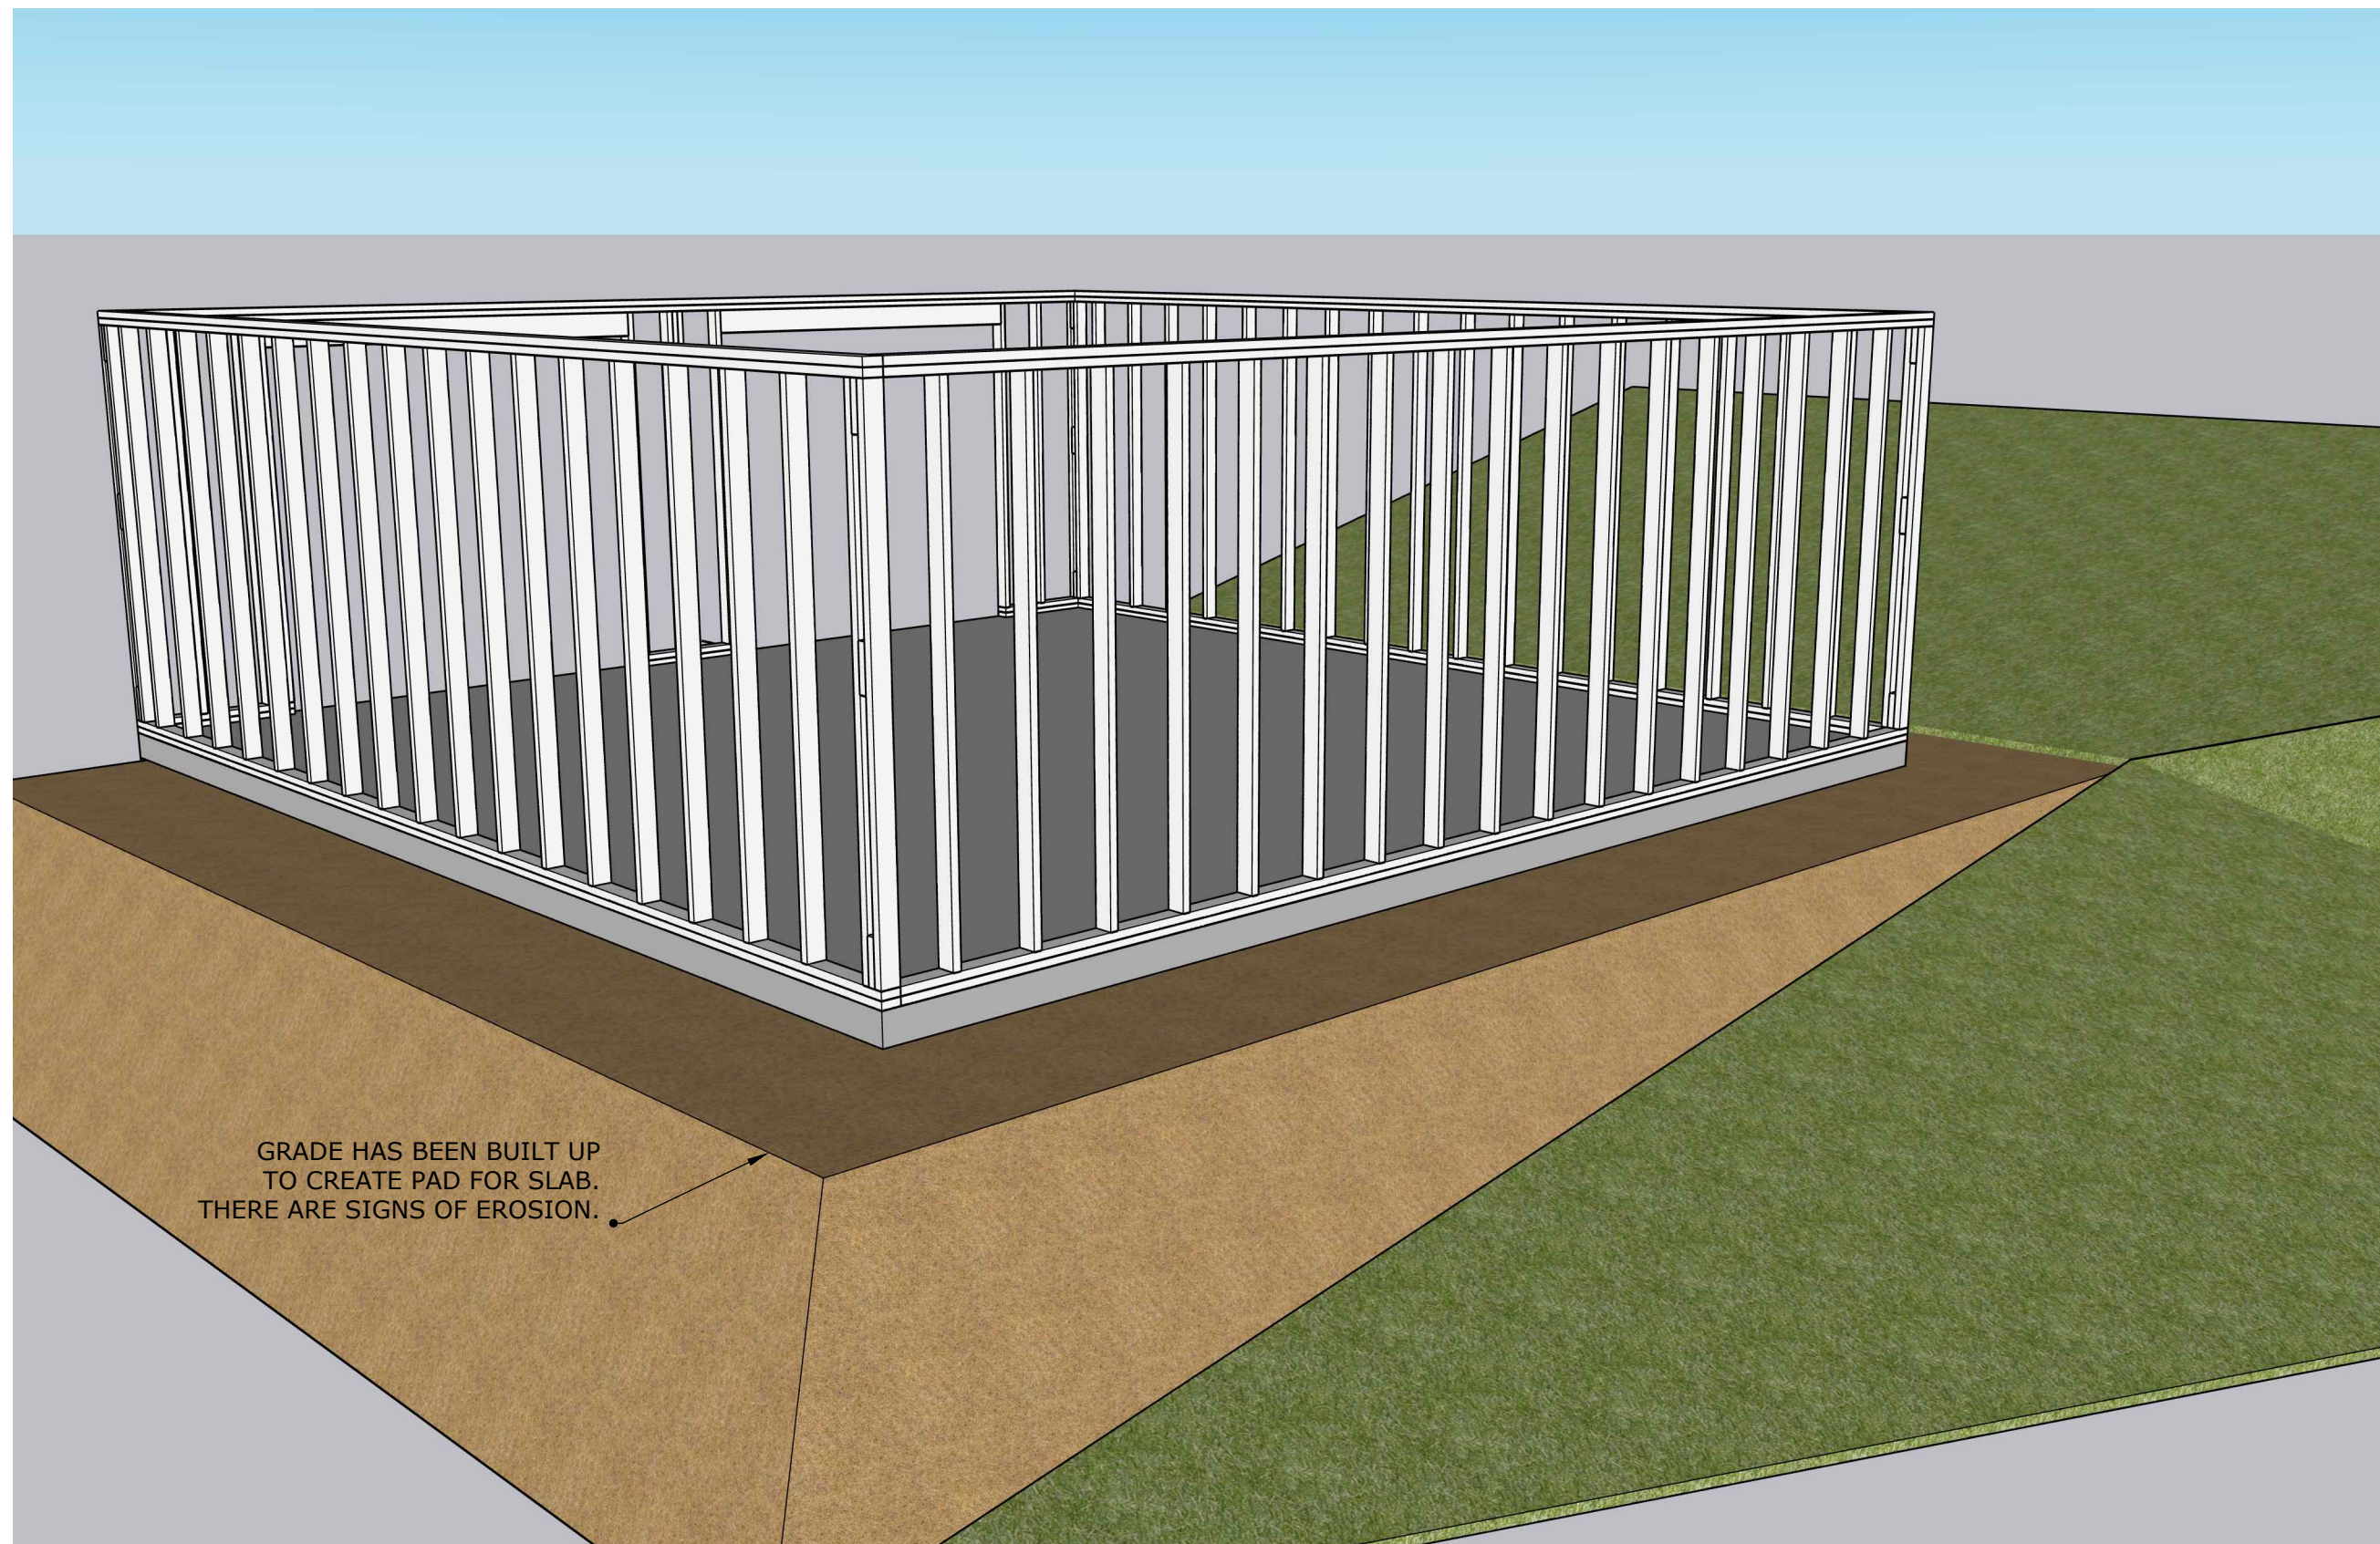
HOUSE WITH FOUNDATION UP THIS BANK

GRADE HAS BEEN BUILT UP
TO CREATE PAD FOR SLAB.
THERE ARE SIGNS OF EROSION.

BACK VIEW: 2 CAR GARAGE WITH UNINSULATED FLOATING SLAB

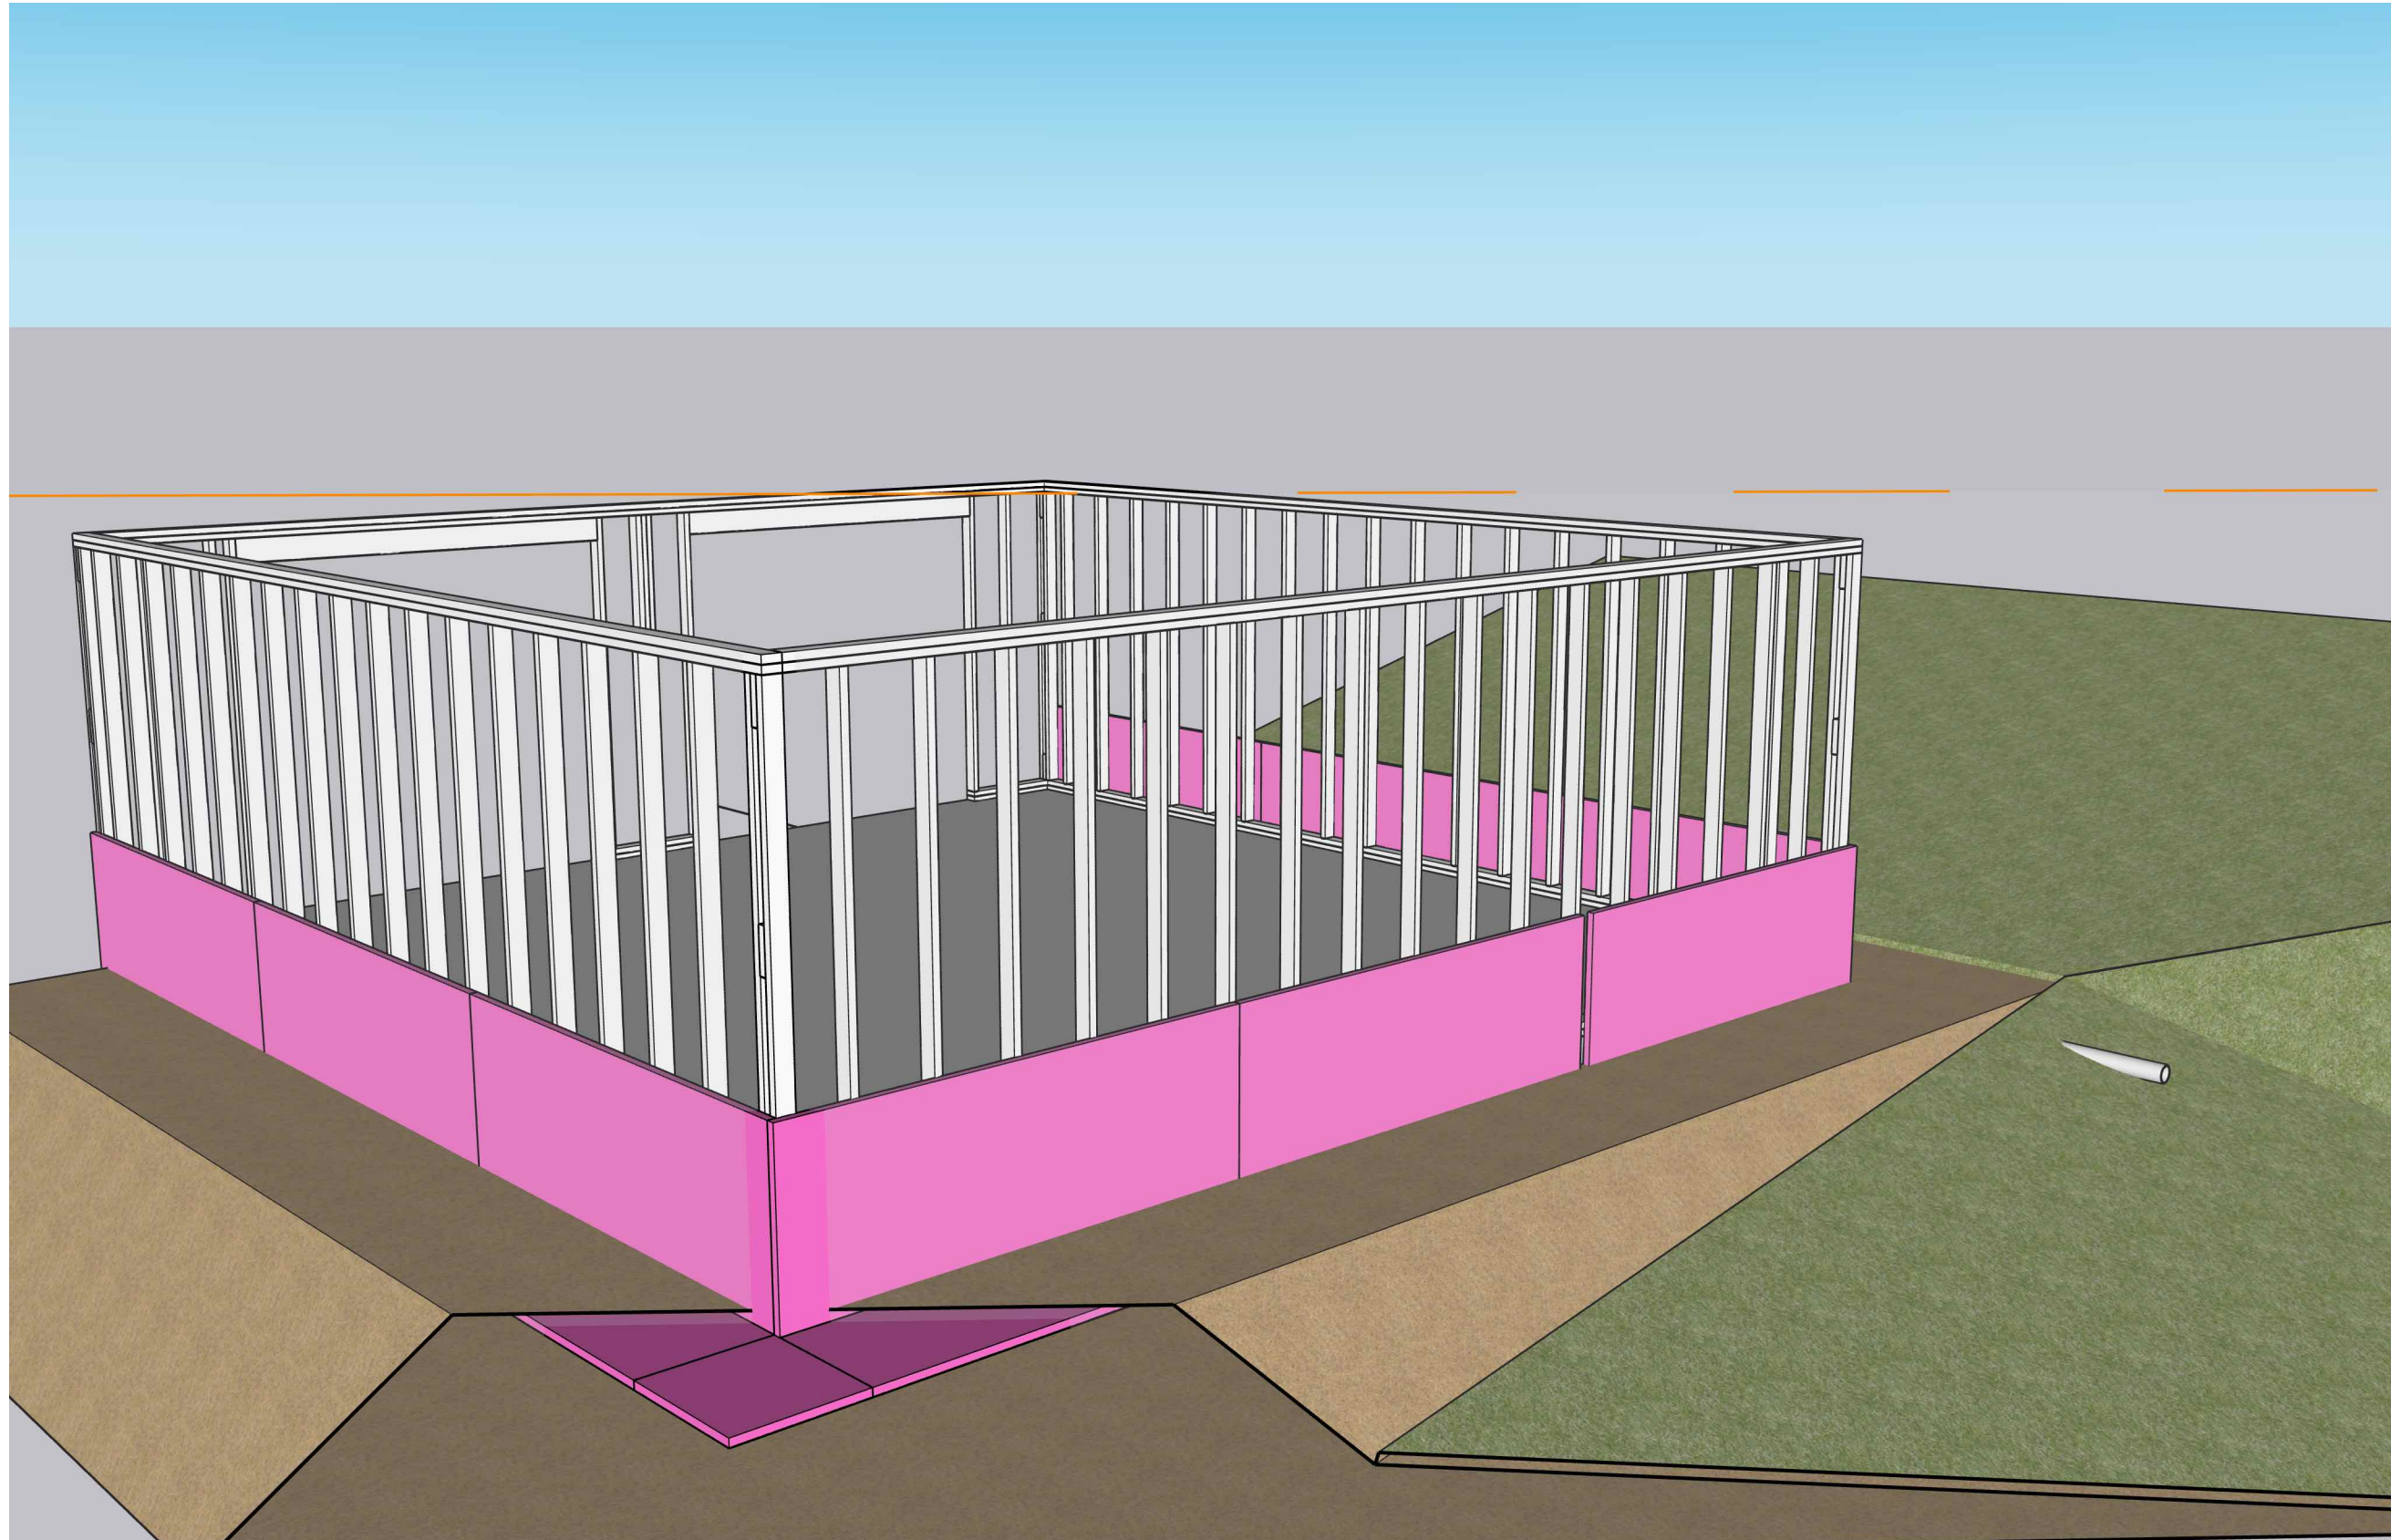
PROPOSAL ONE: FORST-PROTECTED SHALLOW FOUNDATION
