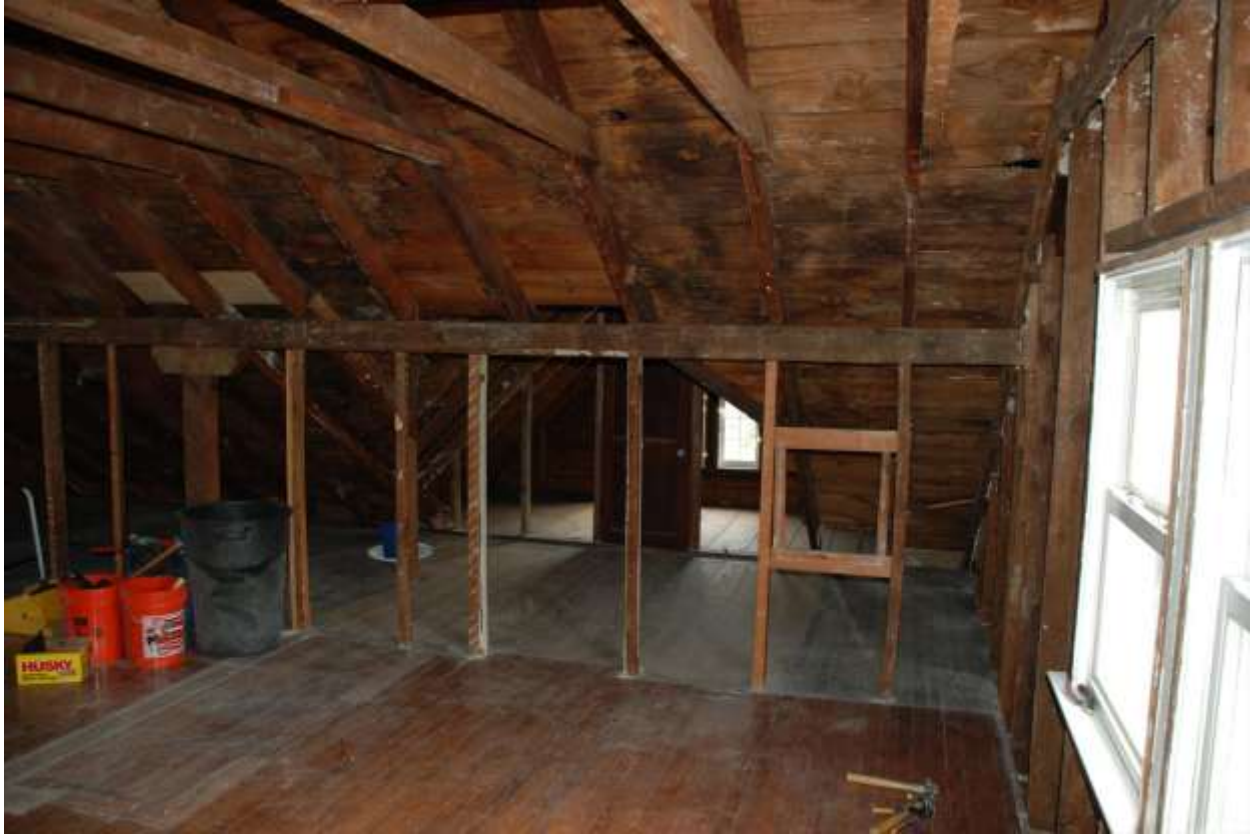
This one was taken upstairs during clean up stage facing towards east:

The small windows there are above porch which is not conditioned but has also been gutted and insulated using XPS. There's a chance moisture travels up those walls where the old door is still hanging.

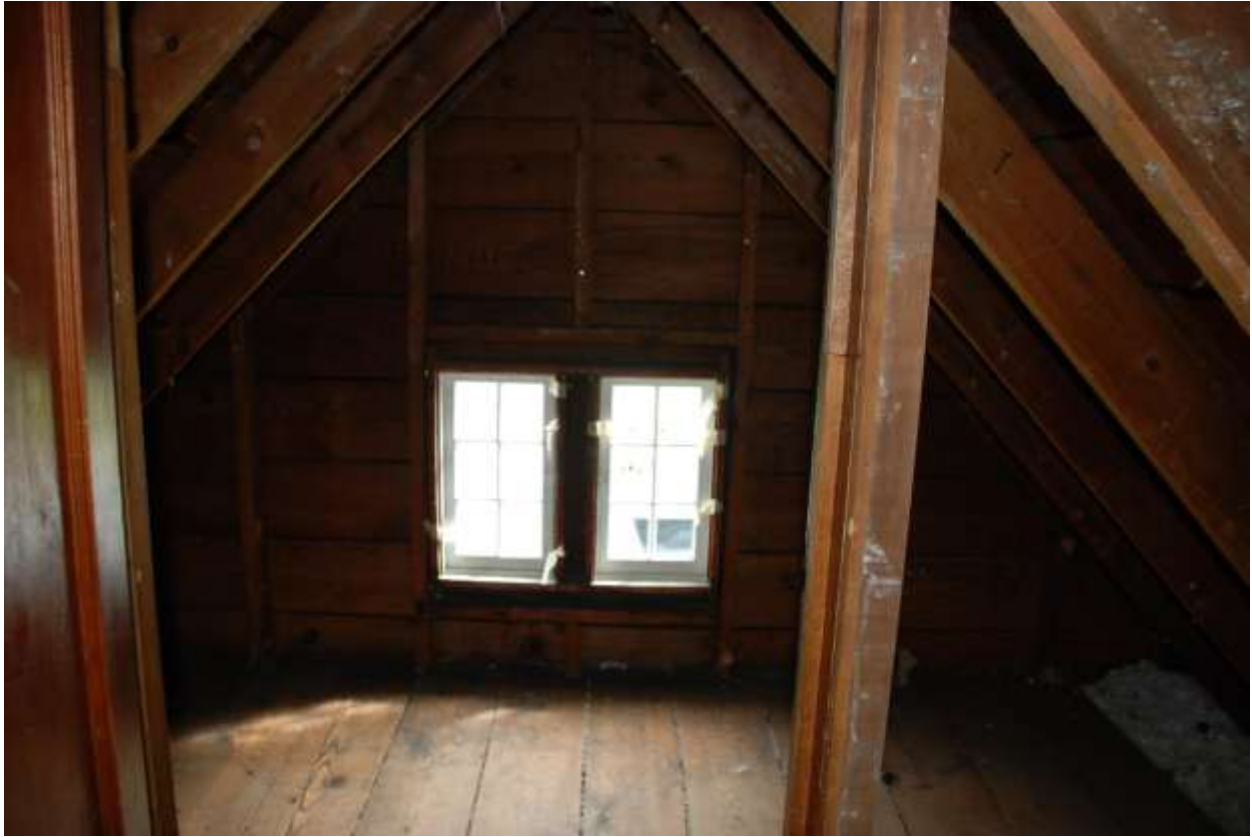
The floor above porch has new blow in cellulose insulation. The windows have been replaced, too.

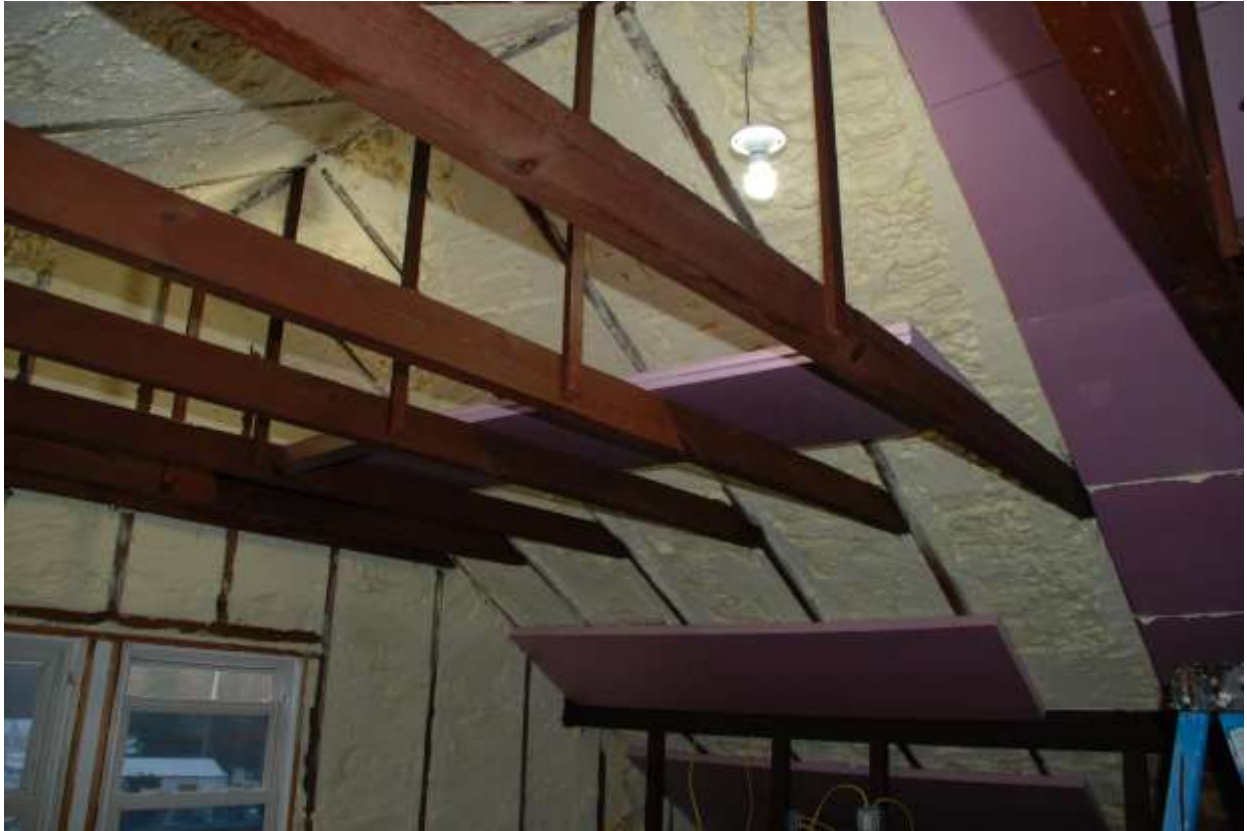
This was when I put it up, as you can see the foam looks good:

I used 'great stuff' from the can to seal between the XPS boards. The sealing process was quite efficient and quick. Water penetrated only from a handful of places very slowly. Each board at the top had a lot of water behind it and we had no idea... The spray foam was soaked.

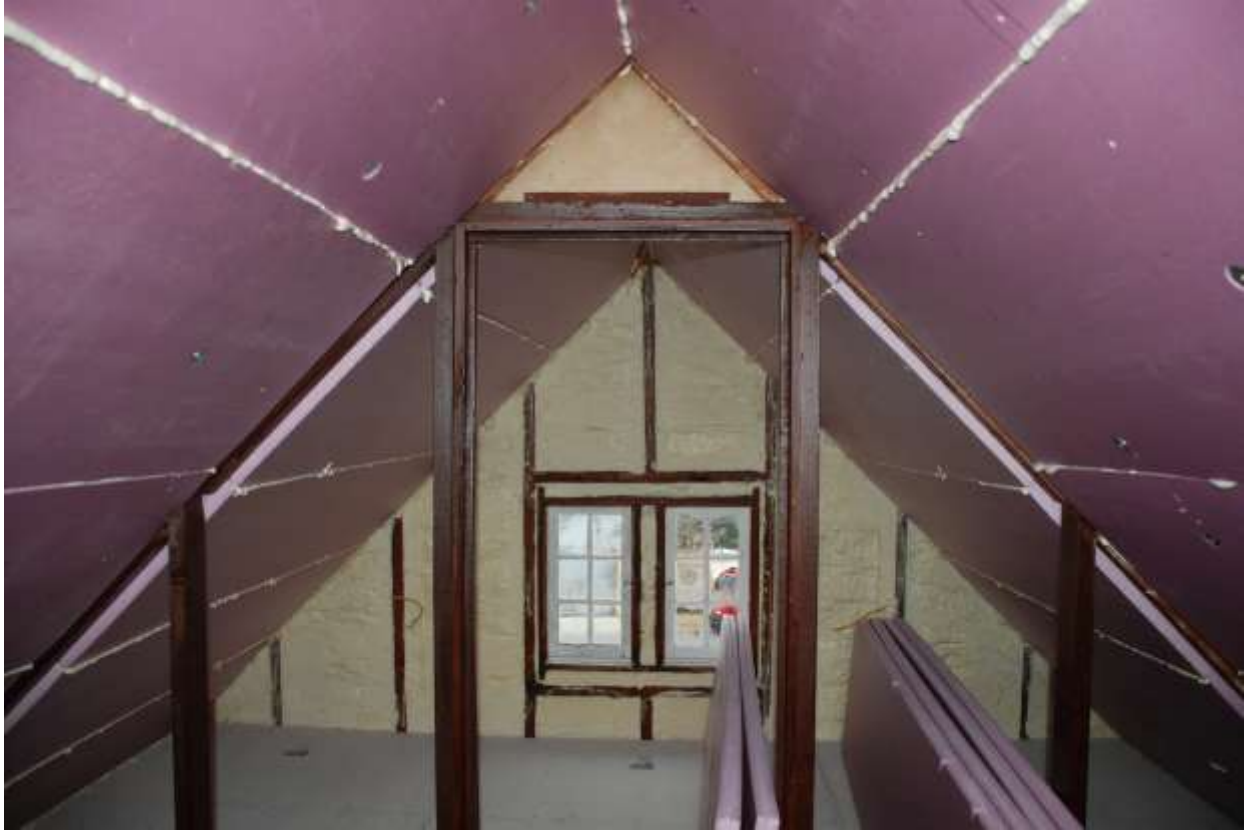
This is what the small room above porch looked like after completion

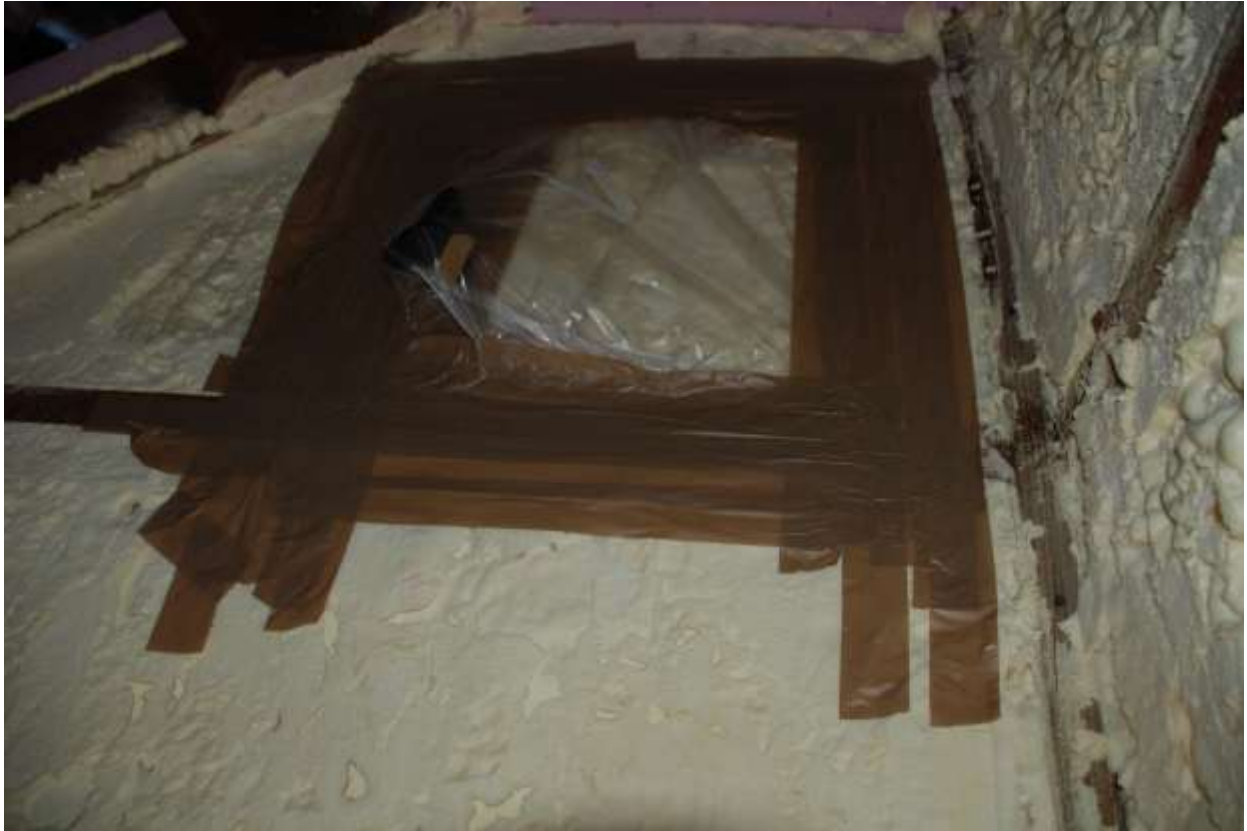
Based on what I have seen the house so far I have reason to believe the moisture is coming out of the foam. It feels that way, too. So I did an old trick and taped thick, transparent plastic on the foam and stuck a thermometer inside. I also had another thermometer (the one above) as control point:

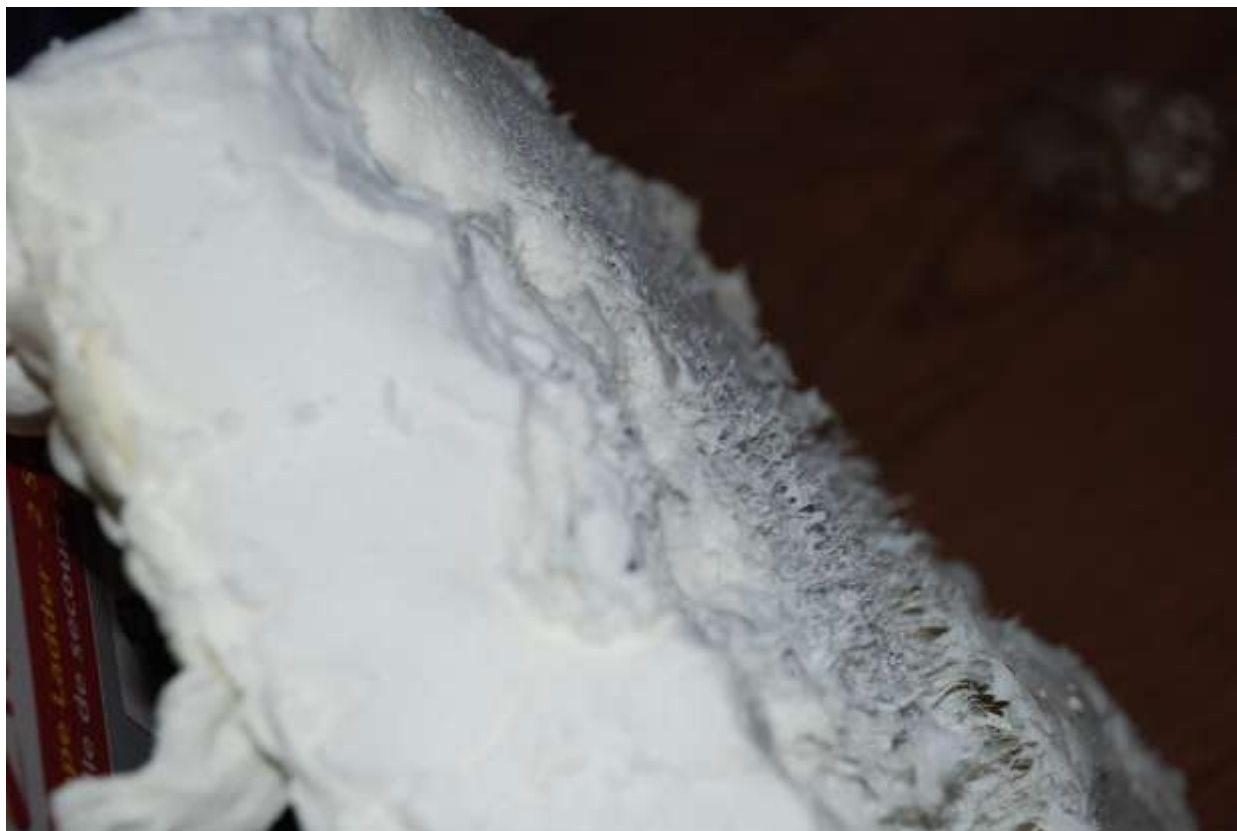
I cut out a couple of areas and the foam appears to have 'hair' on the exterior side. Which leads me to believe the foam actually didn't stick at all to the roof deck:

Here's another piece:

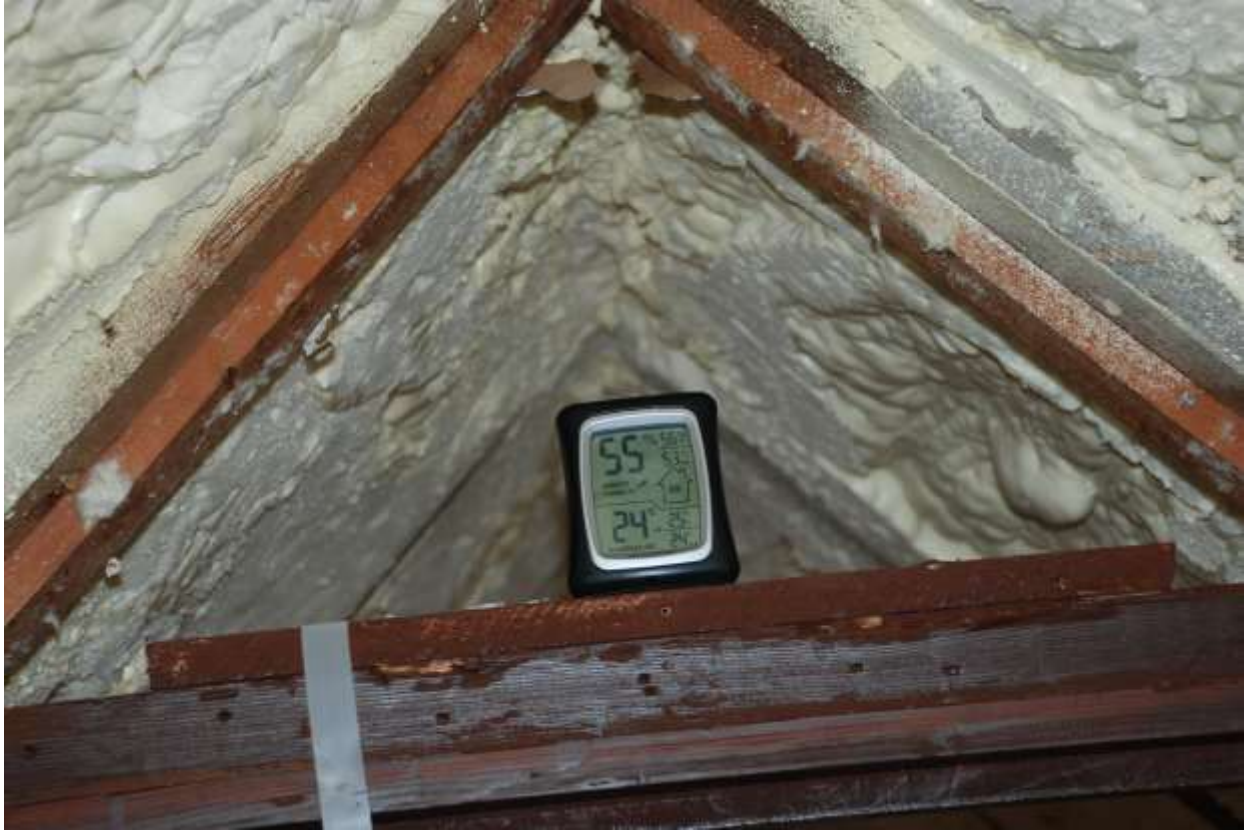
Here are the results which show all day every day the same thing: behind the foam we always have more absolute humidity than outdoors AND inside the house.

This morning:

You can clearly see same temperature but much higher RH. The absolute moisture difference behind foam vs. interior side vs. outdoors appears to be fluctuating. BTW, the hole was covered with the foam pieces I cut out and the thermometer was stuck between planks and foam.
