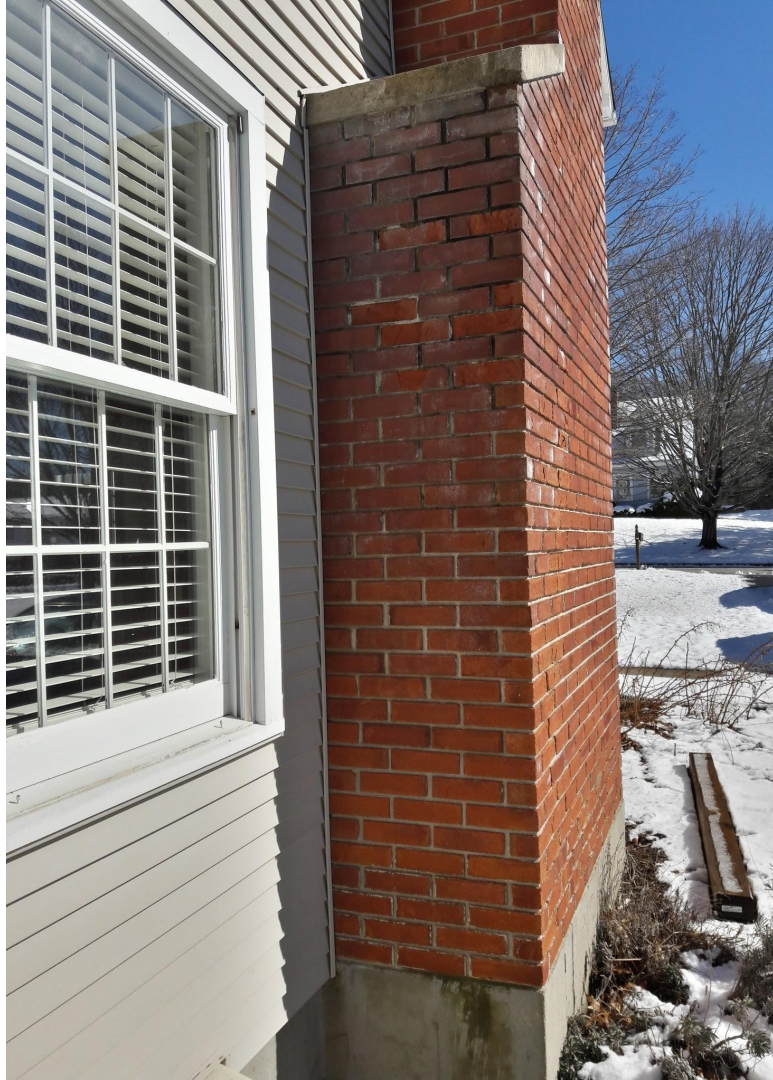
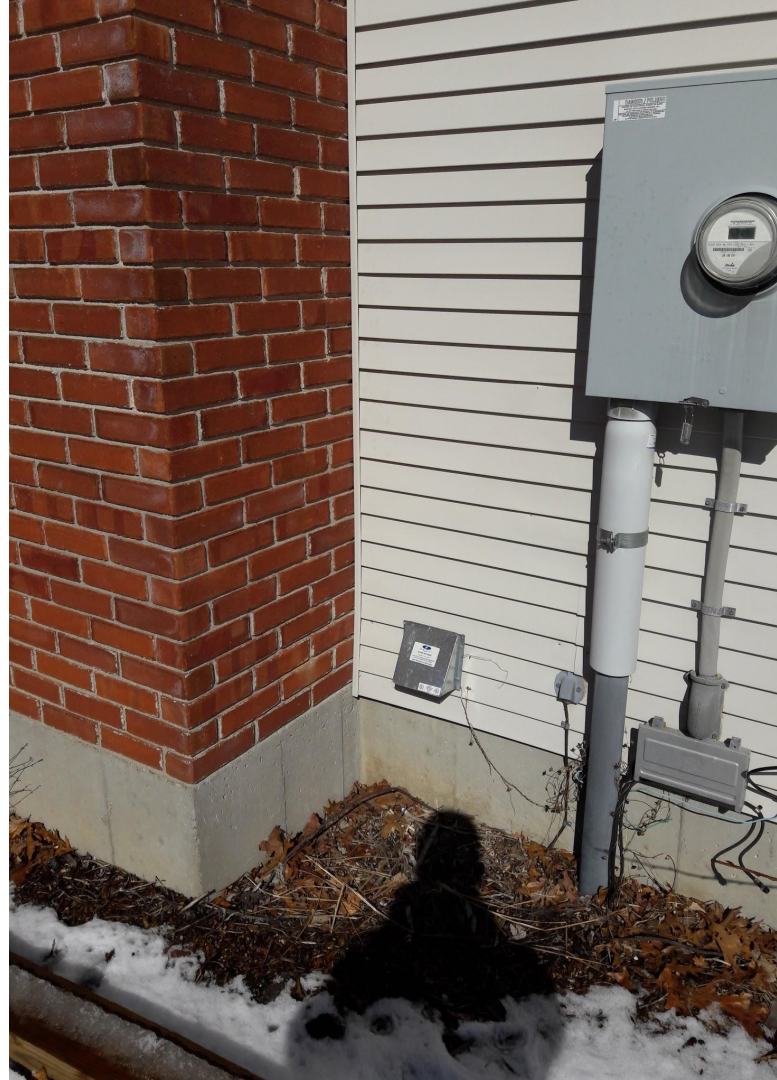
This photo shows my mantel air leakage at steady state with no blower door. Same type of leakage at floor to wall intersection. Looking for exterior air sealing detail and advice to solve this.
