Existing

Proposed

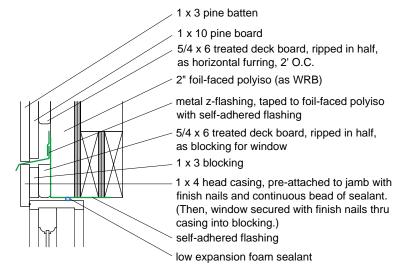
self-adhered flashing low expansion foam sealant

2" foil-faced polyiso (as WRB)

5/4 x 6 treated deck board, ripped in half, as blocking for window

5/4 x 6 treated deck board, ripped in half, as horizontal furring, 2' O.C.

1 x 10 pine board

1 x 3 pine batten

-1 x 4 head casing, secured to jamb with finish nails and continuous bead of sealant. Window secured with finish nails thru casing into blocking.

5/4 x 6 treated deck board, ripped in half, as blocking for window (and as horizontal furring, 2' O.C.)

Remove lap siding; Remove brickmould Add:

- 2" foil-faced polyiso (also as WRB)
- 5/4" board as horizontal strapping,
- vertical 1 x 10 boards with 1 x 3 battens
- metal z-flashing at head
- self-adhesive flashings at jambs and sill

Re-use wood windows, as "outies", with new 1 x 4 casing
