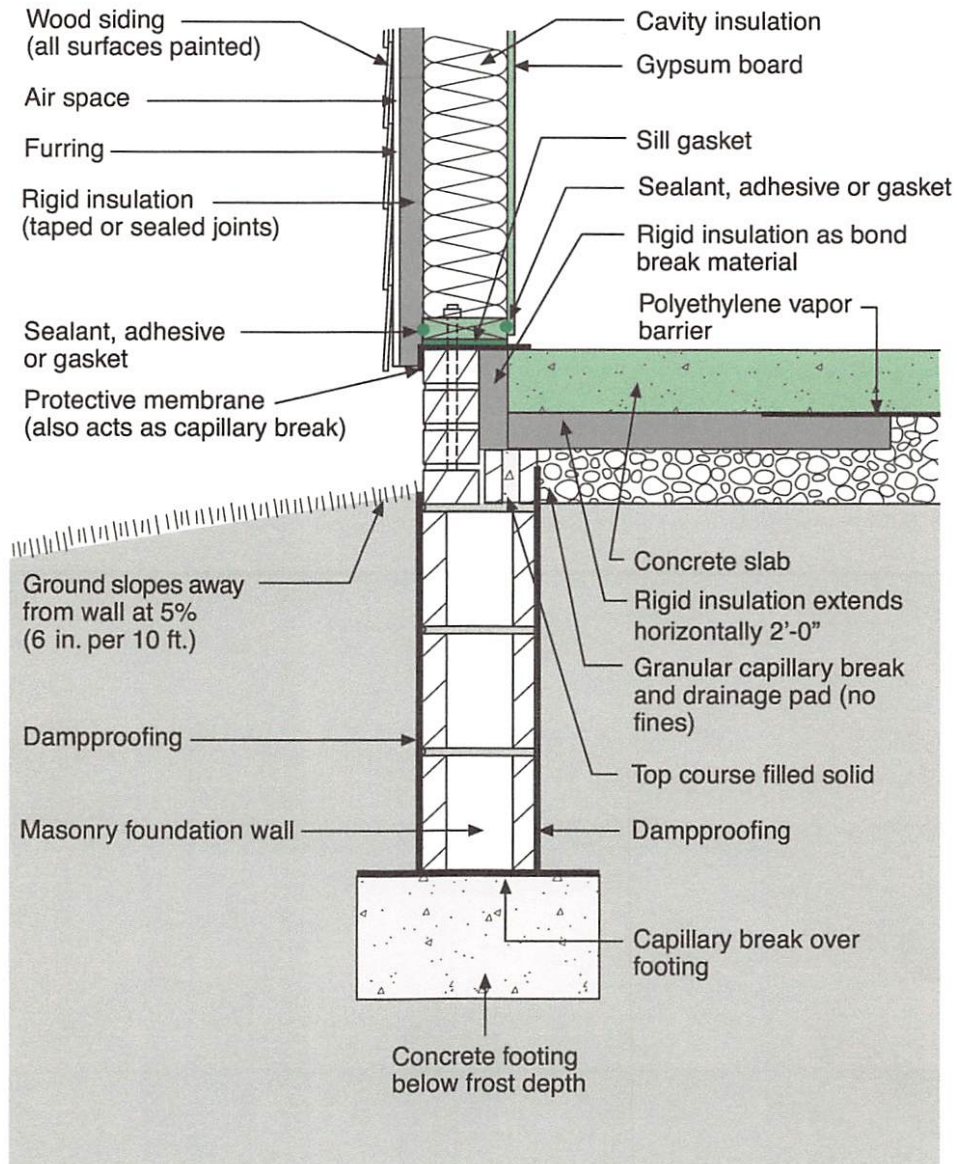
Figure 7.40

Slab with Masonry Perimeter and Wood Siding Above

- Protective membrane acts as termite barrier; sealed to slab
