Without Thermal Break

Floor: R-30, Walls R-32.13, Roof R-60, Windows (U-0.20 to U-.30)

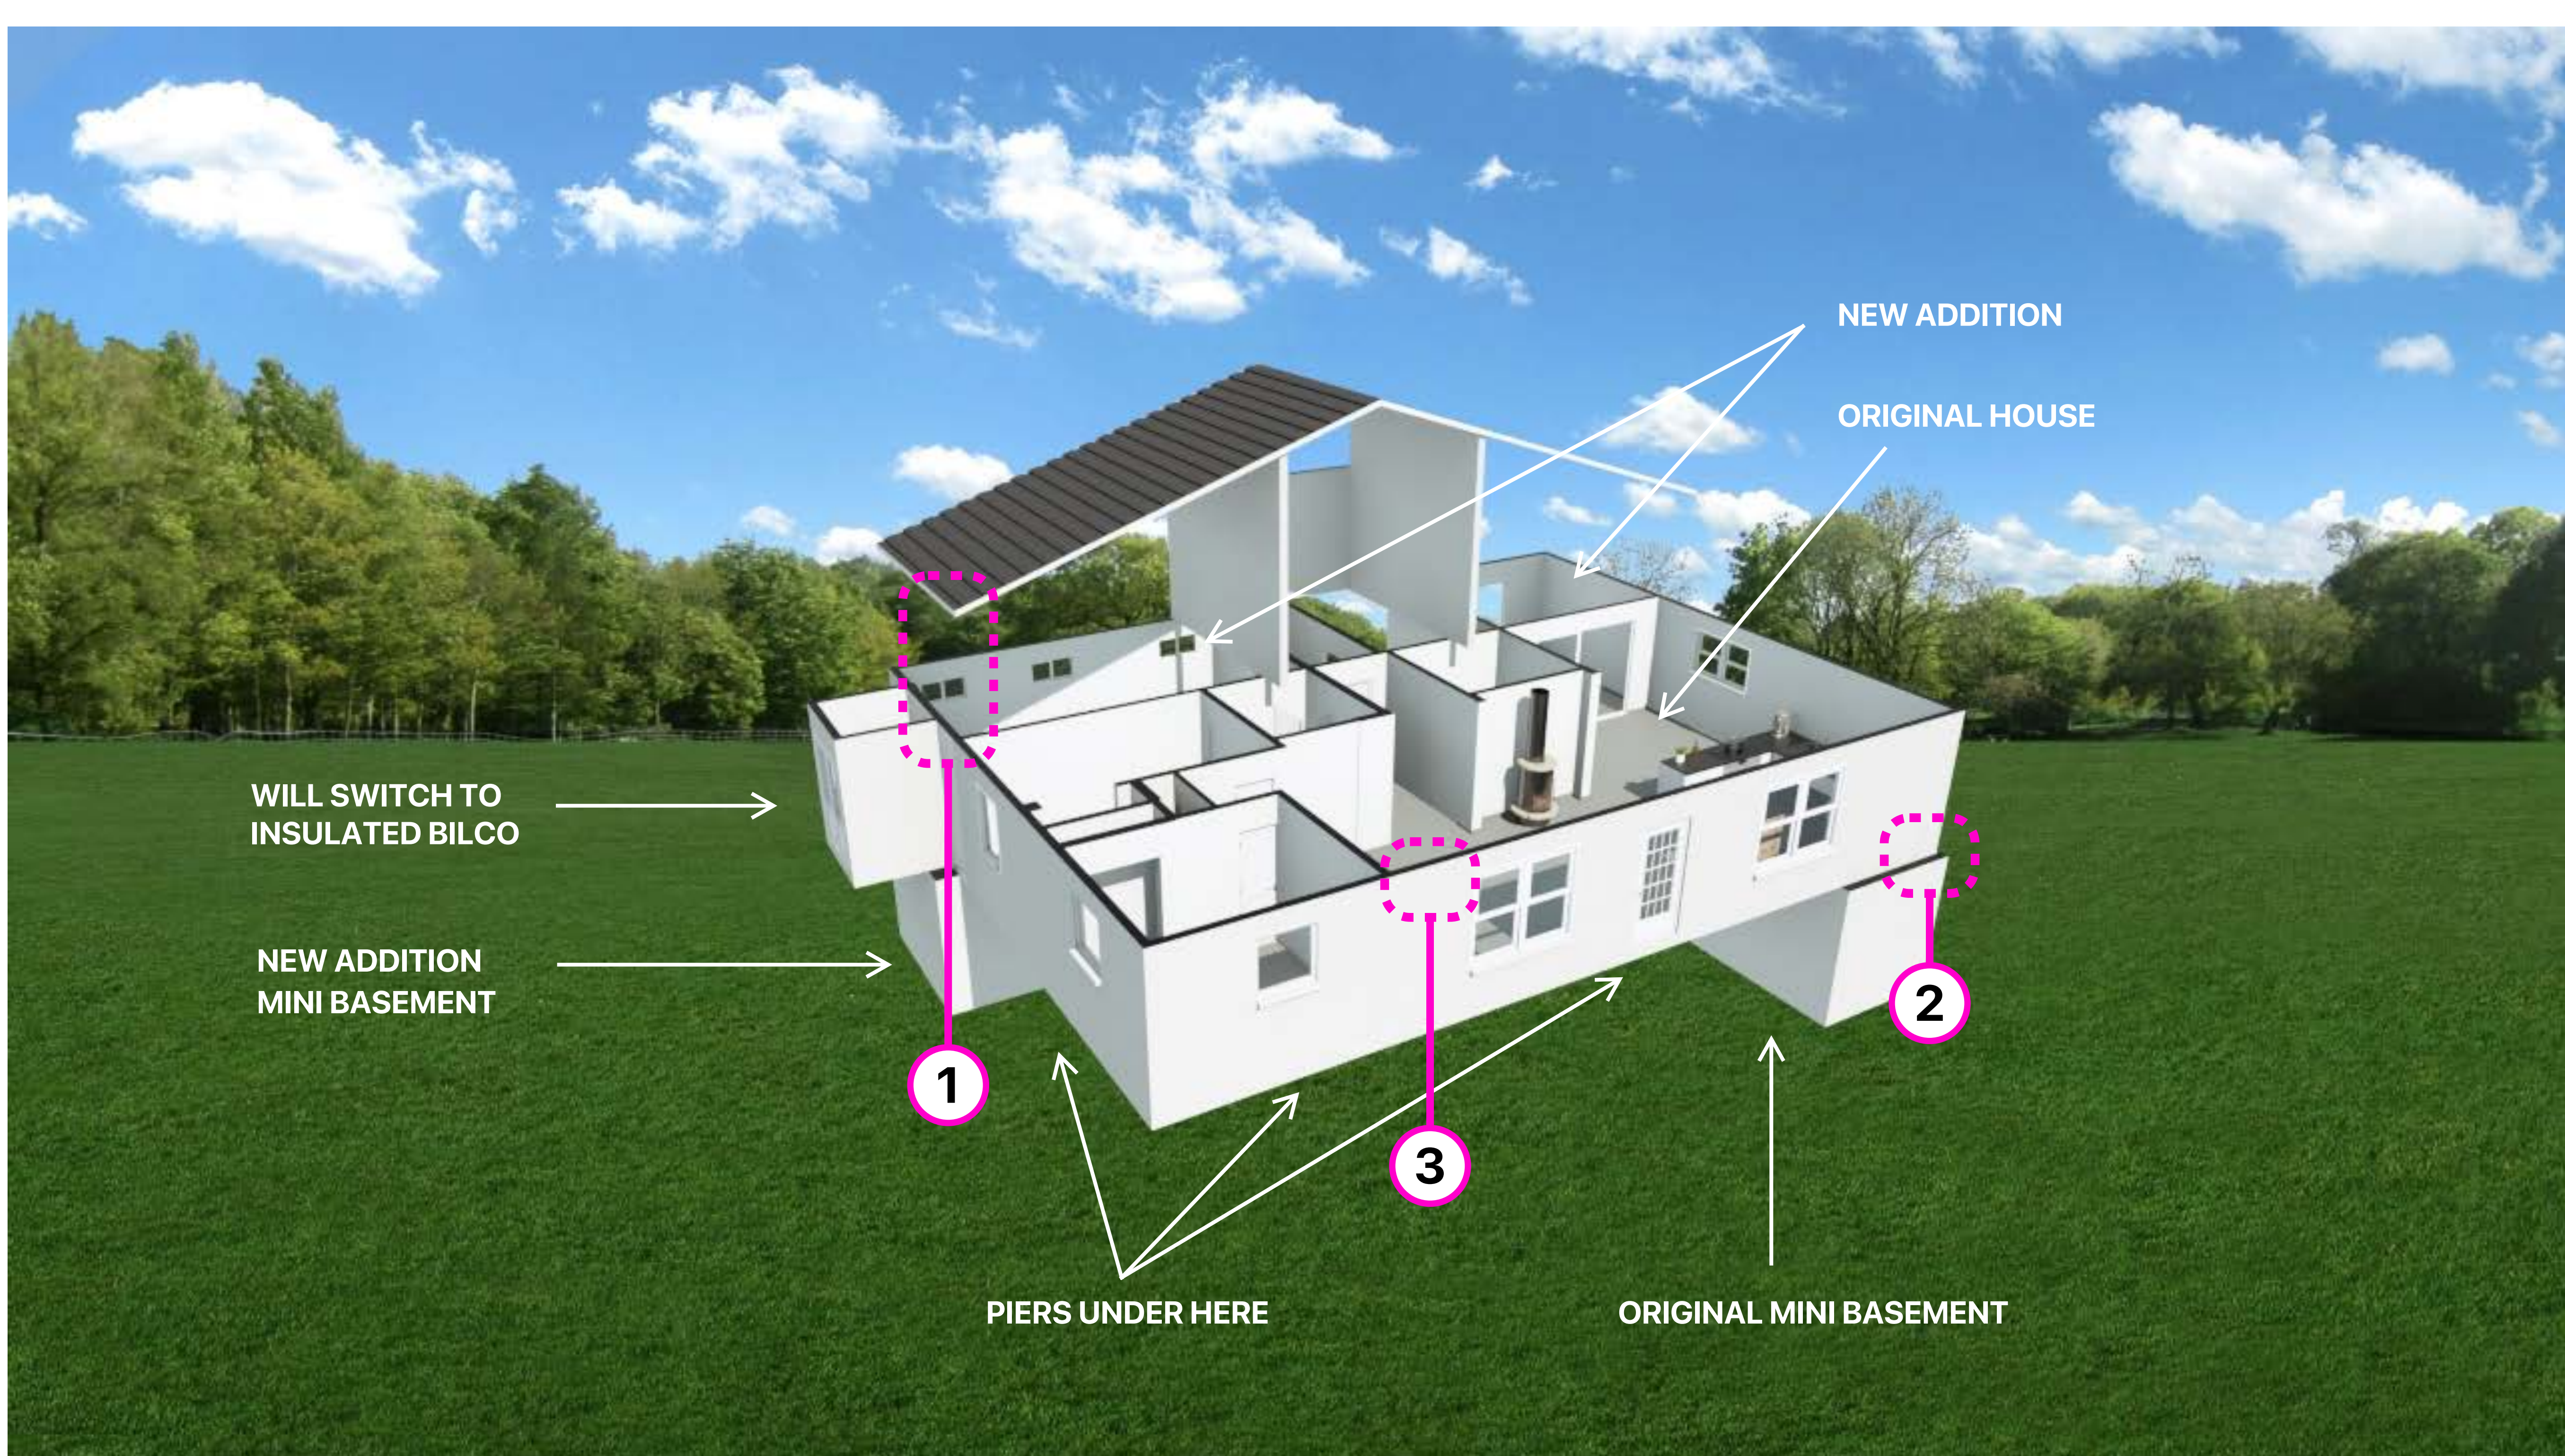
- Service cavity avoids air seal punctures from electrical, holds plumbing, add R value with insulation
- Casement double paned Anderson windows
- No continuous exterior rigid insulation (no thermal break)
- No continuous rigid insulation under floor joists (no thermal break)
- No rain gap

OVERALL R VALUE:
- R23 WALL INSULATION
- R9.13 SERVICE CAVITY
- R32.13 WALL ASSEMBLY
