Current Situation

Proposed Installation

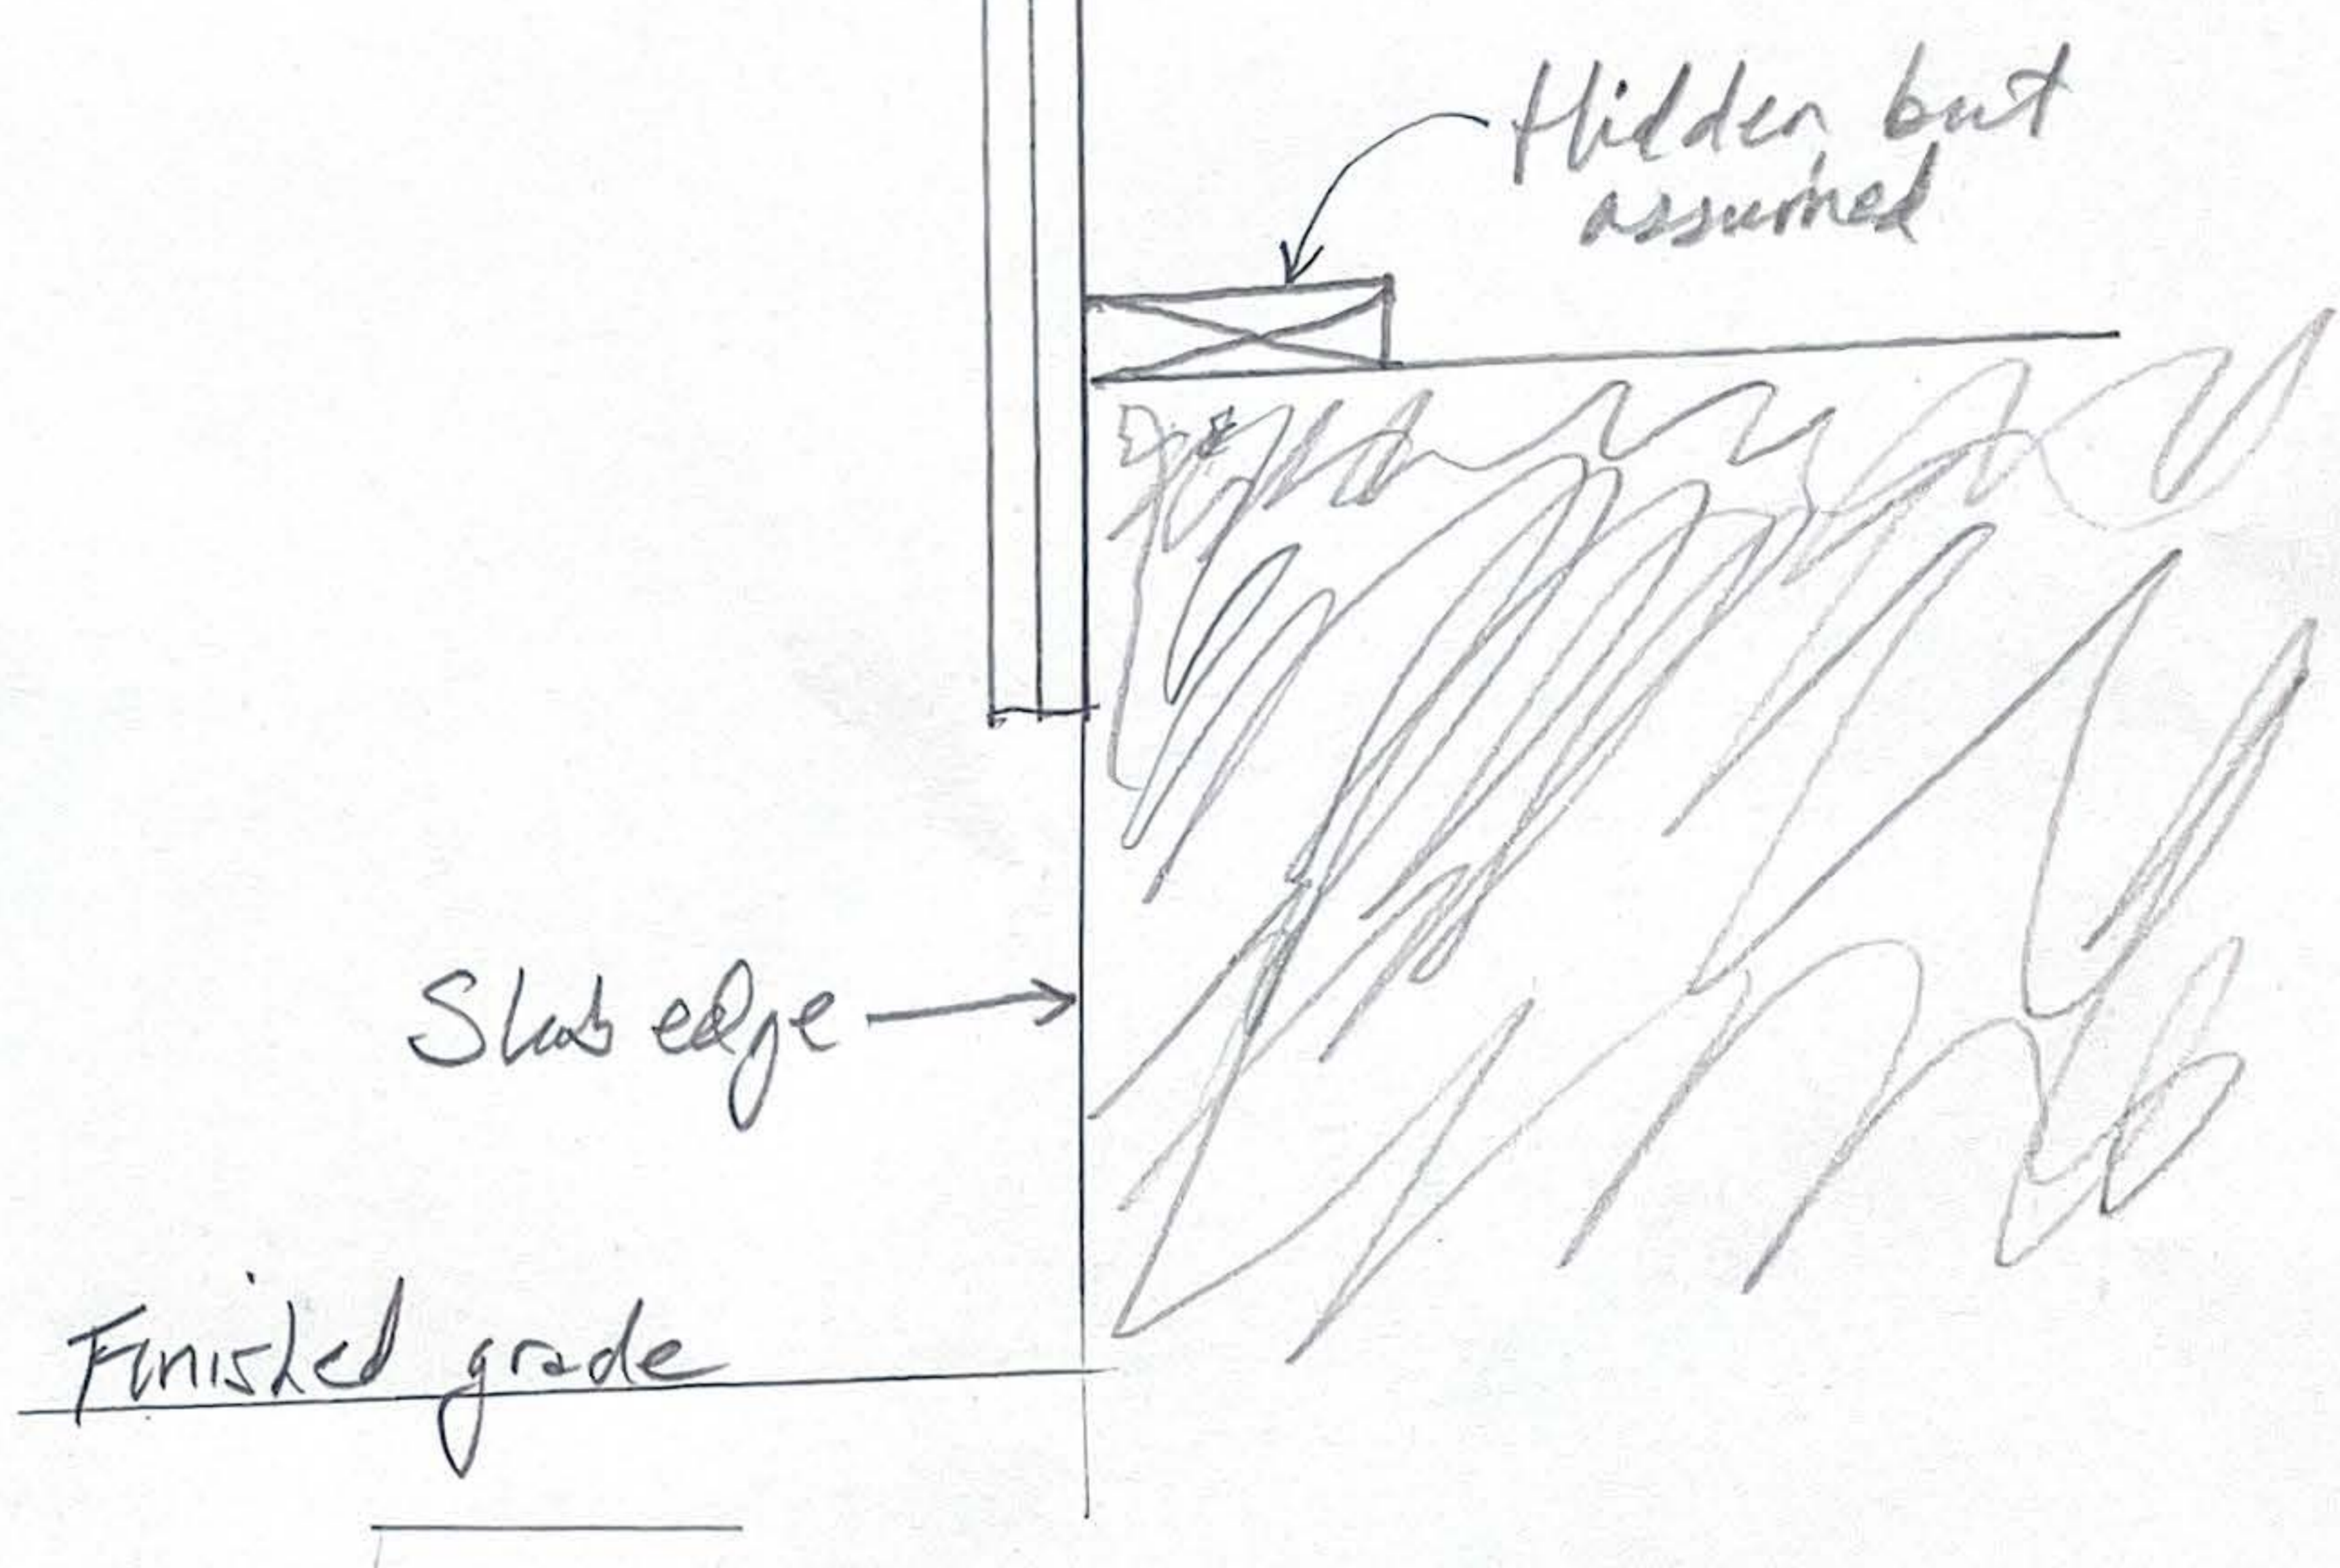
1960s home, so probably no sill sealer or caulk

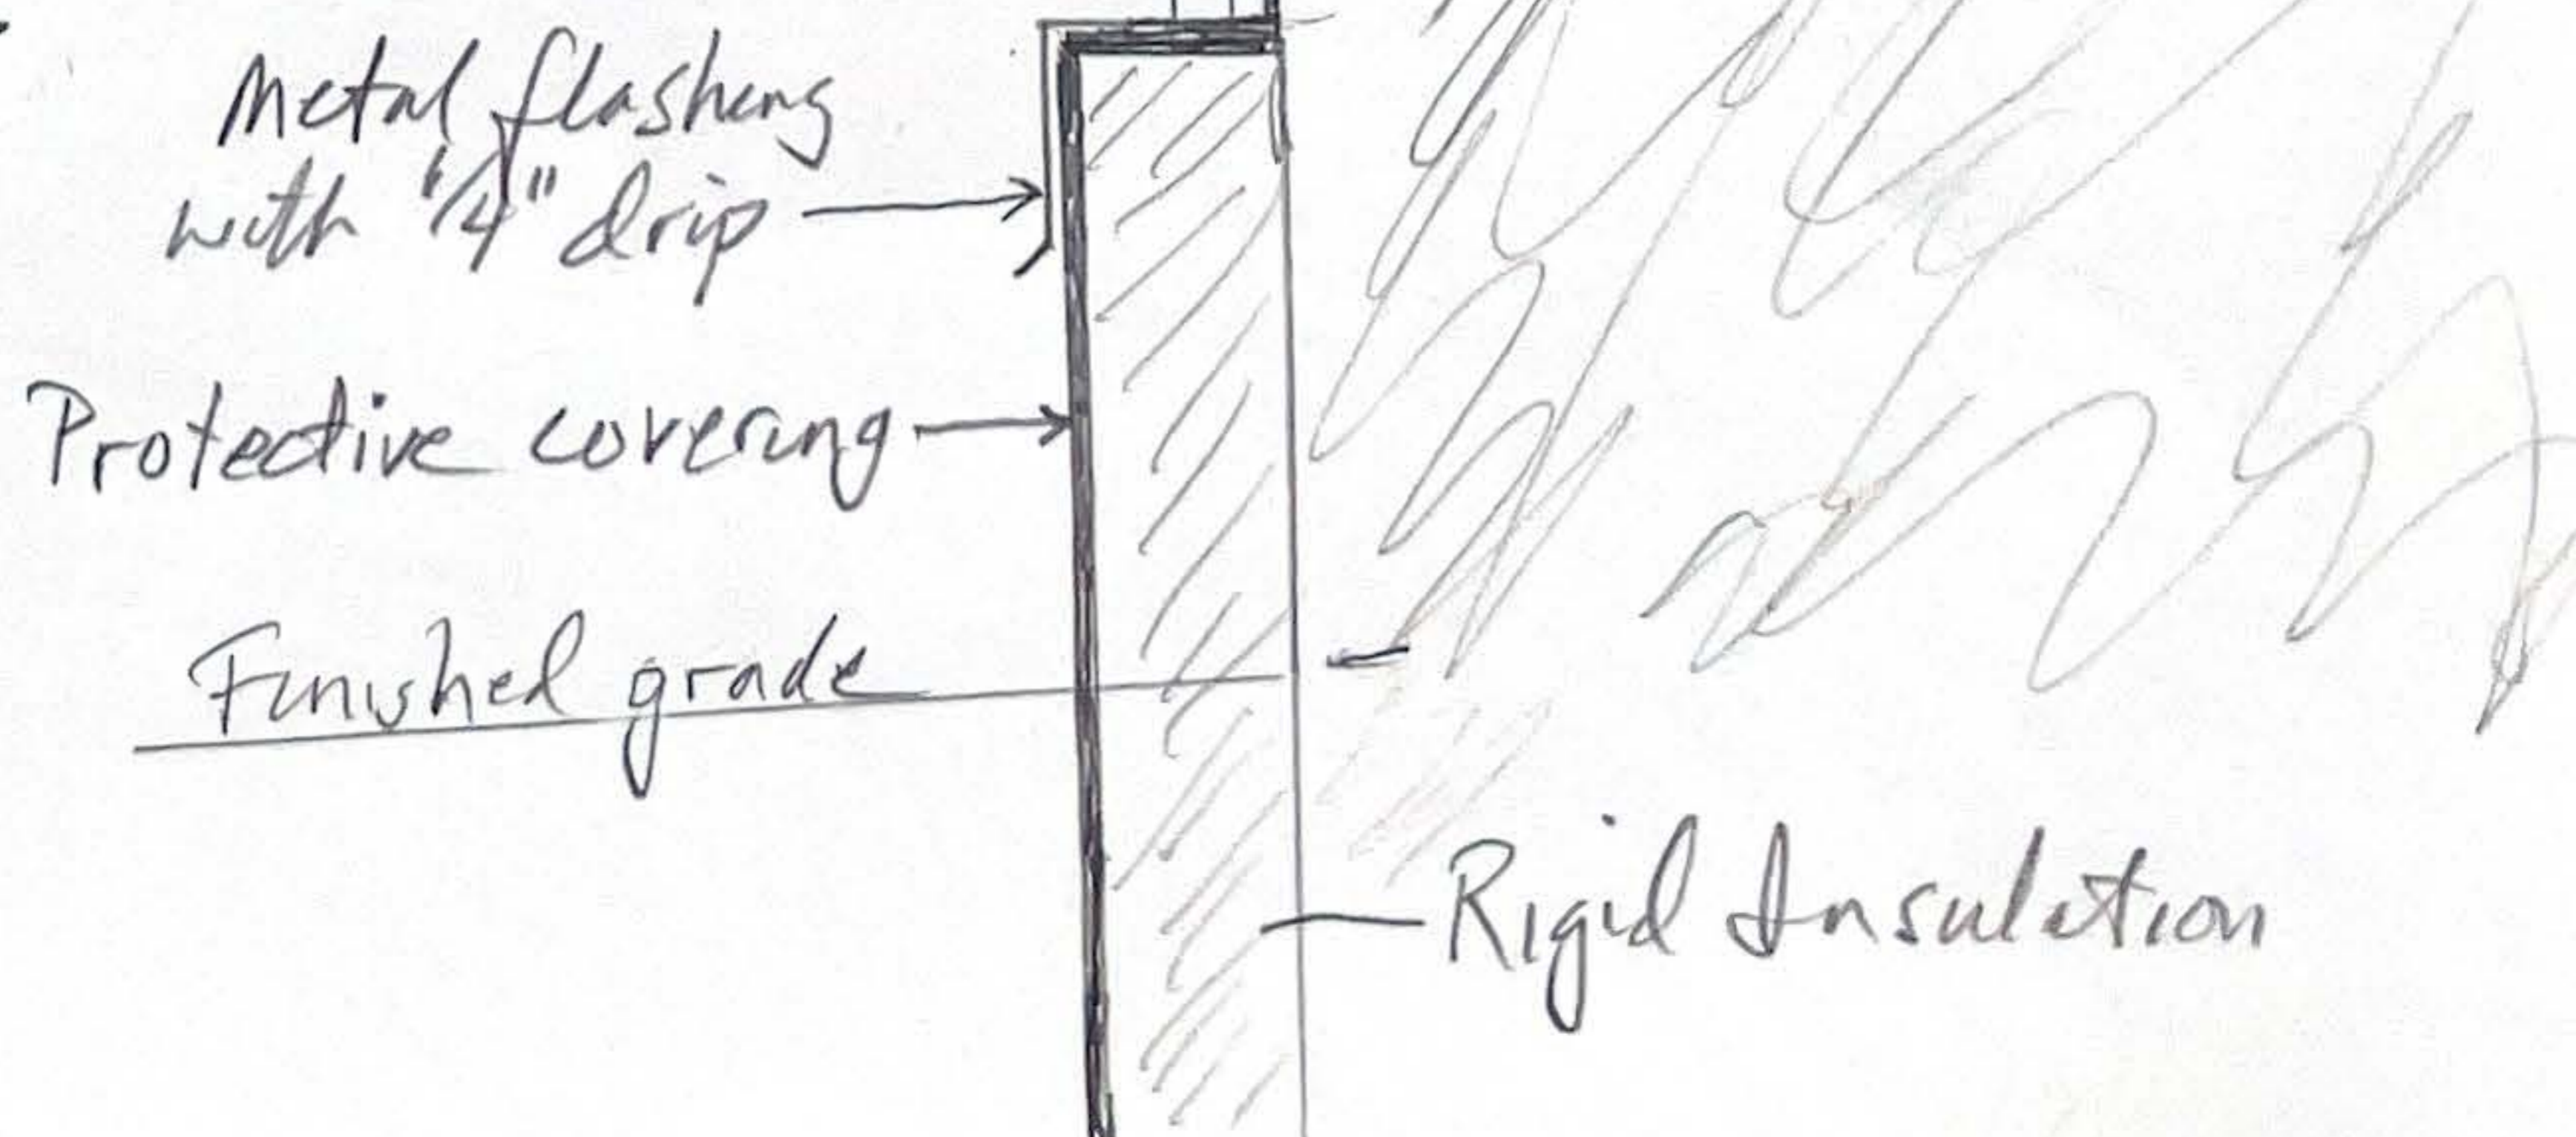
This is a small modification of a GBA detail.

Termites could potentially come up behind protective covering or the insulation.
